With the ODS compiled into a detailed animation of all the components (see Figure 1), it became clear why the gearbox failures were occurring. The following conclusions were made:

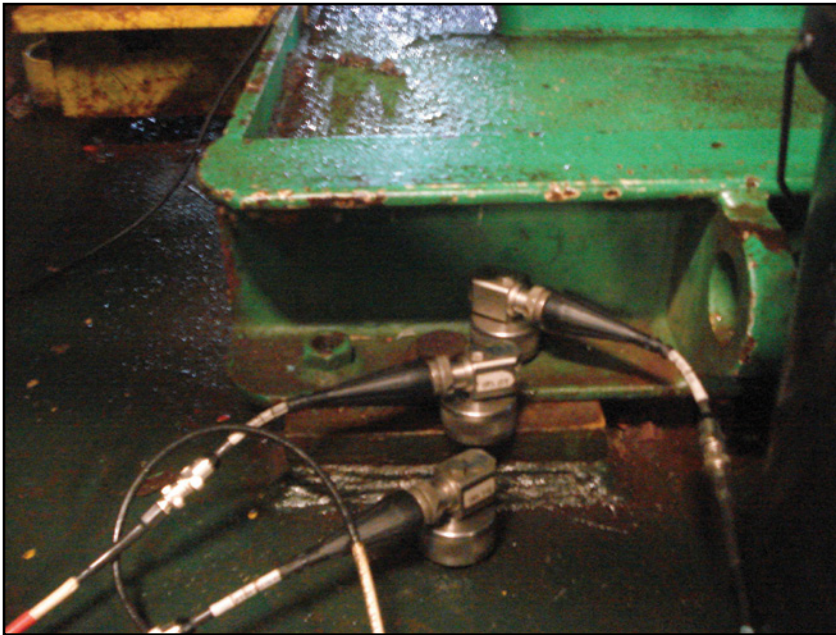
Photo 2: Detailed vibration measurements.

With the ODS compiled from the many vibration test points, it was found that:

- The motor was moving in a circular motion in both the vertical, and axial (parallel to motor shaft) plane. This meant that the motor drive end was moving towards the gearbox and away again, while rocking back and forth about its center.
- The pump and gearbox were moving back and forth in the horizontal direction (perpendicular to motor shaft, in the direction of plunger motion) at the same time the motor motion was occurring.
- The base plate was very flexible underneath the motor and pump, allowing the rocking motion of the motor.
- The platform beams were moving in phase with the base plate motion, showing good connection between the base plate and platform deck. The motion also showed significant flexibility of the platform beams.

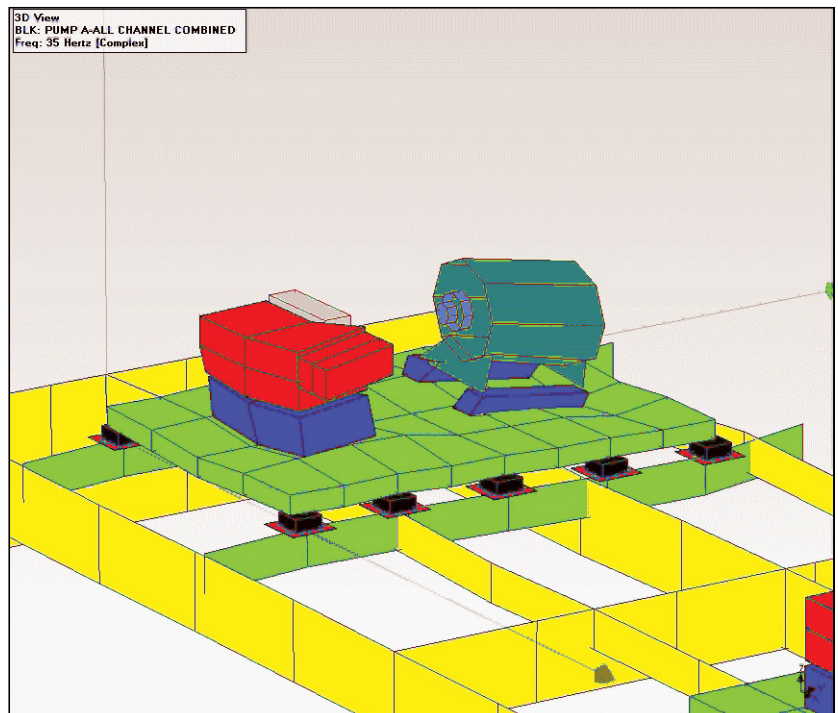
- Excessive flexibility in the base plate was a major contributor to damaging motion of the drive train.
- Platform flexibility underneath the pump base plates was also contributing to damaging motion.
- Connections between the base plate, and platform foundation were good (no loose connections).

- Connections between the motor, pump, and base plate pedestals were good (no loose connections).
- The gearbox failures were due to the combined motion of motor, pump, skid, and platform structure.

Figure 1: Image of pump, motor, base plate and platform ODS.

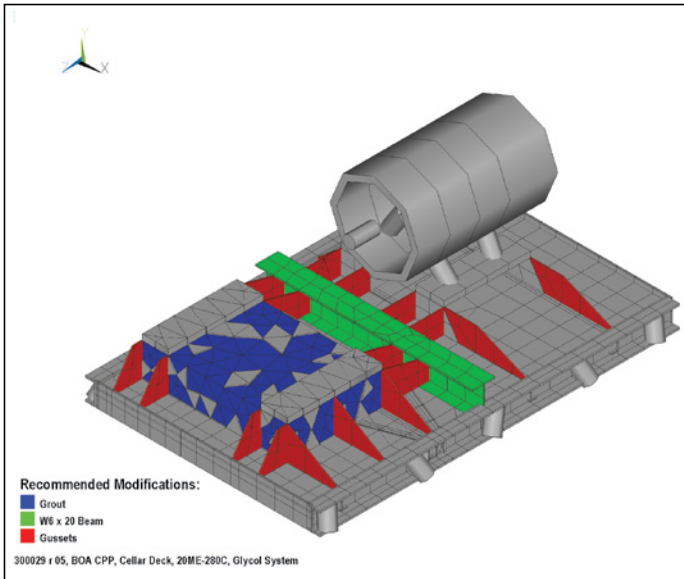
Figure 2: Base plate modifications available for topside access only.

The client agreed to the final modifications that involved stiffening the pump pedestal with grout, increasing the stiffness of the base plate by adding a structural beam on top of

the seal pan, triangular gussets to increase the horizontal and axial stiffness of pump and motor pedestals, and deepening beams under the pumps by welding T-sections underneath selected locations. (See modifications in Figures 2 and 3.)

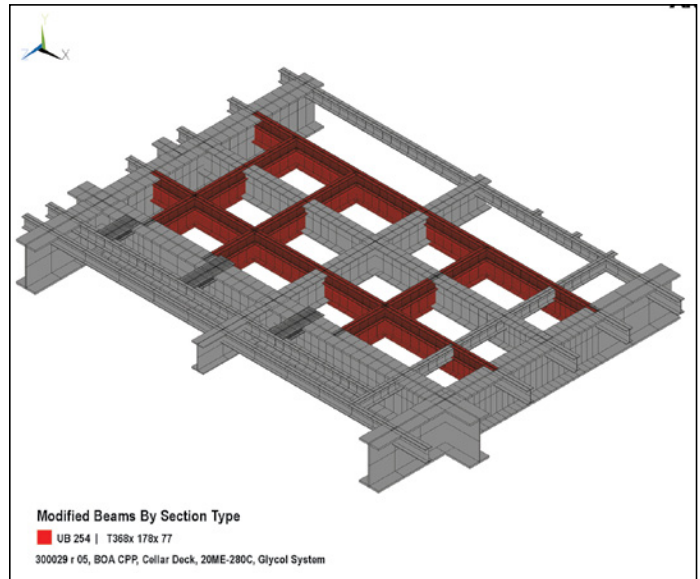
Figure 3: Key beams requiring stiffening.
