RECIPROCATING PUMP DESIGN FLAWS SHUT DOWN OIL PLATFORM

In this case study, two small glycol pumps caused problems at an offshore facility

By Jordan Grose

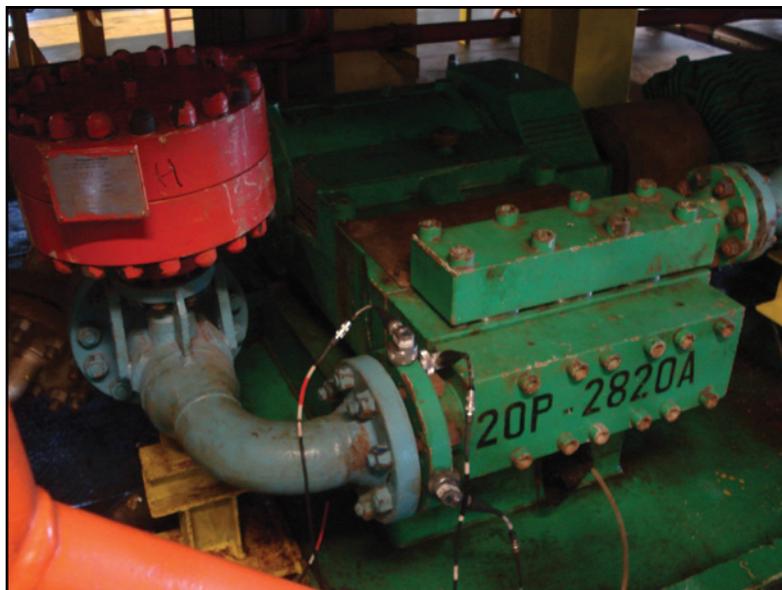
At one large offshore production platform, two reciprocating glycol triplex pumps, 150 hp (110 kW) each, were driven through a gearbox by a 1500 rpm motor (see Photo 1). The system was designed with one pump operating and the second pump as a spare.

But when the gearboxes of these pumps began to fail every four weeks, and the lead time for replacements offshore was six weeks, there was a problem.

That problem was magnified when the spare pump gearbox failed, shutting down production of the entire platform for a few weeks.

Photo 1: Small glycol pumps cause major production platform shutdown.

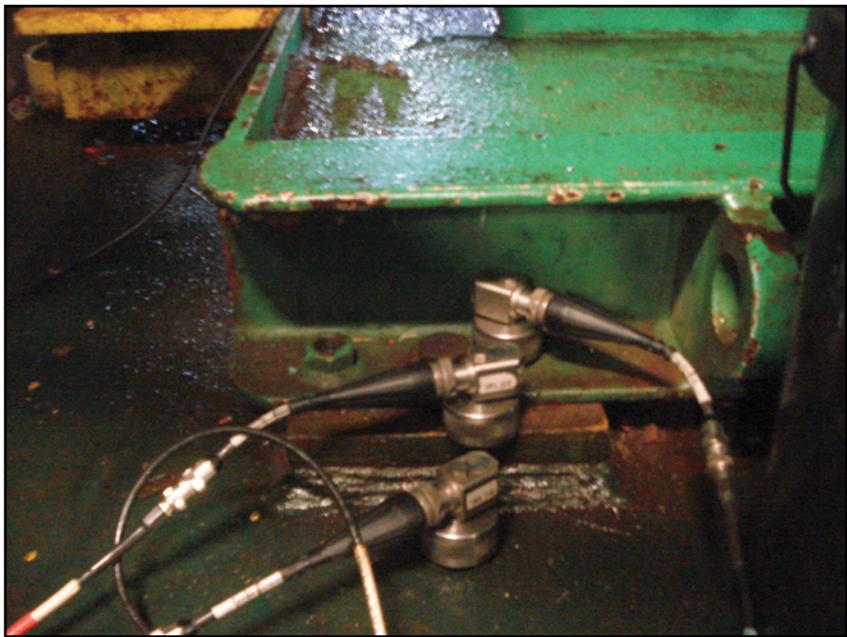
Vibration data was collected on the pump frame, motor frame, gearbox, pump and motor pedestals, base plate (skid), platform mounting pads, and platform beams (see Photo 2).

Photo 2: Detailed vibration measurements.

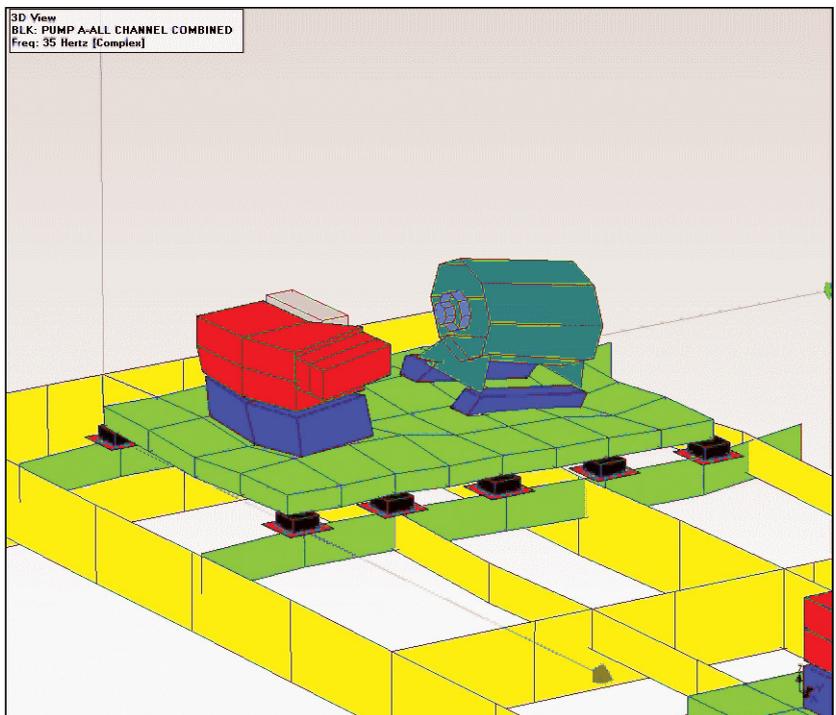
- The motor was moving in a circular motion in both the vertical, and axial (parallel to motor shaft) plane. This meant that the motor drive end was moving towards the gearbox and away again, while rocking back and forth about its center.
- The pump and gearbox were moving back and forth in the horizontal direction (perpendicular to motor shaft, in the direction of plunger motion) at the same time the motor motion was occurring.
- The base plate was very flexible underneath the motor and pump, allowing the rocking motion of the motor.
- The platform beams were moving in phase with the base plate motion, showing good connection between the base plate and platform deck. The motion also showed significant flexibility of the platform beams.

With the ODS compiled into a detailed animation of all the components (see Figure 1), it became clear why the gearbox failures were occurring. The following conclusions were made:

- Excessive flexibility in the base plate was a major contributor to damaging motion of the drive train.
- Platform flexibility underneath the pump base plates was also contributing to damaging motion.
- Connections between the base plate, and platform foundation were good (no loose connections).

- Connections between the motor, pump, and base plate pedestals were good (no loose connections).
- The gearbox failures were due to the combined motion of motor, pump, skid, and platform structure.

Figure 1: Image of pump, motor, base plate and platform ODS.

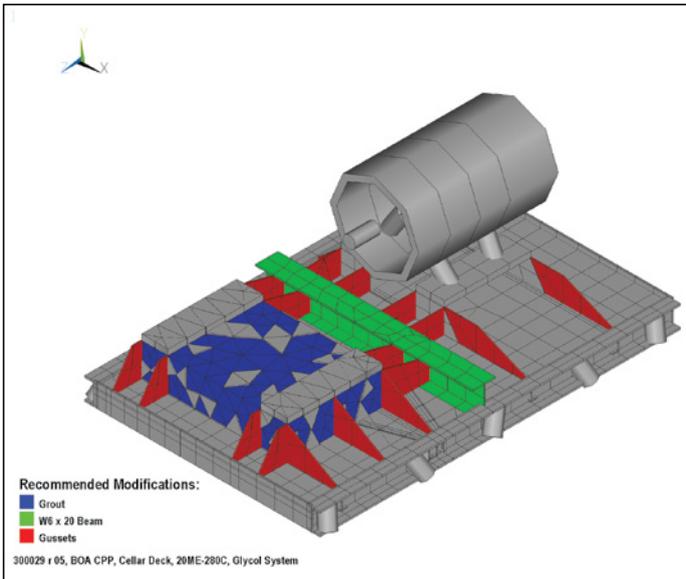
Figure 2: Base plate modifications available for topside access only.

The client agreed to the final modifications that involved stiffening the pump pedestal with grout, increasing the stiffness of the base plate by adding a structural beam on top of

the seal pan, triangular gussets to increase the horizontal and axial stiffness of pump and motor pedestals, and deepening beams under the pumps by welding T-sections underneath selected locations. (See modifications in Figures 2 and 3.)

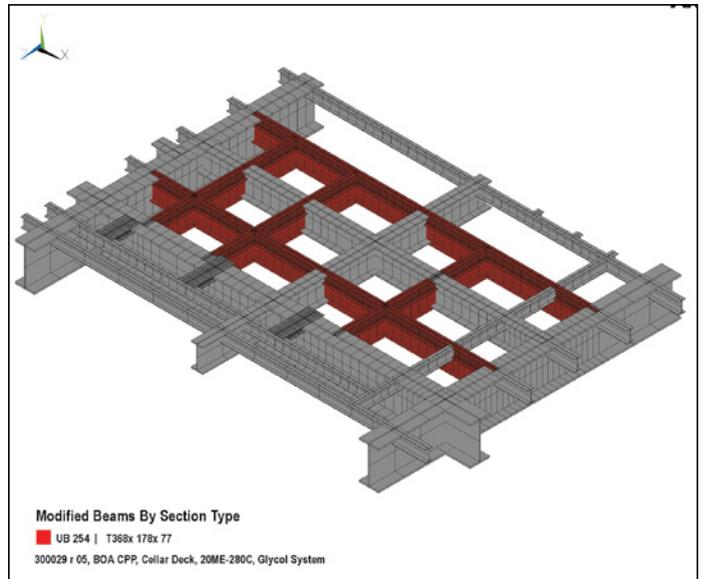
Figure 3: Key beams requiring stiffening.
