# PERPLEXING VARIABLE FREQUENCY DRIVE VIBRATION PROBLEMS

Brian Howes<sup>1</sup>

<sup>1</sup>Beta Machinery Analysis Ltd., Calgary, AB, Canada, T3C 0J7

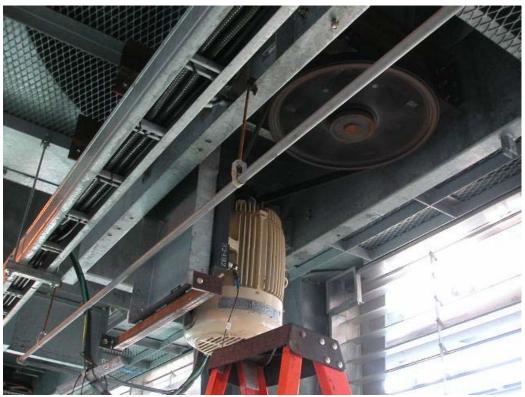
The worst vibrations were in the east-west direction, which is the direction from the motor to the fan. The operating deflected shape (ODS) of the vibration exhibited a rotational motion about a vertical axis through the base of the motor.

The vibrations were so large that they were visible. They were so extreme that the system could not have been run. In fact, a Unit F motor bearing may have been damaged in the relatively limited testing that was done in the attempts to troubleshoot the vibration problem.

Photograph 1: Motor, belt and driven sprocket on unmodified system

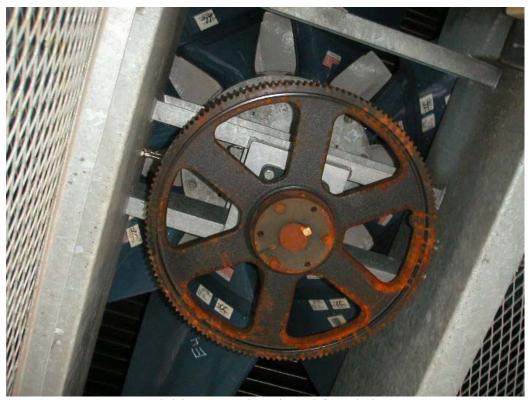
**Photograph 2:** Fan and driven sprocket viewed from below

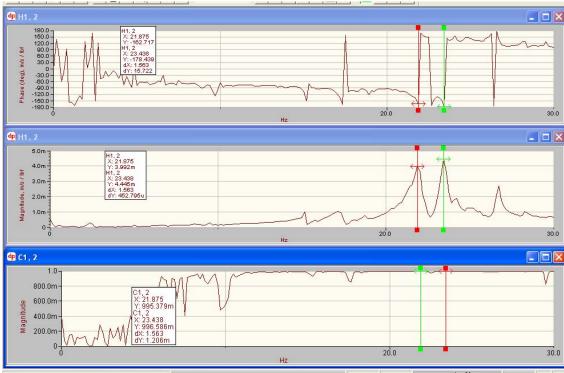
The relevant MNFs are shown in Table 2 below. Figure 1 below shows a typical mechanical natural frequency measurement.

Figure 1: Typical MNF, measured in the east-west direction on a motor, as found

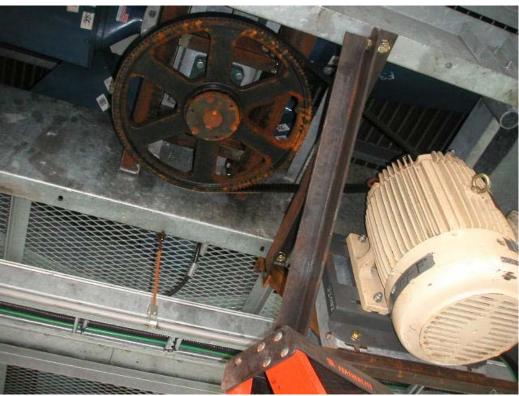
This brace was installed before we arrived. It did not make much difference to the vibrations. The dominant frequency increased about 7%, as discussed above.

**Photograph 3:** The photograph above shows one side of the bracing. The stiffening was primarily in the north-south direction.

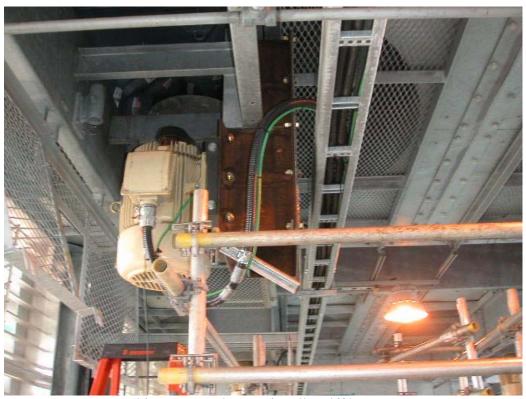
This brace was designed to increase the stiffness in the rotational direction about a vertical axis. It was quite effective, and the vibrations were reduced dramatically, but not enough to be acceptable. The dominant or fixed frequency of vibration actually went down by about 7% with this brace installed.

**Photograph 4:** Looking west at the rotationally stiff brace on motor D
