THE BETA BULLETIN

Profiling of Reciprocating Compressors

Beta Machinery Analysis Ltd. was retained to investigate high vibrations on a fuel gas package, consisting of three fixed speed, two-throw reciprocating compressors. Depending on the demand, up to two of the compressors would be run, with the third as a spare. This was a new installation, and the client was concerned because the vibration monitors were reading vibrations as high as 0.5 ips on the compressor frames of those machines that were running. As well, vibrations at levels of 0.2 ips were measured on the spare compressors. Vibration Profiling proved to be a good tool for analyzing this situation.

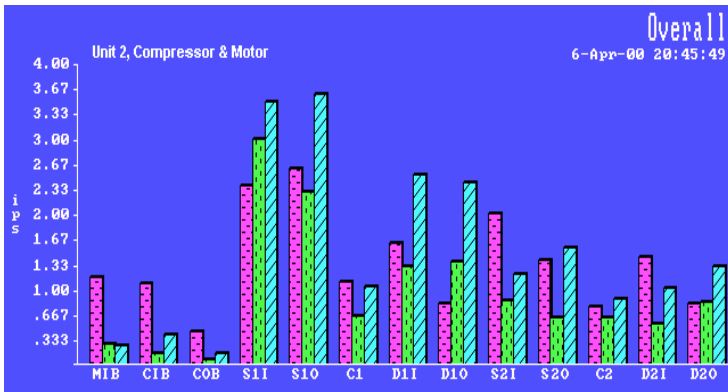
These two profiles show that there were a number of points well above the guideline of 1 ips pk. In fact, the inboard end of the compressor frame had vibrations of over 1 ips in the horizontal direction. As well, the number 1 cylinder suction bottle was over 2 ips pk in the horizontal, vertical and axial directions at both ends. The number 2 cylinder suction bottle was also above guideline in the horizontal and axial direction. High vibrations were also found on Unit 2 piping, especially the relief lines.

Figure 1. Overall vibration profile on Unit 2 as found, taken on compressor, motor, and bottles

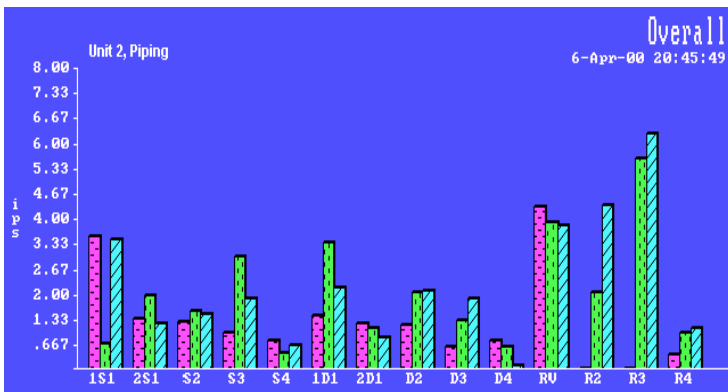
Figure 2. Overall vibration profile on Unit 2 as found, taken on piping.

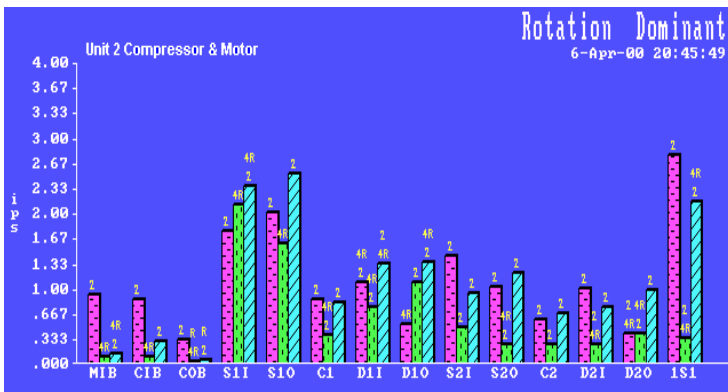
Figure 3. Rotation dominant profile of Unit 2 in the as found condition.

Figures 3 and 4 show the rotation dominant profiles. In this case, the rotation dominant profiles isolate the maximum amplitudes that occur at 1x, 2x, 3x, 4x, 6x and 8x compressor run speed. If we look at the number 1 suction bottle inboard end (S11) in the axial direction (see Table II for a definition of directions), we see a bar higher than 2.33 ips. The “2” immediately above the bar indicates that the 2x compressor run speed (or approximately 40 Hz) was the dominant component. That is, the 2x component had an amplitude of 2.33 ips pk. The “4R” above the “2” indicates that the 4x component was more than 50% of the dominant component. This can be confirmed by looking at the spectrum for that point, as shown in Figure 4. As well, a quick scan across the profile reveals that at most of the points, the second order component (2x) was the highest amplitude.

Further field analysis revealed that the compressors had a mechanical natural frequency near 2x or 40 Hz. The mode shape was a rotation of the compressor and the attached bottles and piping about a vertical axis near the center of the compressor frame. The relief header joining the three compressors also had a mechanical natural frequency at 2x. Acoustic analysis (computer modelling) revealed the presence of high pulsation forces at 2x. The acoustic forces, along with the inherent high unbalance couple at 2x in a two-throw compressor resulted in high amplitude vibrations of the compressors, cylinders, bottles and attached piping.

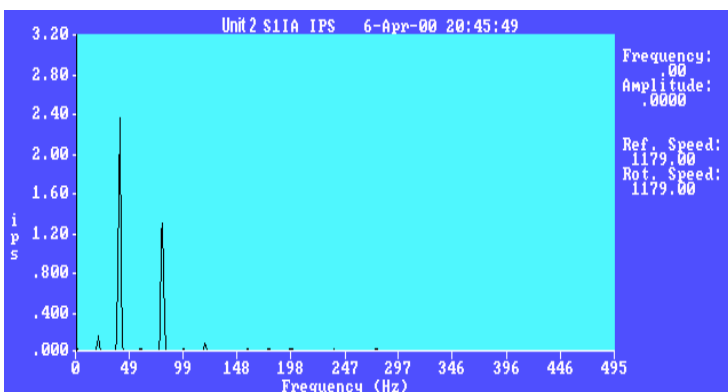
Figure 4. Spectra of the axial vibration measured at S11 on Unit 2 as found.

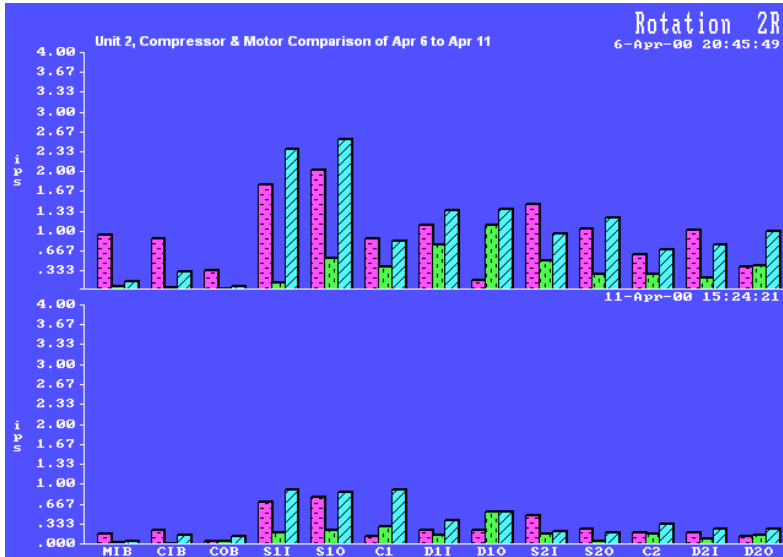
Figure 5. . Comparison of the second order vibration components on Unit 2 compressor, before and after modification.

The solution was to cut the outboard cylinder supports. This lowered the natural frequency of the compressor below 2x run speed. The relief line and pressure relief valves were braced at the appropriate locations. As well, orifice plates were added to reduce the acoustic forces. The profiles of the second order vibrations measured on Unit 2 as found on April 6th and as modified on April 11th are compared in Figure 5. The difference in the amplitude of the second order component of the vibration is clearly seen. A comparison of the resulting overall vibrations on Unit 2 from the as found to the as modified is shown in Figure 6. The difference that the modifications made to the overall vibration levels is quite apparent. Although some of the levels exceeded the 1 ips guideline after modification, they were considered acceptable. Figure 6 was used in a wrap up meeting to quickly help the client understand the success of the modifications.

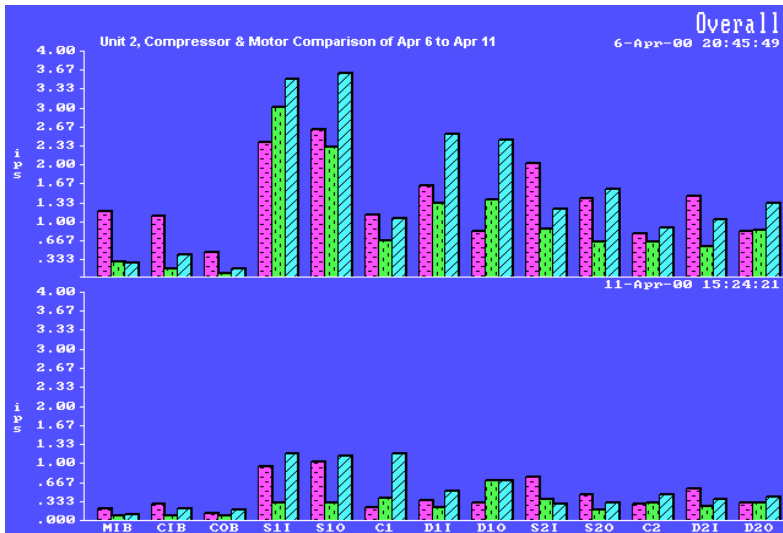
Figure 6. Comparison of the overall vibration profiles on Unit 2 compressor, before and after modification.
