THE BETA BULLETIN

VOLUME 13 #1

Case Study: Turbo Generator

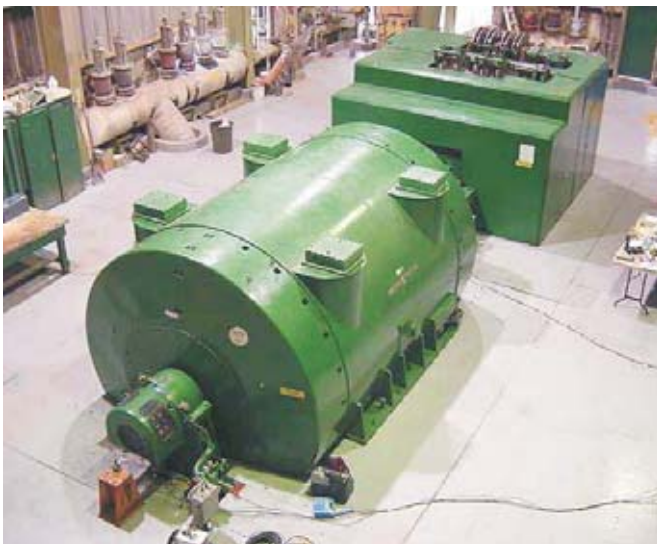
An overall view of the turbo generator is shown in Figure 1. The near end is the opposite drive end bearing of the generator with the exciter cantilevered from it. At the far end is the steam turbine with the turbine's outboard standard containing timing and control devices at the far end (but not visible in the photograph).

Figure 1. Overall view of the turbo generator.

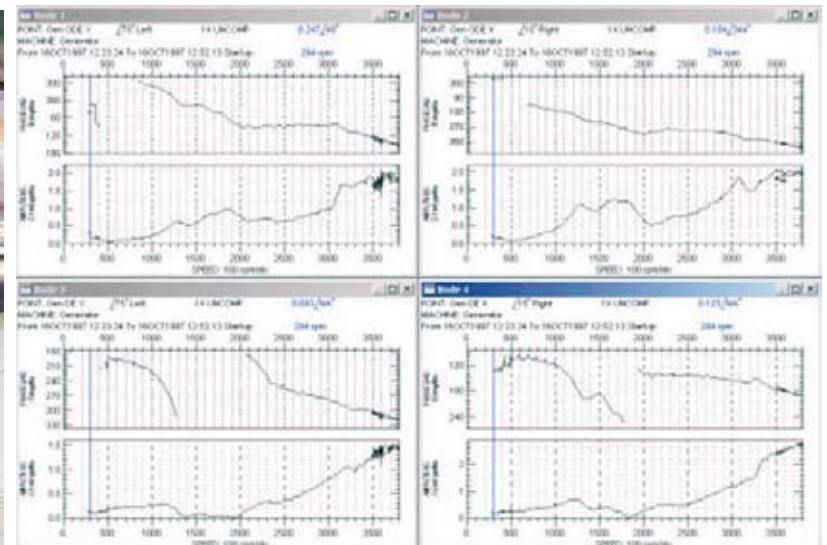
Figure 3 shows the dominant 1x component of the shaft relative measurements. As can be seen, the first critical of the generator rotor was in the 1700-1900 rpm range and was well damped. Also above 2000 rpm the shaft relative motion increased faster than r^2 (particularly the DE X probe readings), suggesting that rotor was approaching a second critical above 3800 rpm. The bump in the ODE X probe reading at 3100 rpm was due to an axial resonance of the opposite drive end bearing pedestal at 52 Hz. The turbine first critical was at 2100 rpm.

Figure 3. As found Bode plots of the shaft relative data for the generator in 1997.

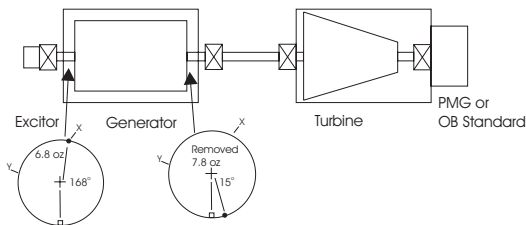
Figure 4. First stage balance weights on generator DE and ODE balance planes.

The balancing of the generator rotor began as a simple two plane process. Since a thermal bow in the rotor had been identified, measurements were taken after one hour of heat soak at full power (36 MW). The first stage of balancing was accomplished by adding correction weights to the DE and ODE generator balance planes. There was significant improvement in both shaft relative and bearing pedestal vibration magnitudes. With the existing looseness in the bearing pedestals a residual unbalance of less than 1.5 oz-in/1000 lb was desired but not yet accomplished (particularly at the ODE). Further adjustments of the weights were attempted, but any reduction in vibration at ODE was met with a corresponding increase at DE. The first stage correction weights are shown in Figure 4.

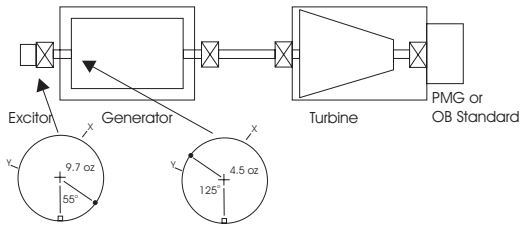
Figure 5. Second stage balance weights on generator ODE and slip ring (exciter) balance planes.

The radius at plane 2 was 9.75", while at the slip ring it was 4". This did not have the desired result. Then two weights were rotated relative to each other so that a couple was imposed, but the force was zero (i.e. 180 degrees apart, see Figure 5). This couple reduced the motion at the ODE, but did not increase the motion significantly at the DE. This resulted in an acceptable residual unbalance.

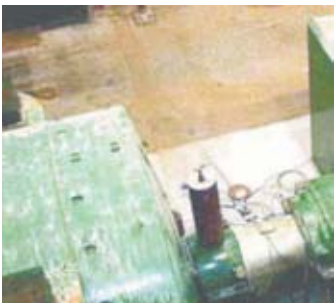
The results were poor with both radial and axial vibration increasing to higher levels. Axial vibration, in particular, was at serious levels. They elected to install mass dampers on the generator bearing pedestals over further balance correction (see Figure 6). The mass dampers improved the high axial vibration.

Figure 6. Tuned mass damper installed on inboard generator pedestal in 2001.

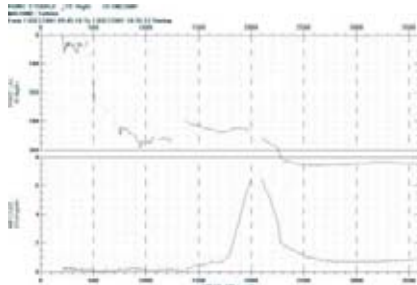
As shown in Figure 7 below, there was a large increase in turbine shaft relative amplitude as the unit passed through its critical speed during rundown. There was a simultaneous 180 degree change in phase, which is characteristic of resonance or a critical speed. The energy level seen at the turbine ODE during passage through the critical speeds was far more severe than expected. The energy of this occurrence could be felt in the building structure. The operators indicated they had noted this was occurring regularly since the June 2001 removal of the turbine and rebalancing of the generator.

Figure 7. Bode plot of 1x component measured at the turbine opposite drive end bearing.

Full bearing clearance for the smaller turbine outboard journal is recorded as 9 mils. API General Purpose Steam Turbine Standard 611 states that the calculated unbalanced peak to peak rotor amplitudes at any speed from zero to trip shall not exceed 75 percent of the minimum design diametrical running clearances throughout one machine. For the turbine outboard bearing the allowable limit for shaft vibration is thus 6.75 mils p-p. The Bode plot indicates an as found shaft vibration of 8 mils p-p, exceeding the allowable limit. This unsafe condition required review of the forecasted trim balance response to avoid worsening this as found result (and hopefully improve it).

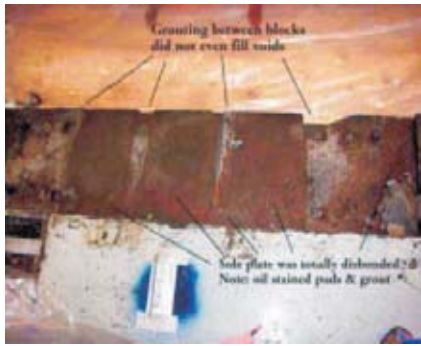
While the generator rotor was out, the looseness of the generator pedestals and soleplates was finally addressed. They were removed, and large voids and degradation of the grout were found (see Figures 9 and 10). The soleplates were re-grouted, and the pedestal spacer pieces were replaced with solid blocks.

Fig. 9 & 10.
Two views of grout under the generator DE bearing pedestal as found in the spring 2003.
