Centrifugal Compressor Case Study

Bill Eckert, P.Eng., Ph.D., Principal Engineer
Beta Machinery Analysis
Calgary, AB Canada
beckert@betamachinery.com

Gas Machinery Conference October 4-6, 2010 Phoenix, AZ

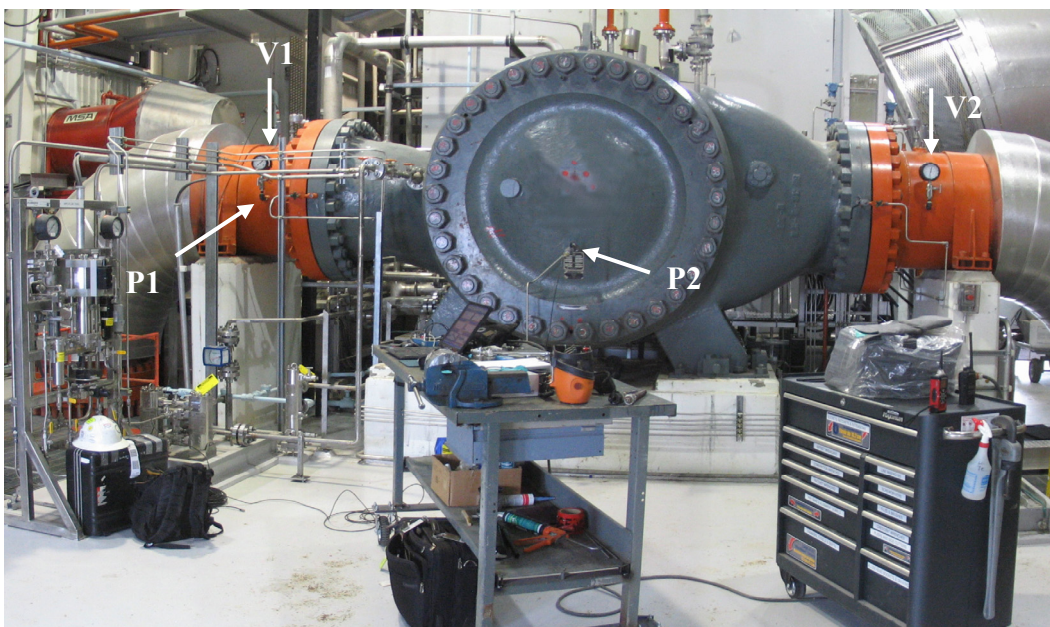
Figure 1. Unit A2 with initial test points marked.

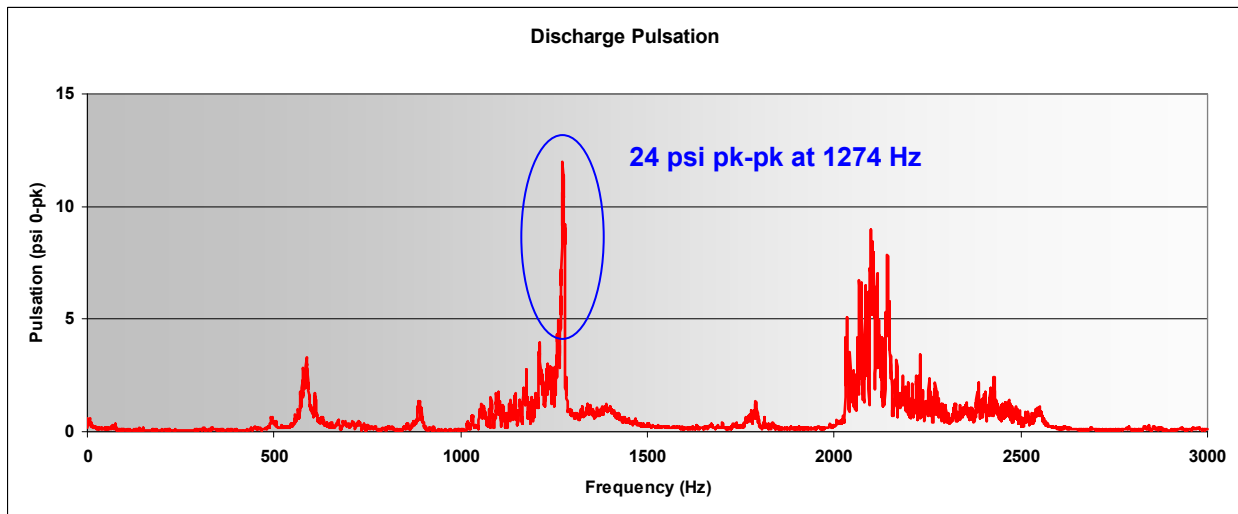
Subsequently, testing of one centrifugal compressor (A2) was done on January 12, 2010 with the primary objective to look for pulsation induced issues. Onsite discussions with plant personnel revealed that a loud noise and vibration of the piping developed at higher operating speeds – again supporting the likelihood of pulsation. Figure 1 shows the unit tested with suction on the right hand side of the photo and discharge on the left. Initially, peak hold pulsations were measured at the compressor discharge and compressor suction eye (marked as points P1 and P2 respectively on the photo) over a speed range of 3600 – 4500 rpm. As the speed increased, the pulsation in the discharge line increased and spiked at the upper end of the speed range (see Figure 2). The peak pulsation was 24 psi pk-pk (compared to a discharge pressure of approximately 825 psig). There is no guideline, but that pulsation is approximately 3% of the mean pressure. In comparison, the pulsation in the suction eye was considerably lower throughout the tested speed range (less than 0.2% of mean pressure) and did not develop a significant single peak (see Figure 3). The frequency of the peak pulsation in the discharge was 1274 Hz which was 17X the run speed and equaled the number of vanes in the impeller (blade pass frequency or BPF). The noise in the building changed when the spike in the pulsation

Figure 2. Pulsations in the discharge piping (P1) over 3600 – 4550 rpm.

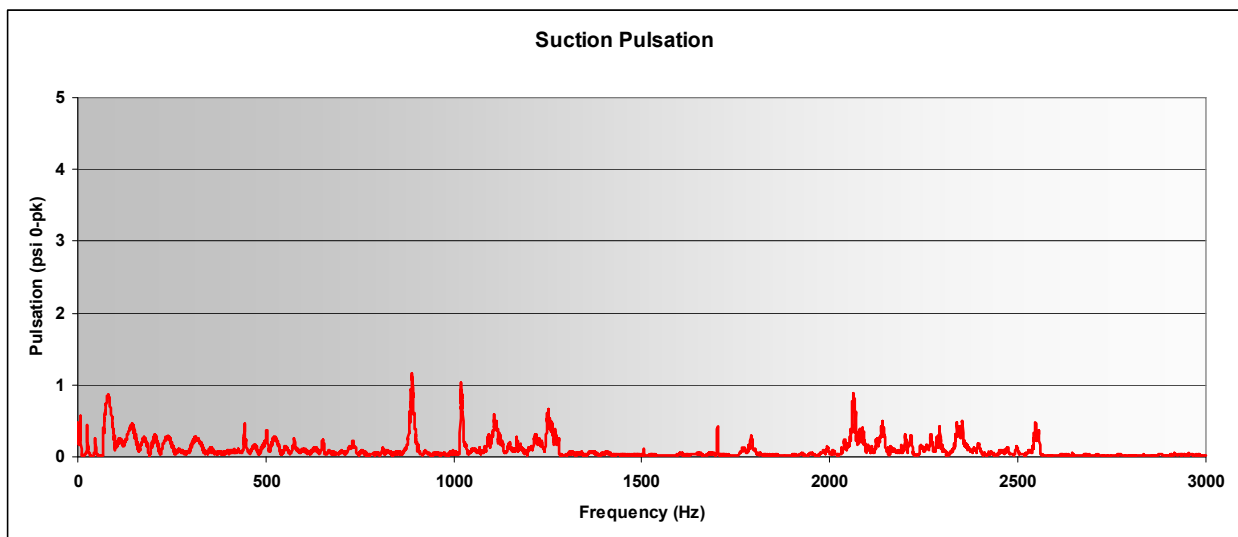
Figure 3. Pulsations in the compressor suction eye (P2) over 3600 – 4550 rpm.

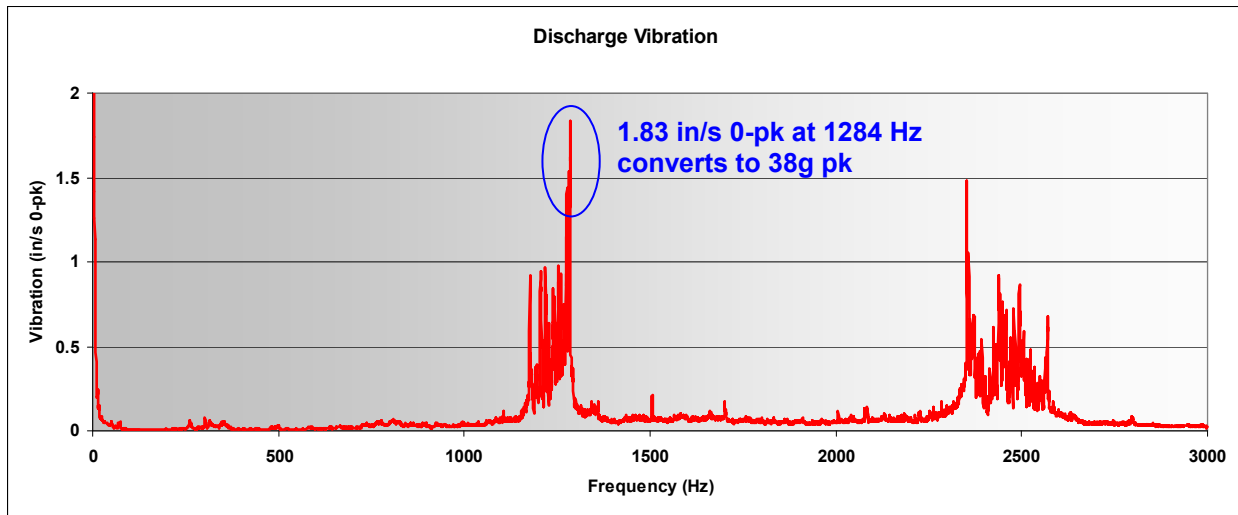
Peak hold vibrations were then measured on the discharge and suction piping beside the temperature instrumentation immediately adjacent to the compressor (marked as points V1 and V2 respectively on the photo) over a speed range of 4100 – 4510 rpm (Figures 4 and 5). As with the pulsations the vibration on the discharge side was significantly higher than the suction side. The discharge piping is 36"OD with 0.75" wall thickness. The peak vibration on the discharge was 1.83 in/s pk at 1284 Hz. Again that frequency was equal to blade pass at 4510 rpm. The vibration is equivalent to 38 g's peak in acceleration terms. Instrumentation that is rated for vibratory service often has an acceleration limit of 10 g's peak. No wonder the RTD's have been failing!

Figure 4. Vibration on the discharge piping beside the thermowell (V1) over 4150 – 4510 rpm.

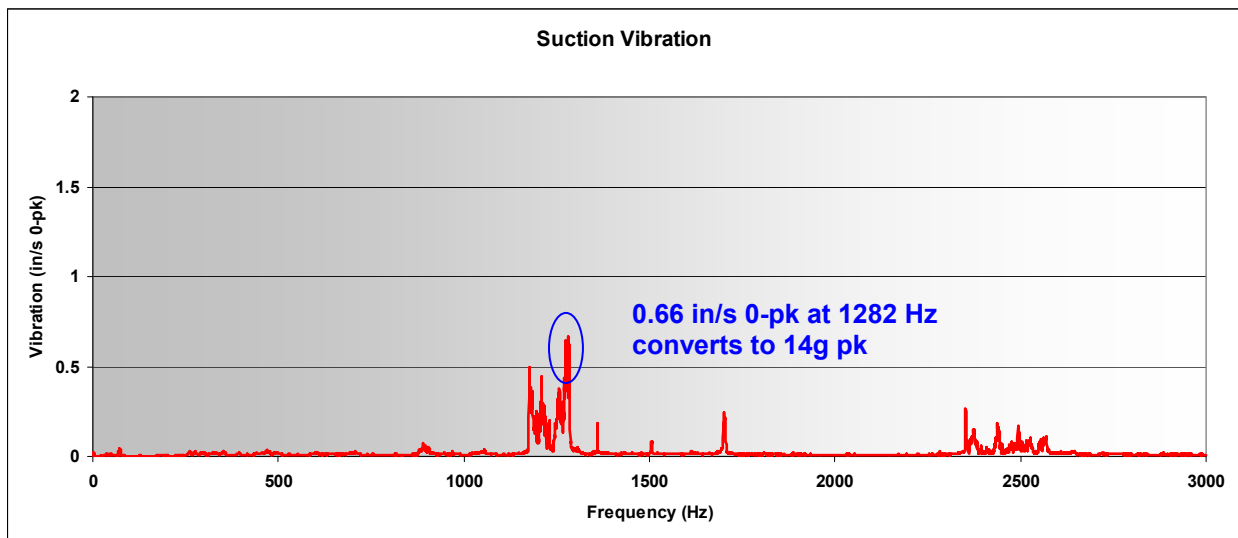
Figure 5. Vibration on the suction piping beside the thermowell (V2) over 4150 – 4510 rpm.

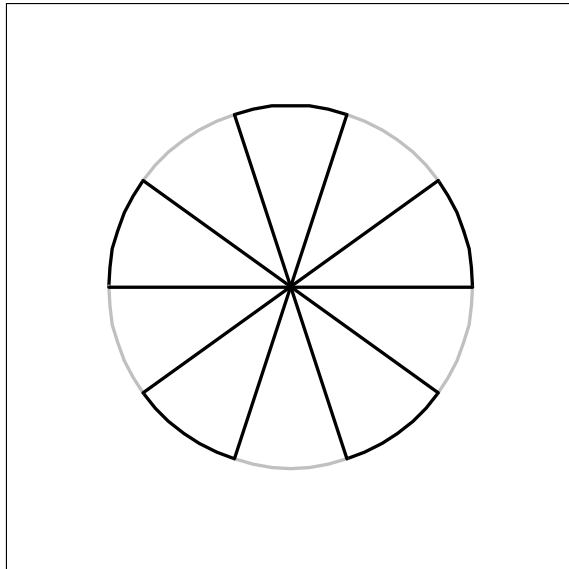
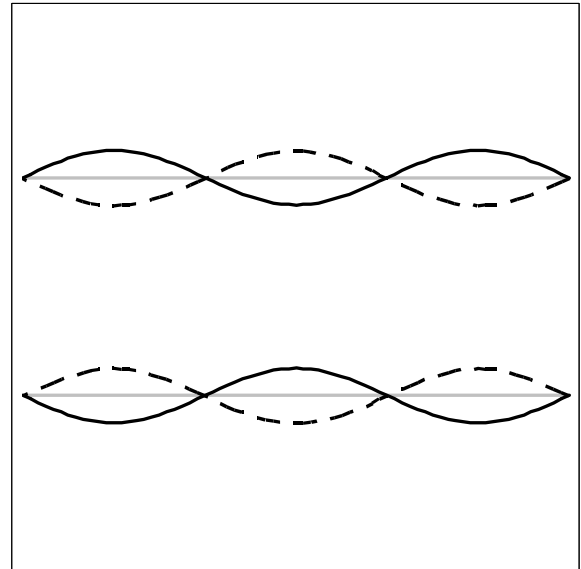
Further study of the problem was conducted to see if coincident acoustic and mechanical natural frequencies could be confirmed analytically. First calculations were performed on the acoustic natural frequencies of the discharge piping. To limit the complexity of the actual geometry, these calculations were limited to the straight run between the discharge flange the first elbow and assumed a rigid pipe wall. At the high frequencies and dimensions, we are not looking at simple plane waves in the pipe. There are many acoustical natural frequencies with transverse and axial components to the mode shape. But interestingly, one of the frequencies that came out of the calculation matched the measured frequency relatively closely (1261 Hz vs 1274 Hz). That acoustical mode had 5 high pressure lobes in one plane and 3 nodes along the axial length (see Figure 7). That obviously matched the ODS measured on the pipe at one circumference of the discharge line. How about along its length?

Figure 7. Acoustic mode $i=5$ (plane), $j=3$ (axial), $k=0$ (circle)

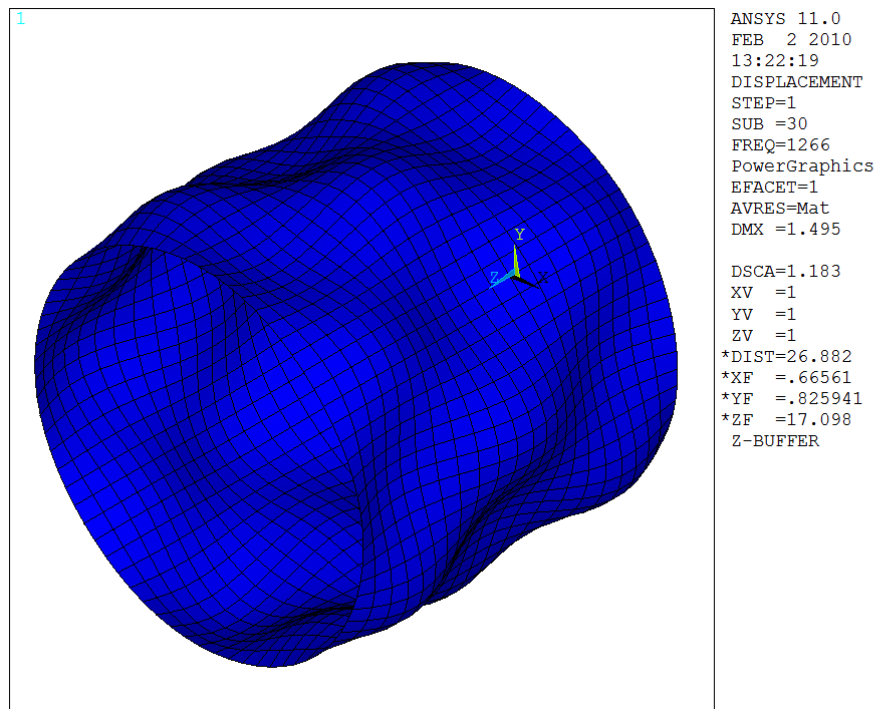
A finite element model of the pipe shell was then run for the same length of discharge pipe and a matching mode shape was found at 1266 Hz. See Figure 8 and 9 below. The analytical results confirmed that not only were there coincident acoustic and mechanical natural frequencies, but that they had corresponding mode shapes. Therefore they would be very highly coupled. That is, the shape of the pipe shell mode in both the circumferential and axial directions matched the pressure distribution inside the pipe caused by the acoustic natural frequency.

Figure 8. 1266 Hz shell mode of the pipe with 5 lobes circumferentially and 3 nodes axially

- 3.2 Stiffen the piping to alter the mechanical natural frequencies of the discharge piping. Of particular concern are the shell modes near blade pass frequency. This may be accomplished by using thicker wall pipe or adding external stiffeners. A thicker spool piece (more than 0.75" wall thickness) would move the natural frequency of the problematic mode to approximately 1400 Hz. The corresponding acoustic natural frequency would be approximately 1270 Hz. This calculation is based upon changing only the straight pipe between the discharge flange and the first elbow. It would be prudent to change the wall thickness of the flange and the first elbow as well. This modification would still allow the acoustic natural frequency to be excited by the blade pass. However, the response of the pipe shell would be much less due to the separation between the mechanical natural and forcing frequencies.

- 3.3 Alternatively add internal stiffeners/splitters to alter both the mechanical pipe shell modes and the acoustical modes of the discharge spool cavity. One potential solution is to weld cross plates in the ID of the spool immediately downstream of the compressor discharge flange to the first elbow. The plates (1/2" thickness minimum) would significantly increase the acoustic natural frequencies of the spool. As well there would be some stiffening of the mechanical natural frequencies (pipe shell modes) and those would be somewhat higher than the present design. Both would then have separation from the 17X blade pass frequency. This recommendation is based upon very approximate calculations. If this is the chosen modification additional calculations should be done to check the many acoustic and mechanical natural frequencies against blade pass to ensure that another mode would not be excited.

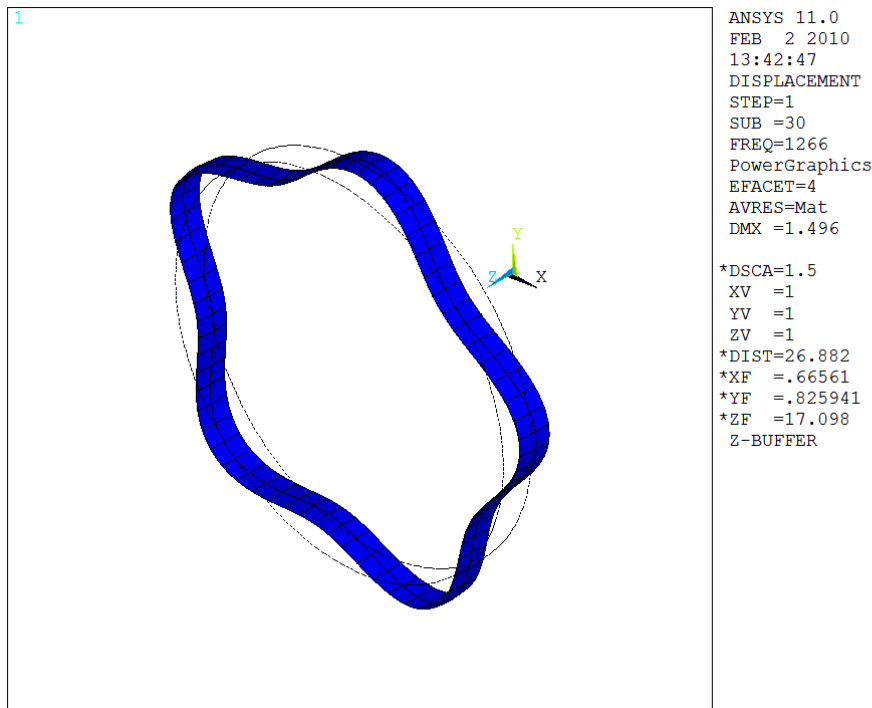
Figure 9. A selected ring of the pipe shell mode to show the 5 lobes more clearly

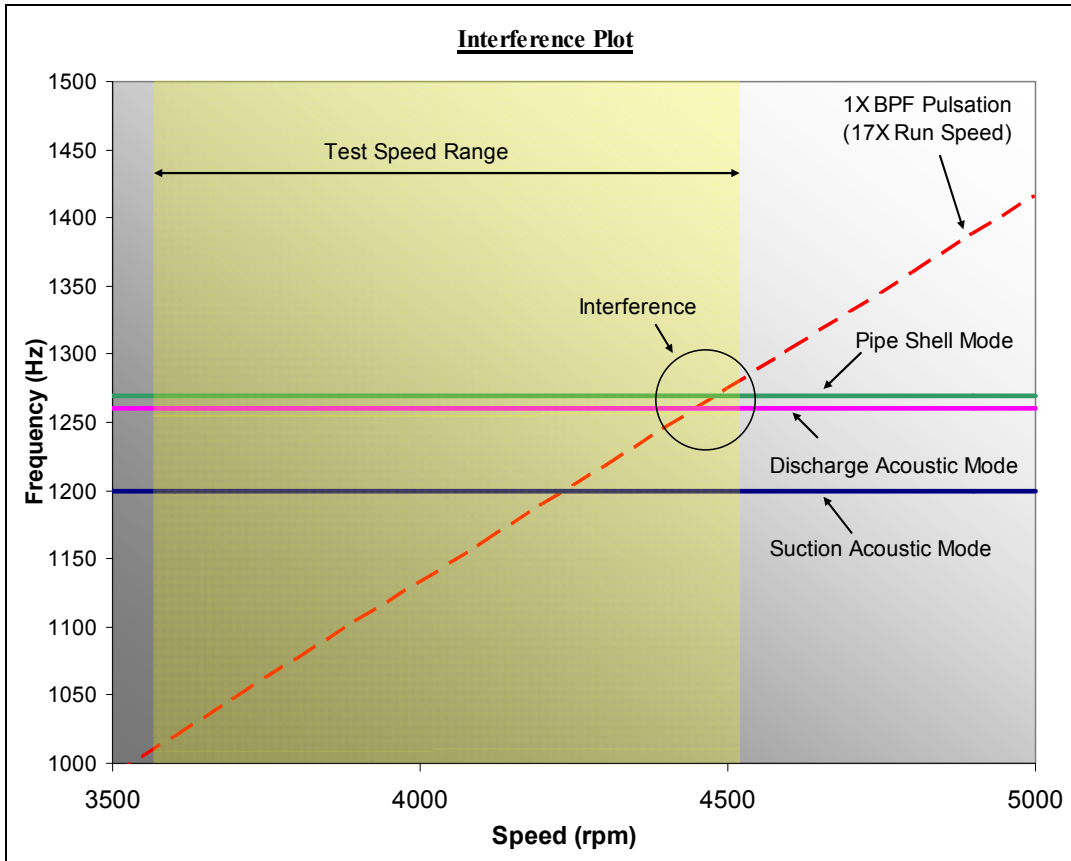
An interference plot was created (Figure 10) which clearly shows the “perfect storm” that occurs when the compressor is running near 4500 rpm. Pulsations at blade pass frequency (17X run speed) are the excitation source for the coincident acoustic natural and pipe shell natural frequencies of the discharge system immediately connected to the compressor discharge flange. The suction acoustic natural frequency (for similar geometry, but different pressures and temperatures) is sufficiently separated from blade the resonance until a lower speed. The shell modes of the suction pipe will be very similar to that of the discharge – so there is no speed where both the acoustic mode and shell mode of the suction pipe are excited by the blade pass frequency at the same speed. That is why failures on the suction side were far fewer. Although there was apparently enough energy transmitted from the discharge to cause a few suction RTD failures.

Figure 10. Interference plot showing the intersection of blade pass frequency pulsation (BPF) with the pipe shell and discharge acoustic natural frequencies between 4400 and 4550 rpm.

- 3.1 Change the wheel or aerodynamic package of the compressor to reduce the blade pass source strength. One possibility is to remove the vane diffusers in the casing. This may be tested on one machine soon.

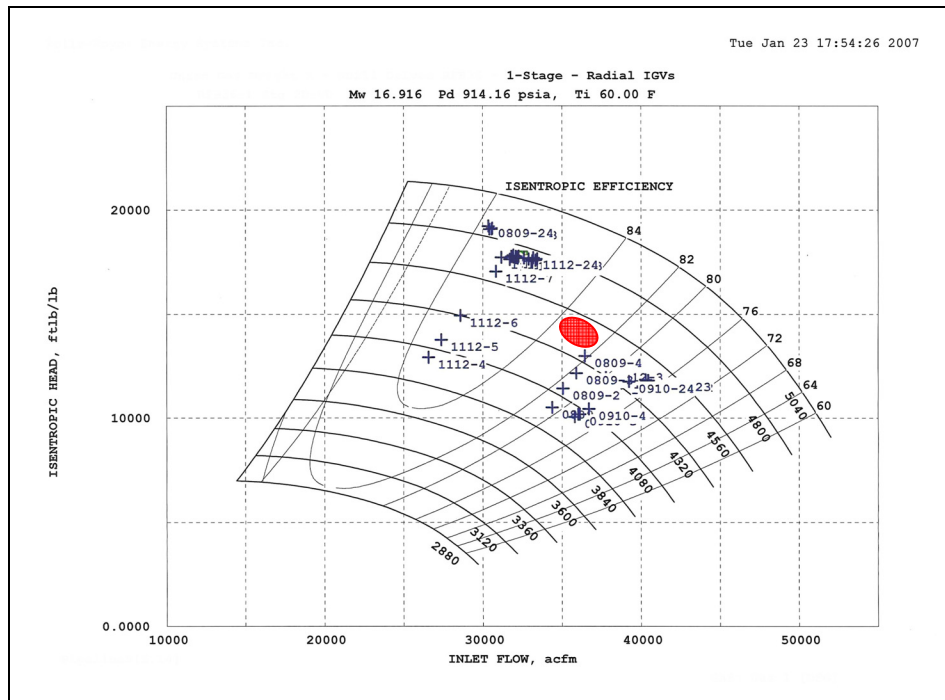
As stated earlier, the source strength of the pulsations will vary with the operating conditions. The operating point at the time of testing is marked on the compressor head curve (Figure 11). The compressor was operating off the best efficiency point, albeit it is not far off.

Figure 11 Head Curve for Unit A compressors. Red oval marks approximate operating conditions when high vibration and pulsation was occurring.

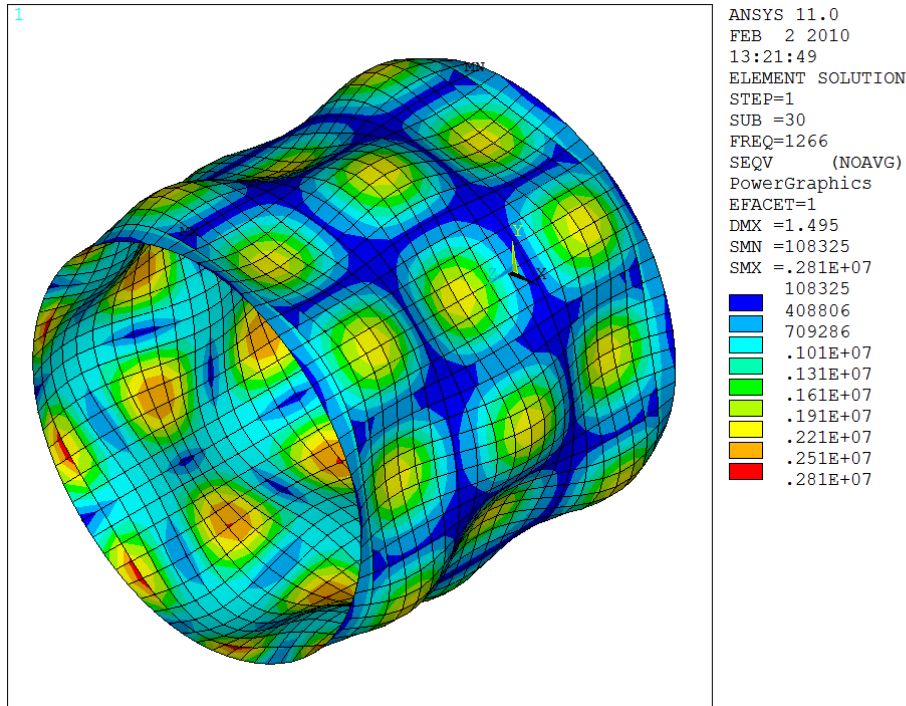
The client had an additional question about the piping vibration. Were the vibrations likely to cause a fatigue failure of the discharge piping itself? Since the finite element model was already available, a stress analysis was completed on the pipe shell mode that was being excited. The finite element model was used to estimate stresses in the pipe shell when the mode was excited to an arbitrary displacement as shown in Figure 12. That calculated stress was then scaled to the actual measured displacement of 1.87×10^{-4} in pk and found to be 710 psi pk-pk. This is well below the endurance limit for carbon steel pipe and allows for some stress intensification at discontinuities in the geometry. Although this indicates there is a very low probability of failure of the pipe itself, it does not mean that small bore connections in the vicinity will have acceptable stress range levels.

Figure 12. Stress plot for the 1266 Hz pipe shell mode.
