# A CENTRIFUGAL COMPRESSOR SYNCHRONOUS MOTOR CASE HISTORY

*B.C. Howes*

**Beta Machinery Analysis Ltd., Calgary, Alberta, Canada, T3C 0J7**

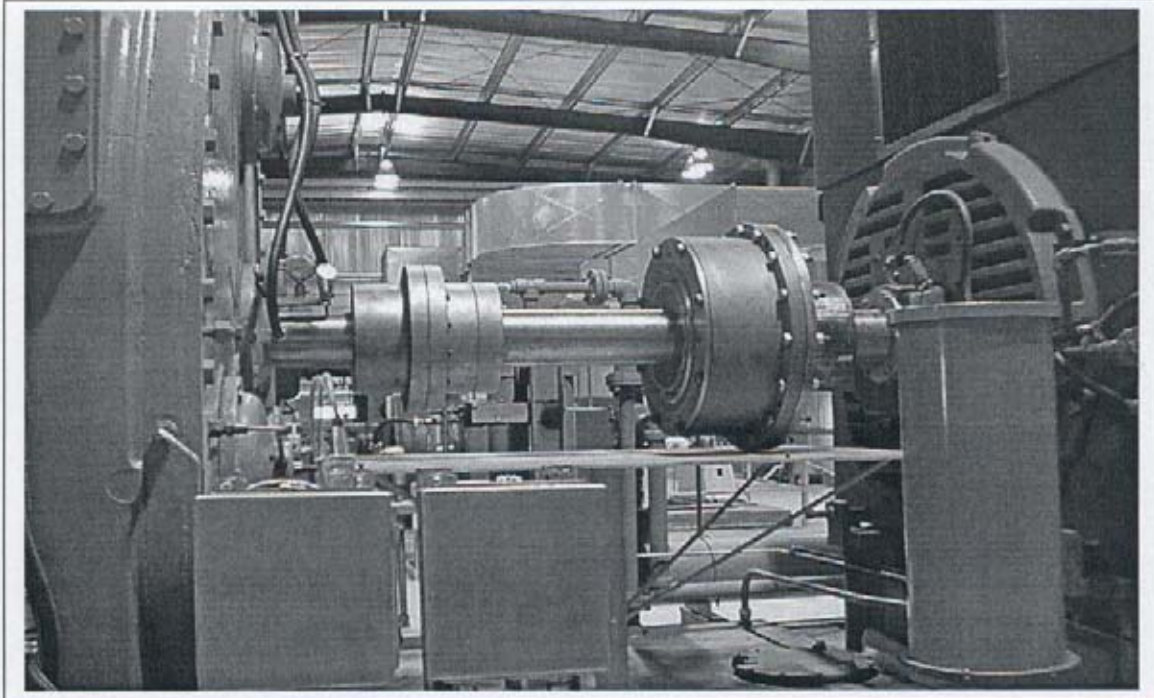
The gear coupling had been replaced with a new coupling just before starting the testing described here. The old coupling had excessive radial clearance. Also, the old gear had straight teeth on both sides. The new coupling had the male teeth crowned.

Picture 1: Gear coupling on the left, and Elastomeric coupling on the right

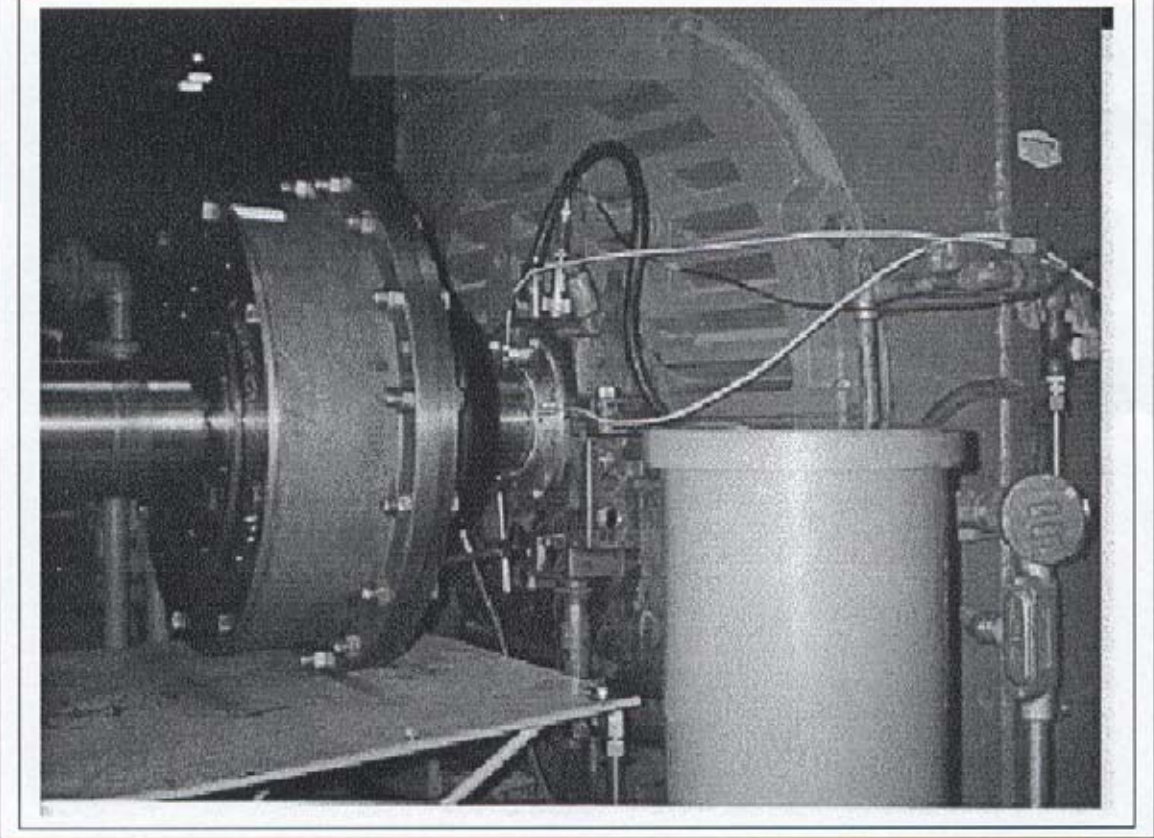
Picture 2: Motor with Elastomeric Coupling, Note: Proximity Probes

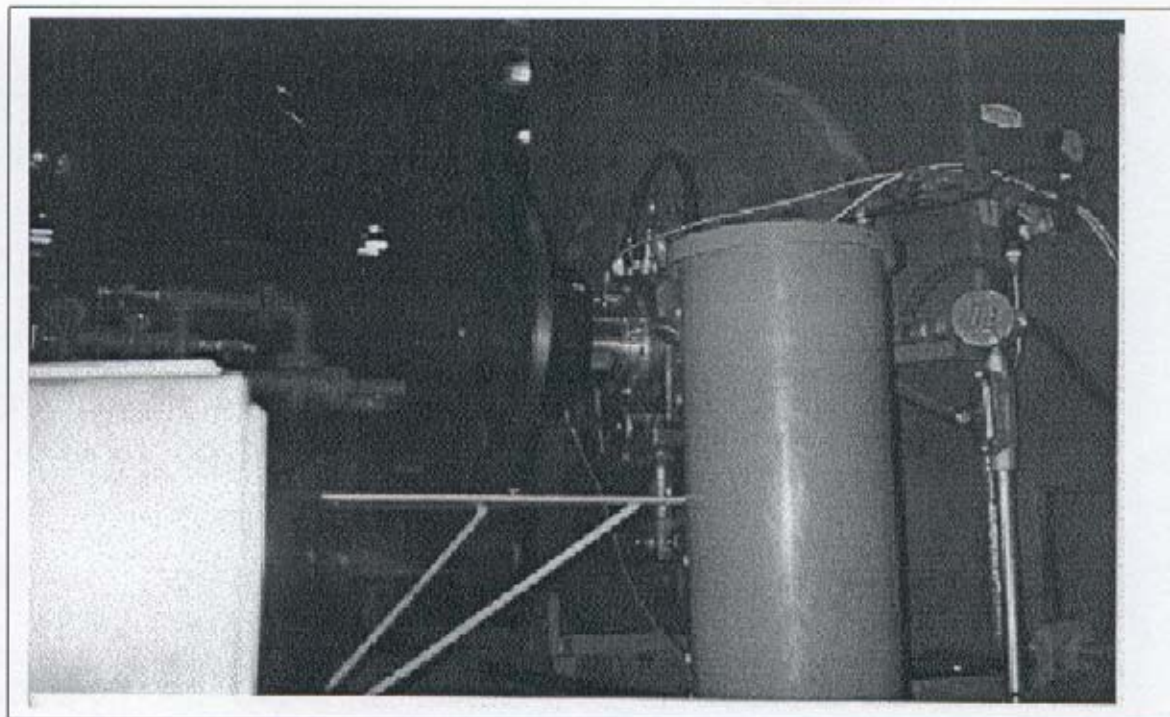
Picture 3: Motor Solo, Coupling Removed

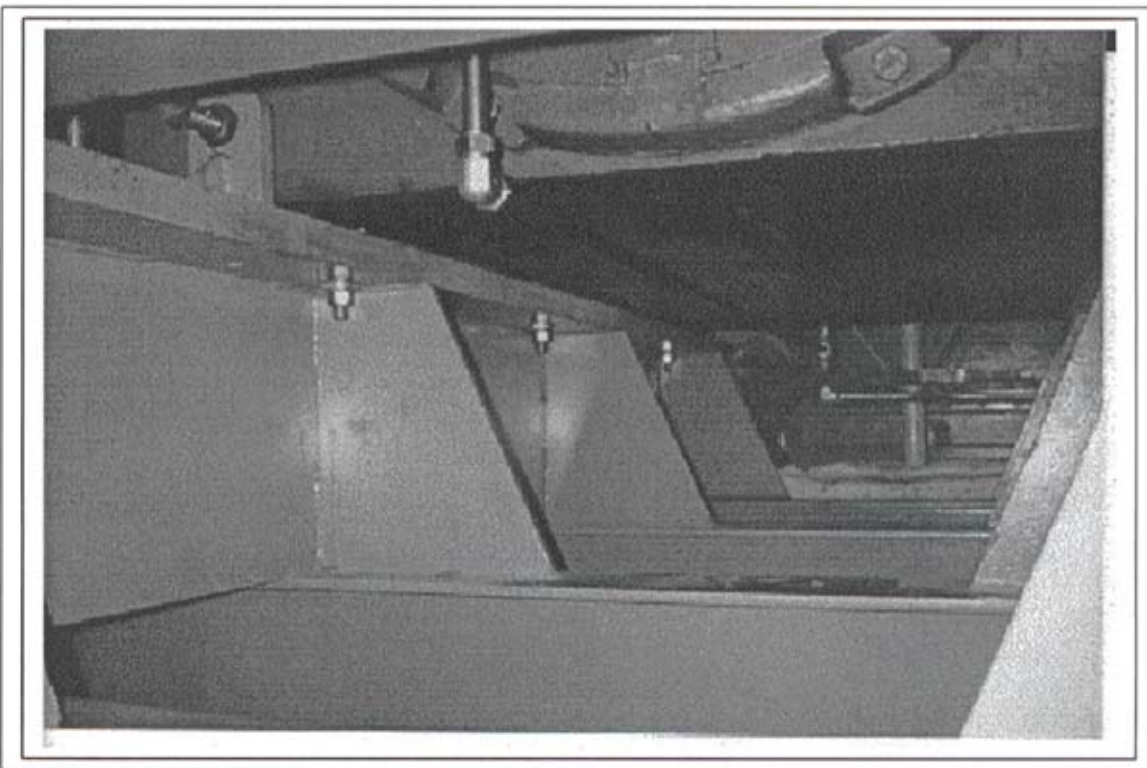
Inspection of the skid [see Pictures 4 and 5] suggested that removing some of the horizontal stiffness in the pony skid [the top part of the skid] should lower the offending MNF and reduce vibrations to acceptable levels. In a spirit of bonhomie, we embarked on the uncharted sea. Cutting progressively more and more of the gussets reduced the apparent MNF from bump testing, but was unsuccessful in reducing the vibrations at the top of the motor even though the operating deflected shape [ODS] changed [see Figure 4].

Picture 4: As Found Gussets, Pony Skid under Motor

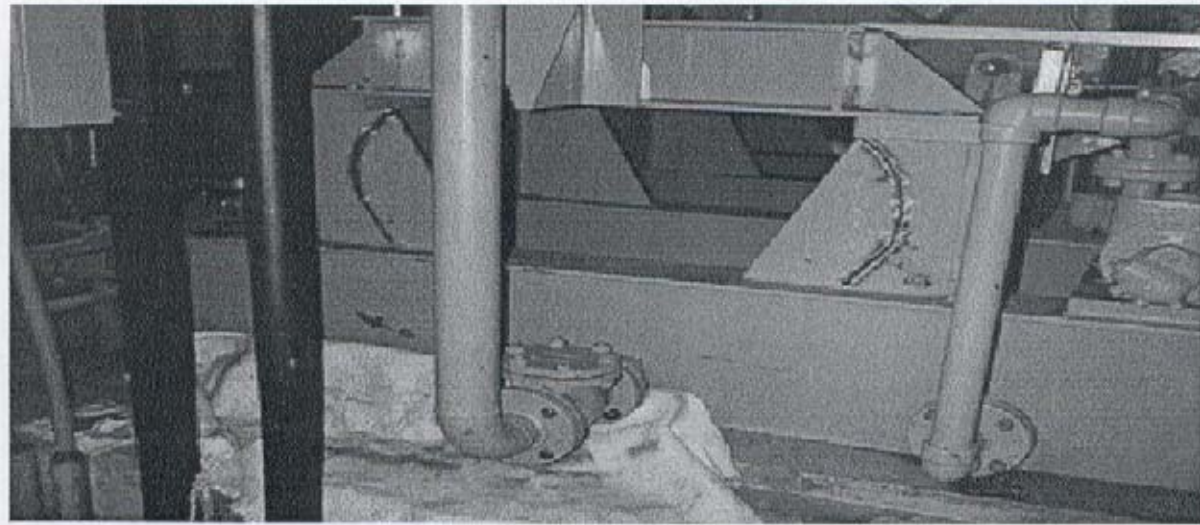
Picture 5: First Scallops in Pony Skid Gussets

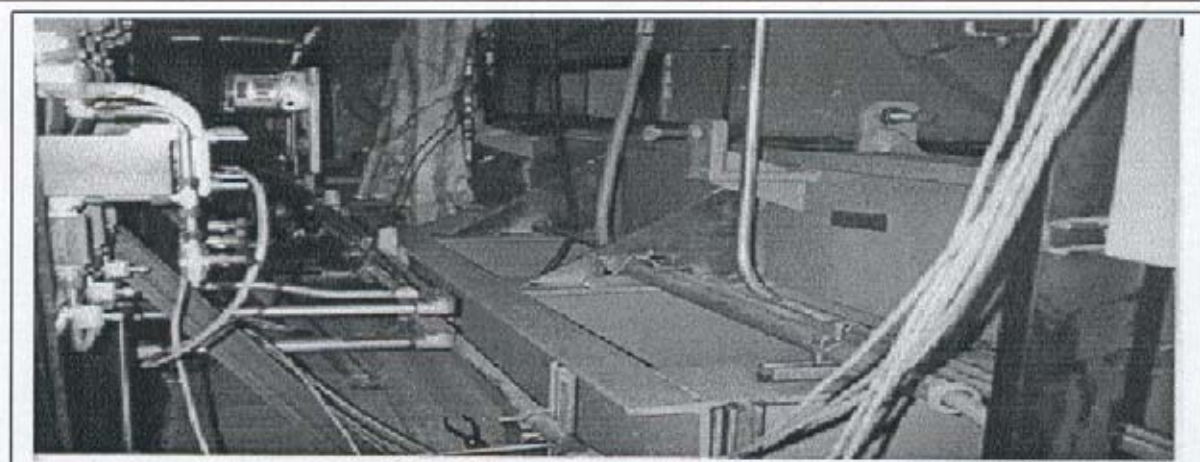
carefully numbered in case of this very eventuality] were welded back in place, and additional gussets were welded to the outside of the pony skid [see Picture 6]. The result of over-tuning was not entirely clear as we were unable to achieve enough separation between the bump test MNF and run speed. However, the ODS plot shown in Figure 4 indicates that the problem is likely due to the movement of the motor relative to the skid across the shim packs. This movement appears to be non-linear. Hence the apparent improvement in MNF without significant improvement in running vibrations.

Picture 6: External Gussets added to motor pony skid

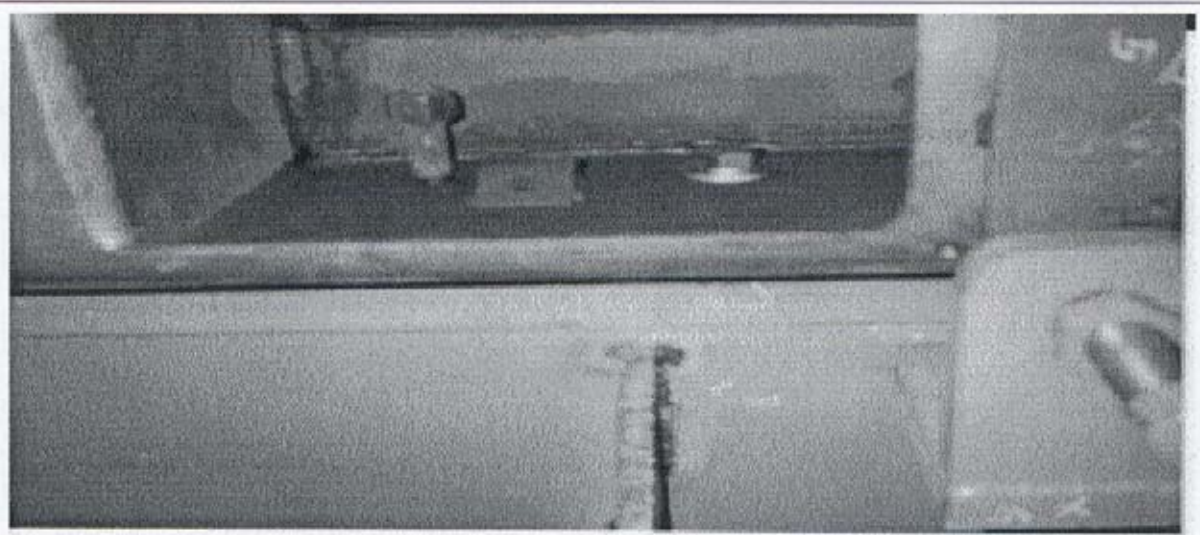
Refer to Picture 7. It shows a location provided by the motor manufacturer for a dowel. Each anchor bolt location has this provision. Installation of dowels was recommended.

Picture 7: Motor anchor bolt, jack bolt, and dowel location

Motors should be doweled to the skid or sole plate after installation and alignment testing is complete.

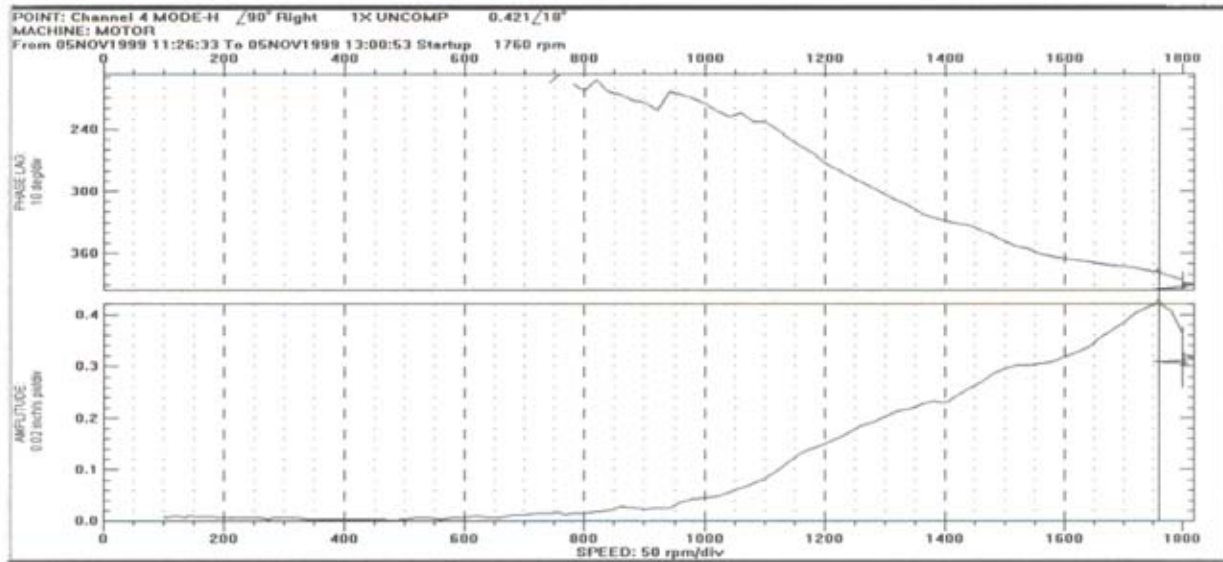
The motor horizontal vibrations showed that a structural resonance or mechanical natural frequency [MNF] was present very close to run speed. This showed another reason why the unit had had so many maintenance problems over its life. Bump tests were performed that confirmed the proximity of an MNF to run speed. Note that there is a 180 degree difference in phase between the ends of the motor in Figure 1 and 2.

Figure 1: Rundown vibration plot for the motor outboard end, horizontal [6 gussets cut]

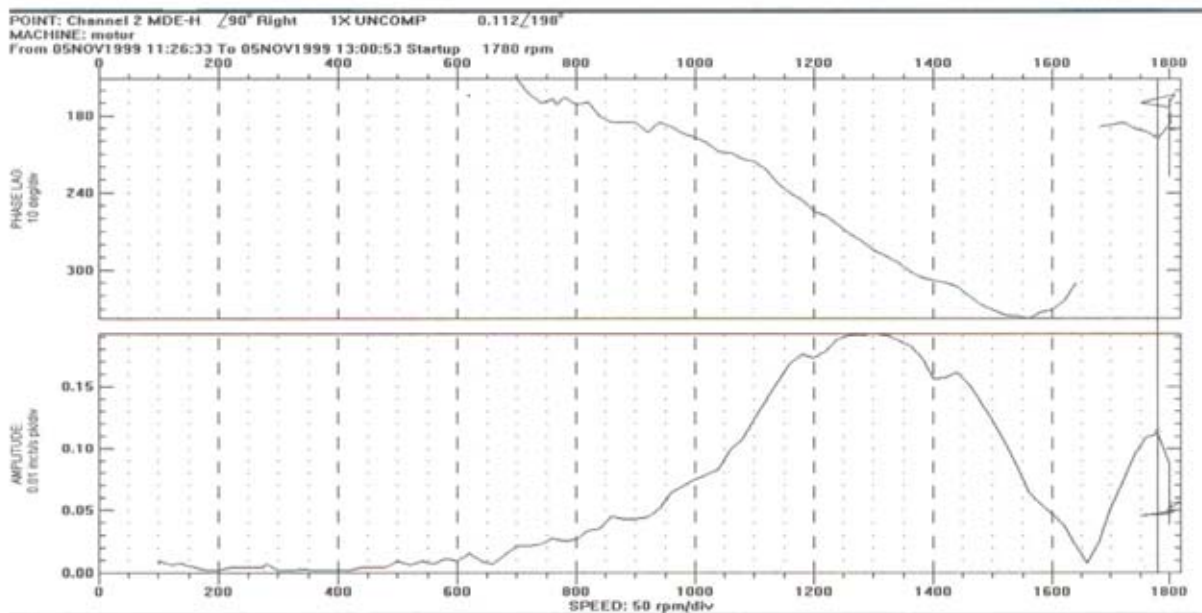
Figure 2: Rundown vibration plot for the motor inboard end, horizontal [6 gussets cut]

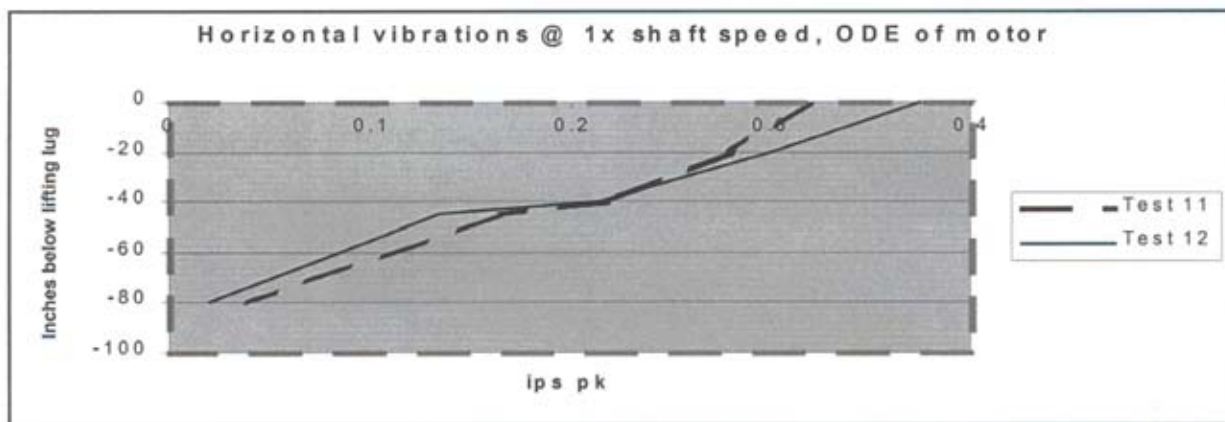
Figure 4: Operating Deflected Shape [ODS] of motor outboard end with gussets cut out [Test 11, see Photograph 4] and with gussets replaced plus external gussets added [Test 12, see Photograph 5] Note the discontinuity at the -45 inch level. The shim pack between the motor feet and the top of the pony skid is at this level. Bump testing showed the horizontal out-of-phase mechanical natural frequency of the motor was about 23 Hz for Test 11 and 32.5 Hz for Test 12.]
