# INCORRECT VALVE SELECTION ON PLUNGER PUMPS RESULTS IN UNDETECTED HIGH FREQUENCY VIBRATION AND COSTLY FAILURES, A CASE STUDY

*Brian C. Howes, M.Sc., P.Eng.*

*Beta Machinery Analysis Ltd. Suite 300, 1615 Tenth Avenue Southwest Calgary, AB, T3C 0J7*

*For Canadian Machinery Vibration Association 1996 Annual Meeting*

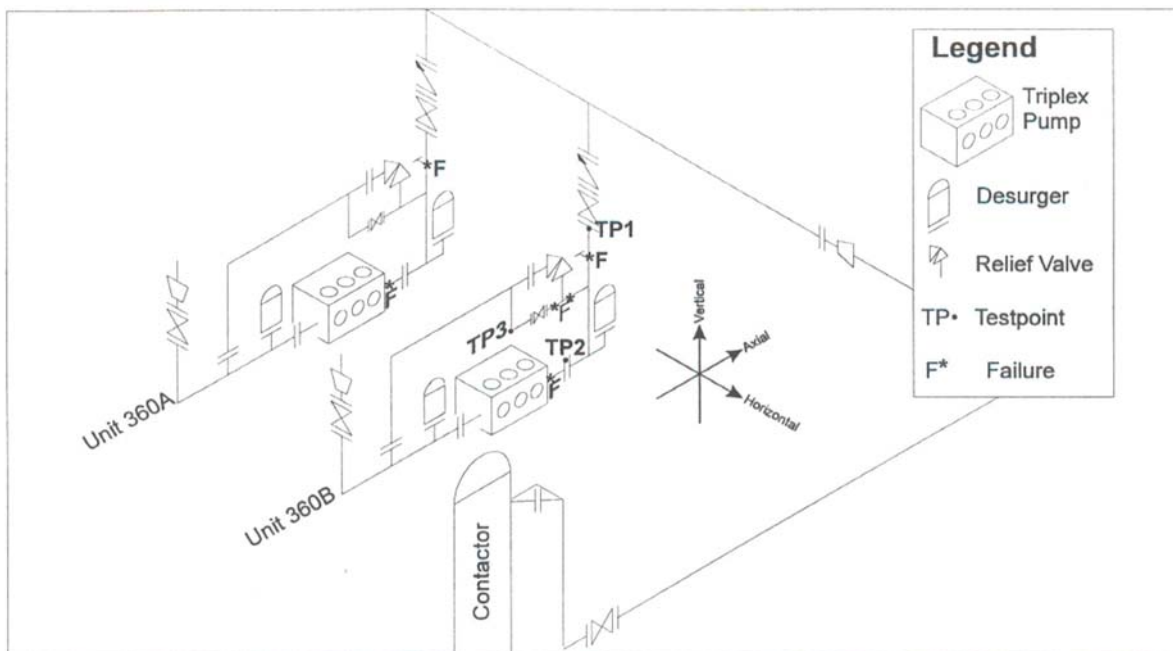
**Figure 1** Two identical plunger pumps, with one on 100% standby, are used to remove hydrogen sulfide and carbon dioxide from a natural gas stream. Both pumps experienced failures on the discharge piping.

Figure 1 shows the areas where failures occurred. Both pump discharge system had similar failures.

- the relief valve nipple on the vertical riser directly after the pump discharge,
- the pressure tap nipple at the same location, and
- the top side of the discharge nozzle socket weld.

Originally, the discharge system had been installed without desurgers, which was an oversight. The owners recognized this shortcoming after a few hours of operation, and installed discharge desurgers where fittings were available. Improvement was noted. Later,

they installed a larger desurger for each pump, as close as possible to the pump's discharge. There was a substantial reduction in **perceptible** vibration. However, piping failures continued to occur, each time causing downtime and loss of amine.

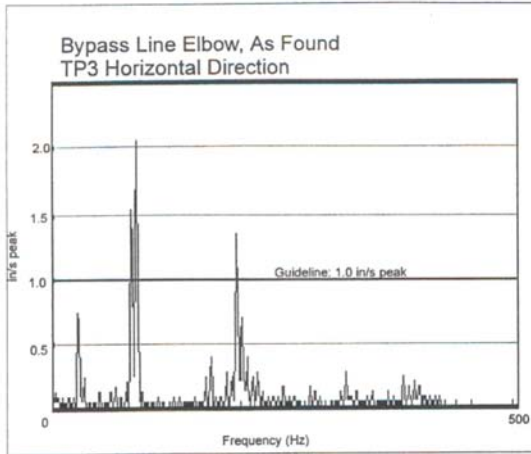
Piping attachments had vibration levels of up to 2.0 in/s pk (Figure 1, TP 3). This level is double the guideline, and explains why the nipples

**Figure 2** *Vibration on the piping attachments was double the guideline.*

failed. This vibration was not readily apparent to the human touch, and it was later determined to be a high frequency vibration. See Figure 2.

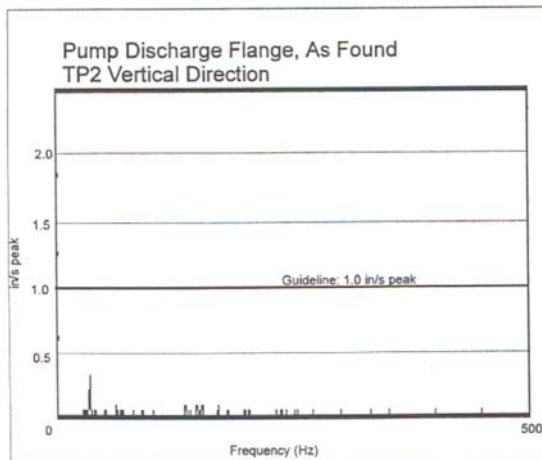
Vibration on the main piping, on the other hand, was well below guideline, based on spectrum analysis. The discharge riser (TP 1) had approximately 0.5 in/s pk vibration in the horizontal and vertical directions. The pump discharge nozzle flange (TP 2) showed vibration of 0.3 in/s at 2X plunger passing frequency. See Figure 3.

**Figure 3** *According to the spectrum, vertical vibration on the pump discharge flange was well within the guideline, even though the weld had broken at the pump.*

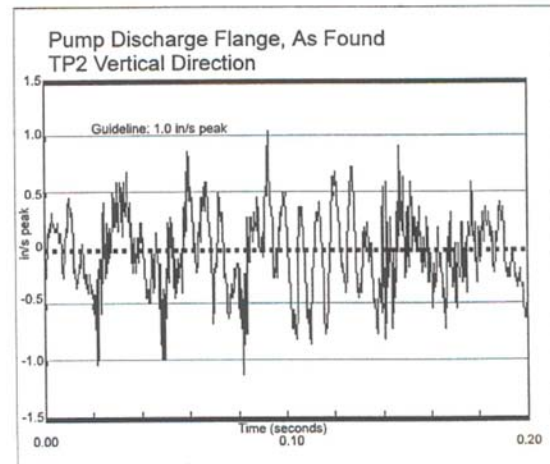
In an attempt to determine why breakage occurred at the pump discharge flange even though vibration was apparently acceptable we measured time waveforms. These revealed a much different picture. On the pump discharge flange in the vertical direction, for instance, (same location as shown in Figure 3), “spiky” positive and negative 1.0 in/s peaks occurred. See Figure 4.

**Figure 4** *The time domain pattern showed sharp peaks, with much greater amplitude than that shown in the spectrum*

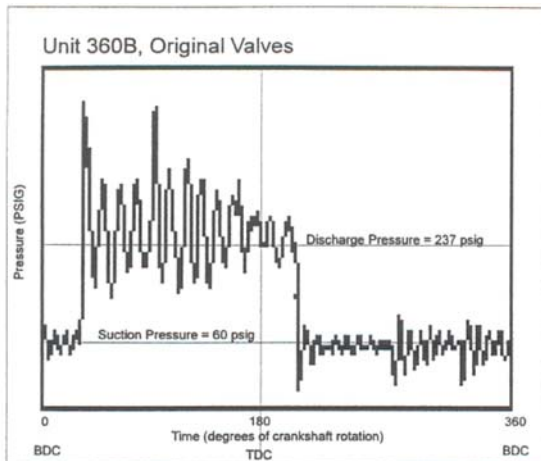
**Figure 5** The As Found Pressure-Time curve showed that the valve events were significantly late.

Now, the question was “What phenomenon could generate sharp vibration peaks?” Experience led us to question the valve timing on the pump. To check, we measured a pressure-time curve, shown in Figure 5.

The suction valves closed up to 30 degrees after dead centre, as compared to the expected angle of less than 10 degrees. Similarly, the discharge valves closed up to 23 degrees after dead centre.

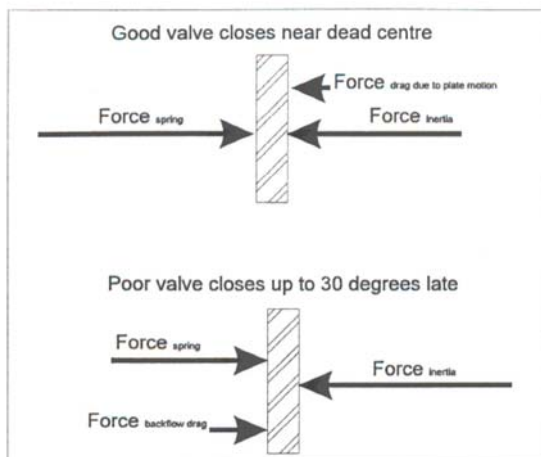
**Figure 6** Exaggerated comparison of forces acting to close the valve. If the contribution of the spring to valve closure is less, that of the drag force must be greater.

Consider valve spring stiffness and assume the same free length and installed length (preload). Insufficient spring stiffness could cause the suction valve to close late because there is less contribution from the spring toward forcing the valve to close. To compensate for the lack of force from the spring, drag force from backflow is required to close the valve. See Figure 6. The discharge valve opening is late accordingly, since it must happen after suction closing.

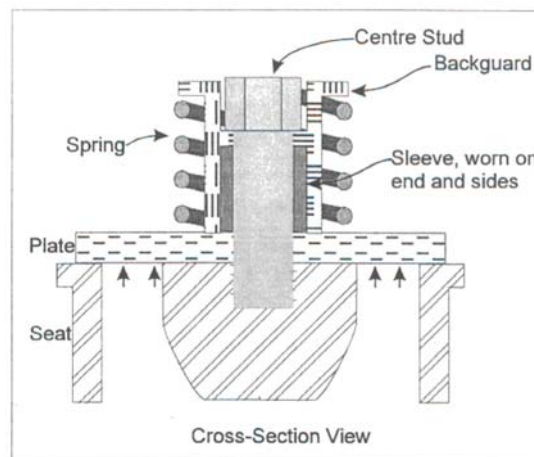
**Figure 7** The structure and wear pattern of the valve is an important piece of the puzzle.

When the original valves (with the relatively flexible springs) were removed, we examined them carefully to see if they confirmed our theory. A sketch of the valve cross-section is shown in Figure 7. Typically, the centre bolt was loose and the cylindrical sleeve in the centre of the valve showed excessive wear on both its ends and its sides. Some of the valve plates and backguards were worn. Cavitation damage was found on at least one plunger.

These patterns and modes of failure would suggest that the plate opened more violently than it should have and by travelling farther than it should have, hit the backguard. The repeated impacts could have loosened the nut, allowing the sleeve to move radially. That movement could have allowed the wear that was found on the ends and sides of the sleeve. (Valve flutter and squirming in relation to the guide can also

cause sleeve wear, but that wear is usually on the sides of the sleeve, not the ends.)

On Beta's recommendation, and with the concurrence of the pump supplier, the owner installed valves with stiffer springs and plastic plates to correct the late valve closures. When the pump was run with the new valves, it was so quiet that operators questioned whether the pump was functioning!

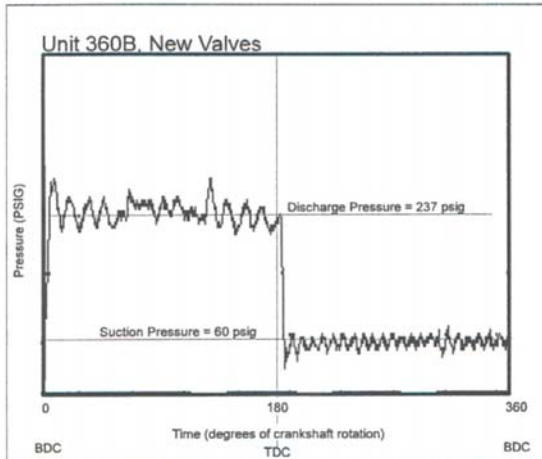
**Figure 8** The Pressure-Time curve for the new valves showed closure within 6 degrees of dead centre. Plunger velocity is still slow, and therefore impacts are low.

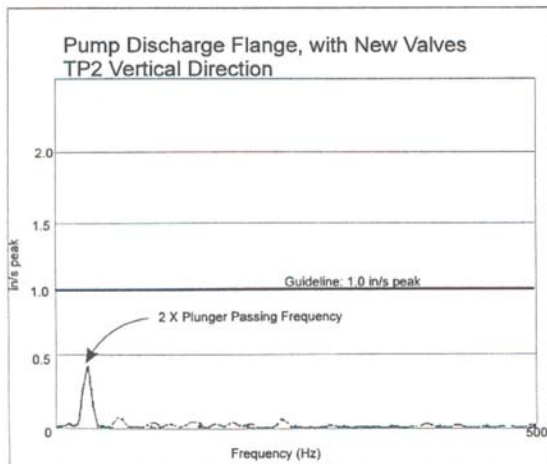
**Figure 9** The spectrum related to Figure 9 has little energy at higher harmonics.

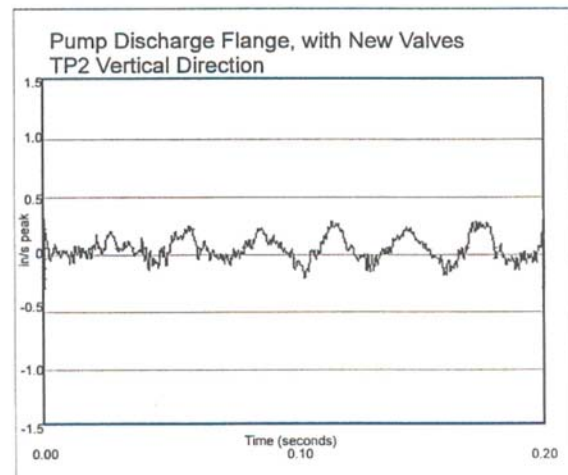
**Figure 10** Vibration taken after the valves were replaced showed acceptable levels.
