Machinery Vibration Limits and Dynamic Structural Response

By
Brian C. Howes, P. Eng., M.Sc.

Case History 1: High Vibrations, Acceptable Forces, Structural Resonance

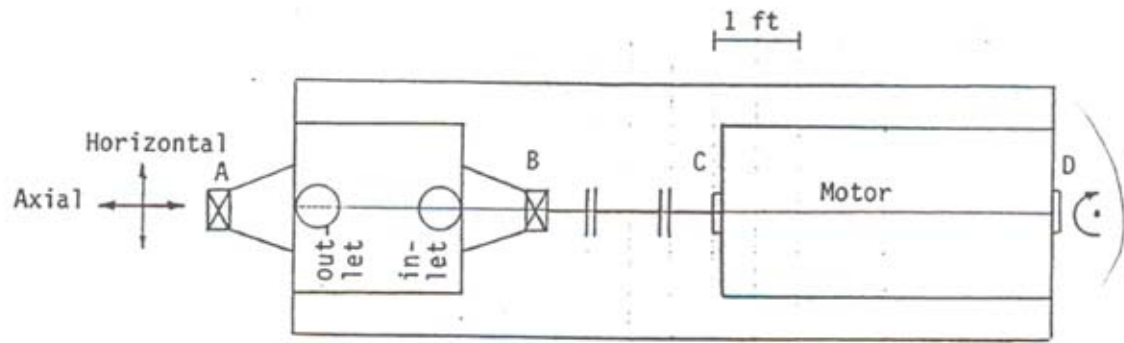
Figure 1: Layout & Operating Conditions

The system schematic layout and operating conditions are presented in Figure 1.

The pump had plain journal bearings cantilevered from the main pump about 10 inches. The impellor had 4 stages with 7 vanes on each impellor. The diffusers had 6 vanes.

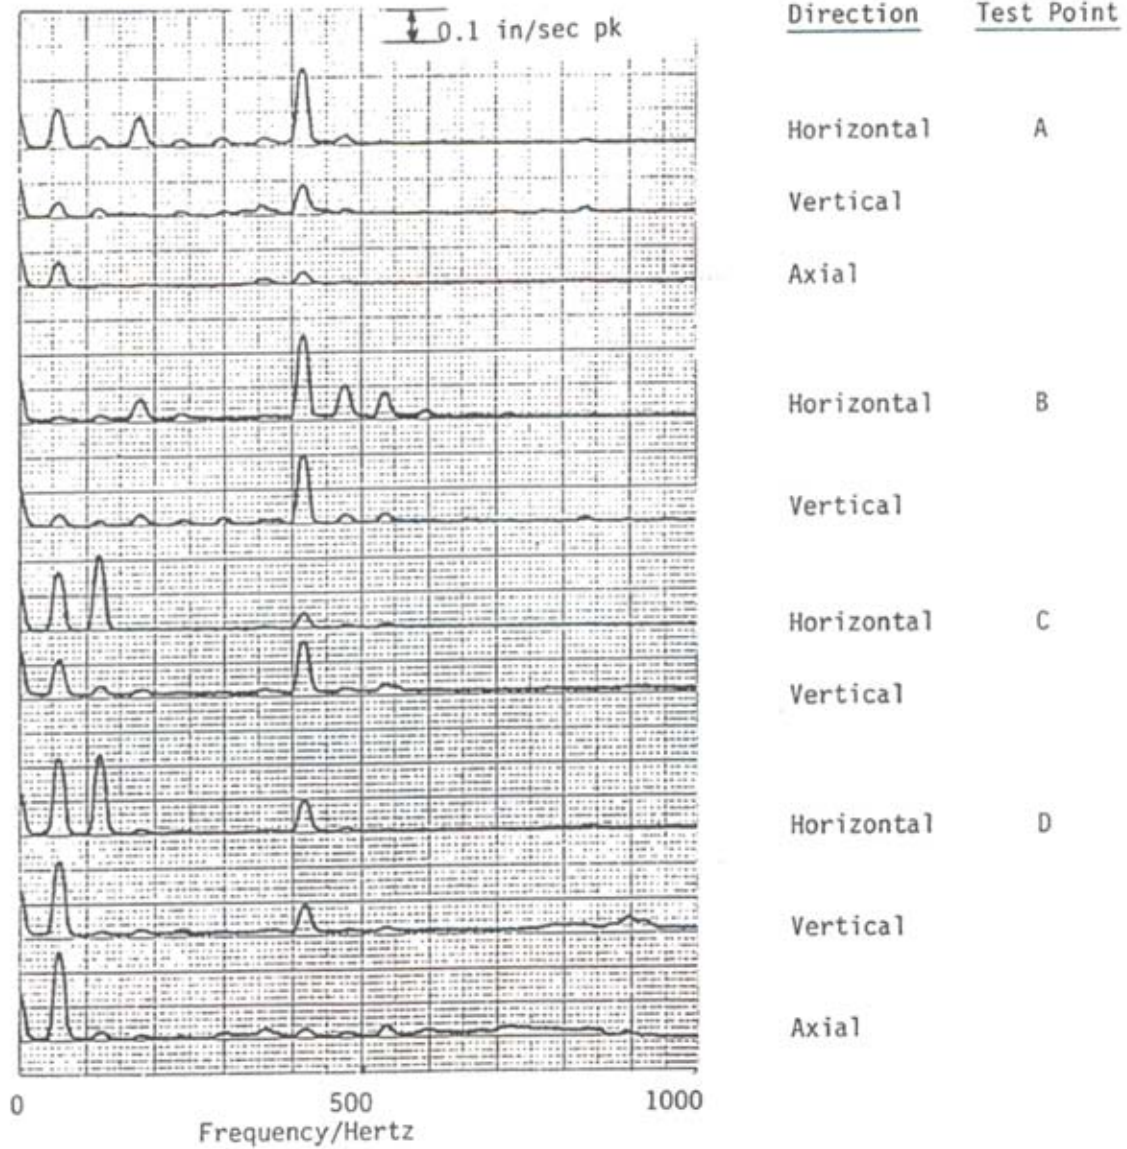
The vibration levels at or near the four bearings were recorded initially. The unfiltered readings showed high vibrations, particularly on the pump inboard. These data are presented in Table 1 in terms of both velocity and acceleration. They are also presented in Figure 2 in spectral form.

The coupled motor vibrations were high also as show in Figure 2. Uncoupled, the motor did not run very much smoother. The uncoupled motor vibration data are presented in Table 2 and Figure 3.

The majority of the vibrations on the pump bearings were observed to be at 7 times shaft speed. This frequency coincides with vane passing frequency on the impellor. The pump body did not show high levels of vibration. Immediately, suspicion fell on the impellor design. The pump characteristics had been extrapolated from 3000 RPM tests. Could an error have been made in the design? Were the impellors not staggered on the shaft? The buyer believed that the impellors were staggered, but we did not see the impellor to confirm this point.

“As Found” Vibration
Boiler Feed Pump and Motor

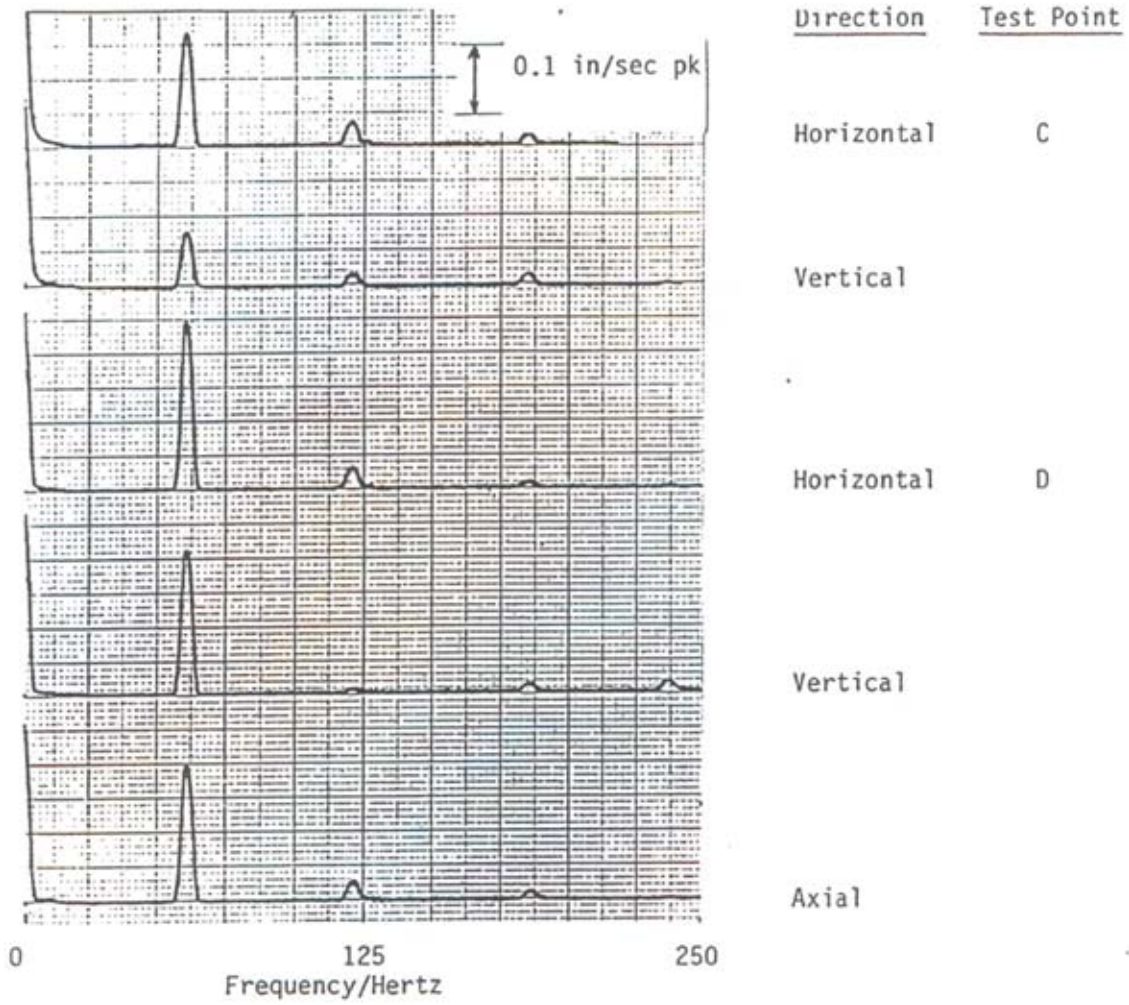
Figure 3

Vibration Data on the Motor
Uncoupled from the Pump

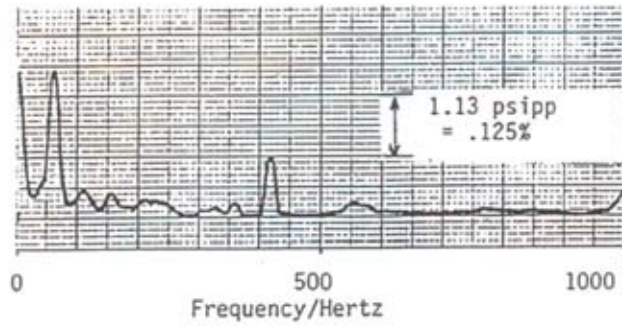
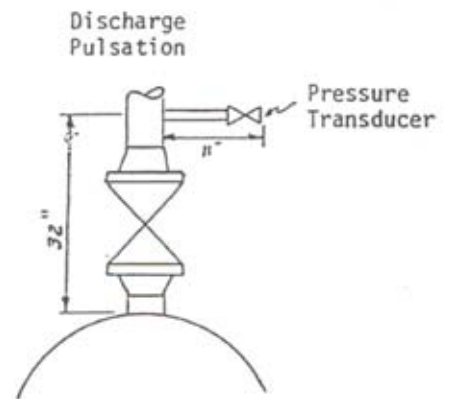
In an attempt to further our understanding of the pump, we measured pressure pulsations at the outlet of the pump. The spectrum of these pulsations is presented in Figure 4.

Also shown on Figure 4 are dimensions associated with the pulsation measurement. The pressure transducer was located at least 43 inches from the pump impellor.

Reference "4" suggests that pulsations less than 3% of line pressure are acceptable in centrifugal pumps. Pulsations were less than this limit at the measurement point.

The results of the pulsation measurements did not prove that the impellor design was unacceptable, nor that there was an acoustical resonance in the piping. They did not prove that the impellor design was adequate either.

Boiler Feed Pump Pulsation
Measured on the Discharge

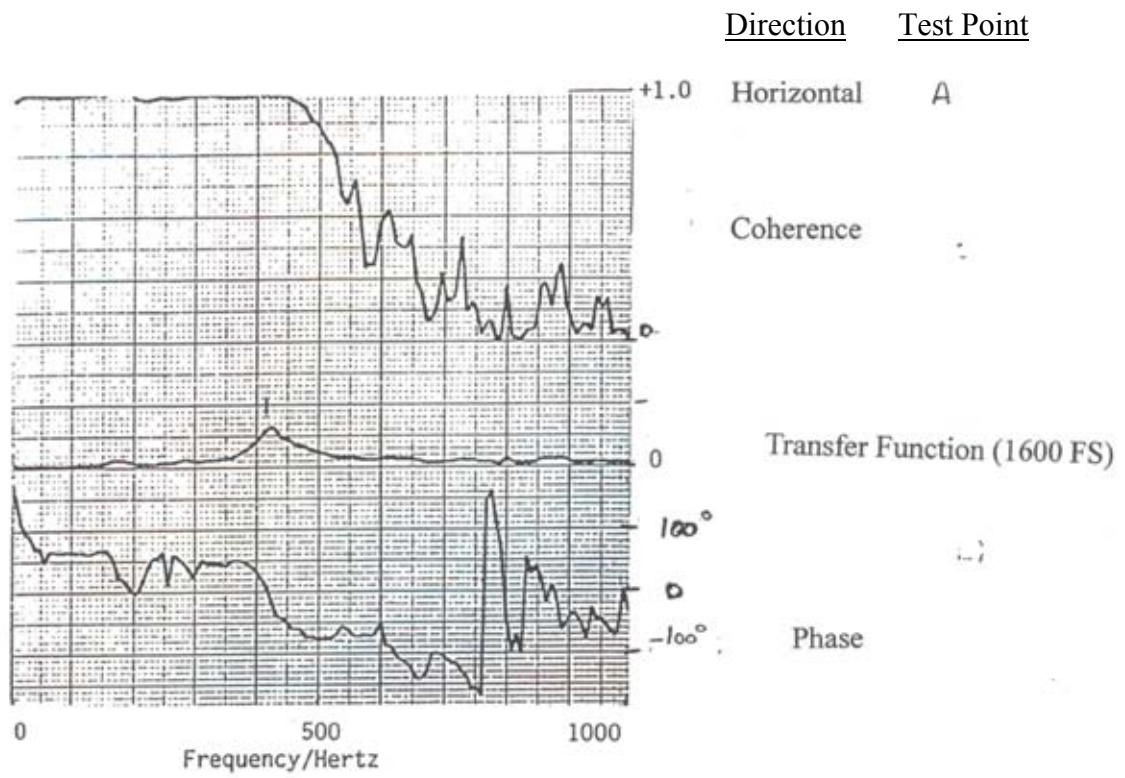
Figure 5

Analysis of Figures 5 and 6 shows a horizontal structural resonance on the outboard bearing housing at 424 Hz (approximately equal to vane passing frequency) which does not appear on the pump body. Figure 7 shows the vertical structural resonance of the outboard bearing to be somewhat below vane passing frequency.

Transfer Function Measurements
Boiler Feed Pump, Outboard Bearing

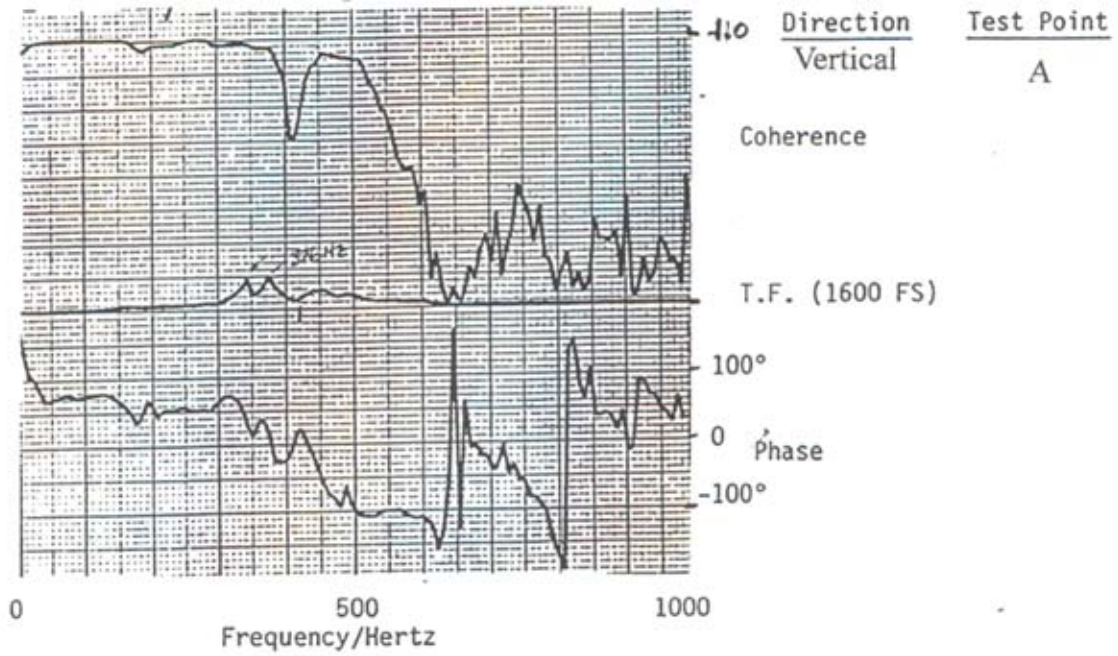
Figure 7

Transfer Function Measurements
Boiler Feed Pump, Outboard Bearing

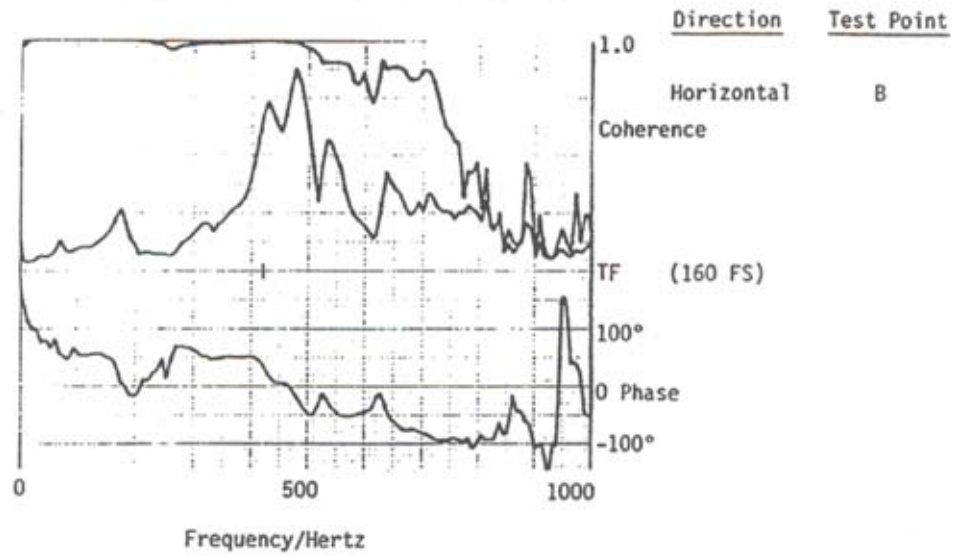
Figure 8

Figures 8 and 9 show a broader frequency range with high flexibility for the inboard bearing than for the outboard bearing. Again, however, the resonant region is clearly present at vane passing frequency for a 7 vane pump operating at 3600 RPM. At 3000 RPM, no such problem would appear.

Transfer Function Measurement on Boiler Feed Pump, Inboard Bearing, Horizontal

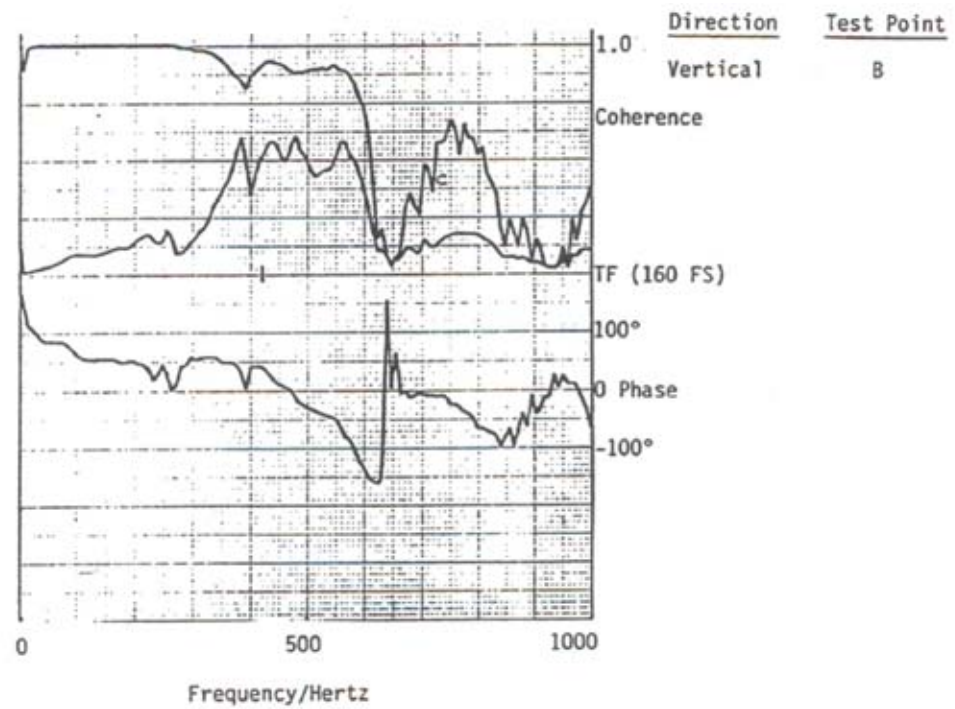
Figure 9

Transfer Function Measurement on Boiler Feed Pump, Inboard Bearing, Vertical

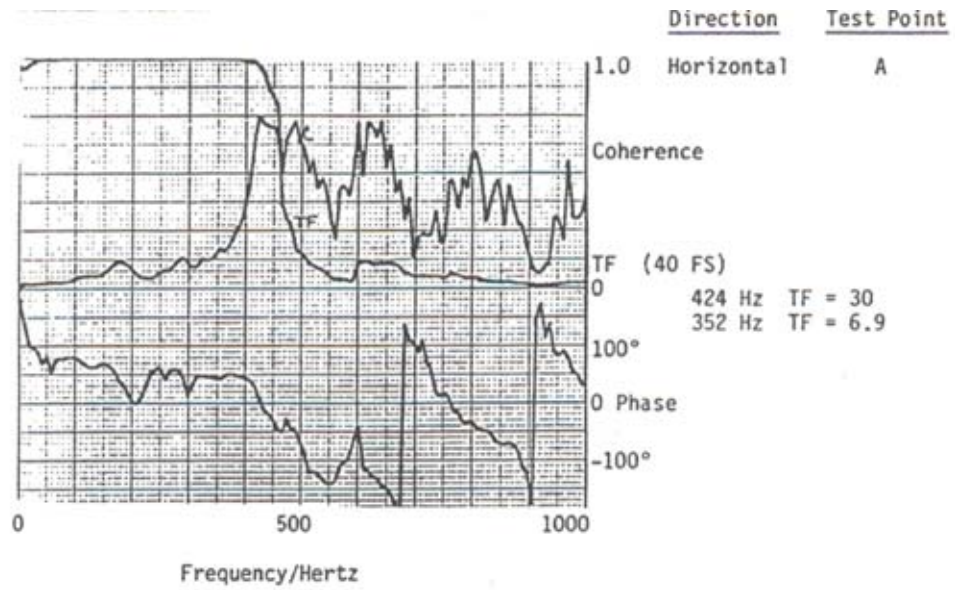
Figure 10

Figures 10 to 13 show the "as found" and resulting transfer functions measured at each step in the modifications discussed above. The expected reduction in vibrations at 424 Hz can be calculated from the reduction in measured dynamic flexibility in the plots. The best reduction obtained was a factor of 2 for MOD 3.

Outboard Bearing, Horizontal, Transfer Function Measurement. Repeated for Comparison with Modified System

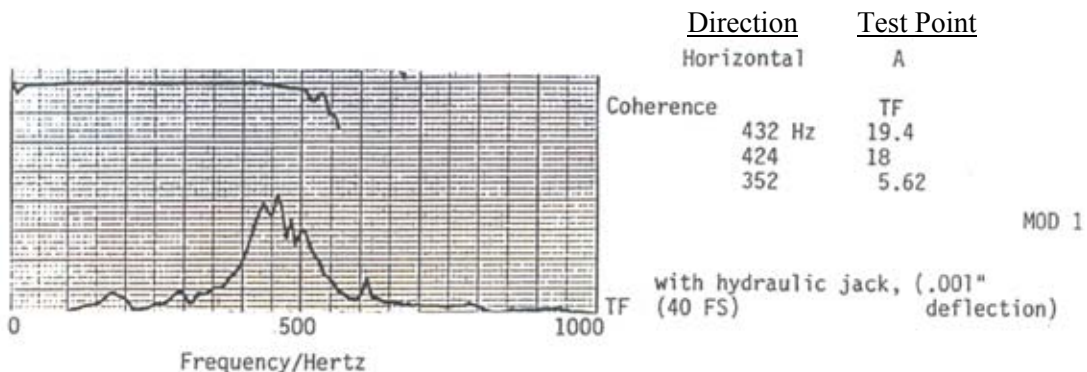
Figure 11

Transfer Function Measured for MOD 1 (Stiffening)

MOD 1 A hydraulic jack resting against the pump body was used to stiffen the outboard bearing in the horizontal direction. The housing static deflection was limited to .001", measured with a dial indicator relative to the pump body.

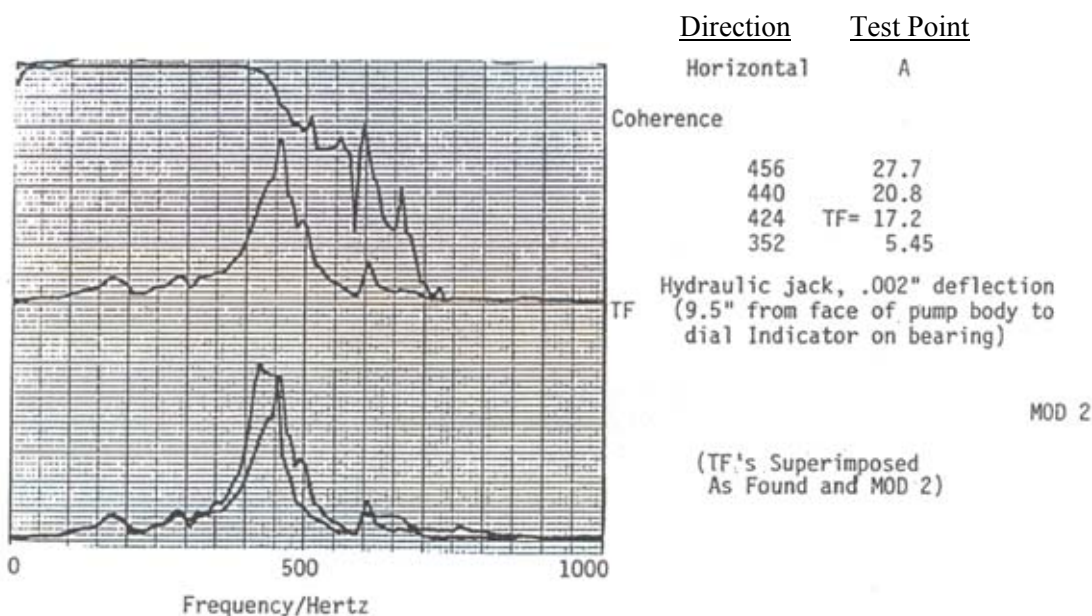
Figure 12

Transfer Function Measured for MOD 2 (Stiffening)

MOD 2 The static deflection was increased to .002".

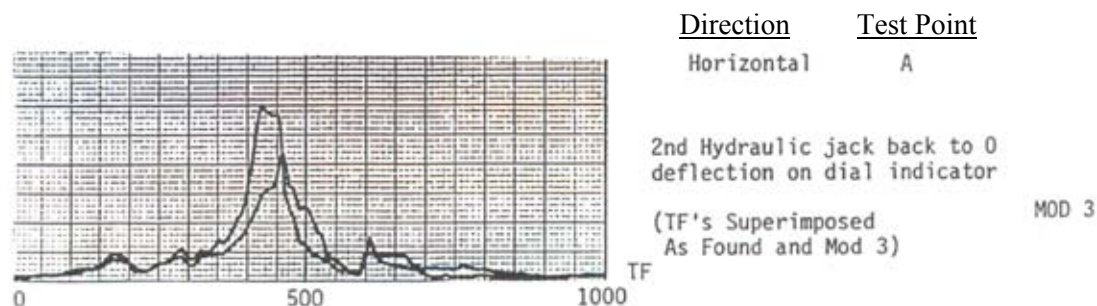
Figure 13

Transfer Function Measured for MOD 3 (Stiffening)

MOD 3 A second jack was added on the opposite side and was loaded to reduce the deflection to zero.

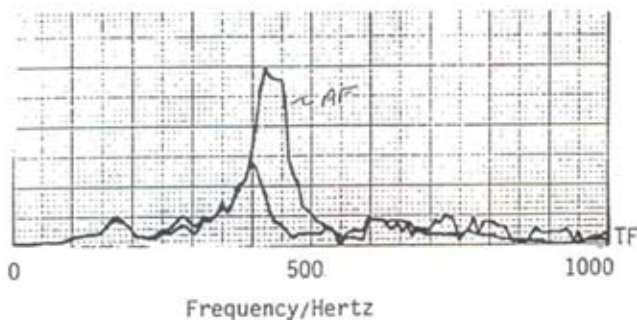
Figure 14

Figures 14 to 16 show the as found and resulting transfer functions measured on the pump. Note that Figure 16 is for the vertical direction. The best expected reduction in vibrations for MOD 5 appears to be greater than a factor of 20 in the horizontal direction.

Transfer Function Measured for MOD 4 (Added Mass)

MOD 4 The jacks were removed and weights totaling 20.5 lbs. were clamped to the outboard bearing housing.

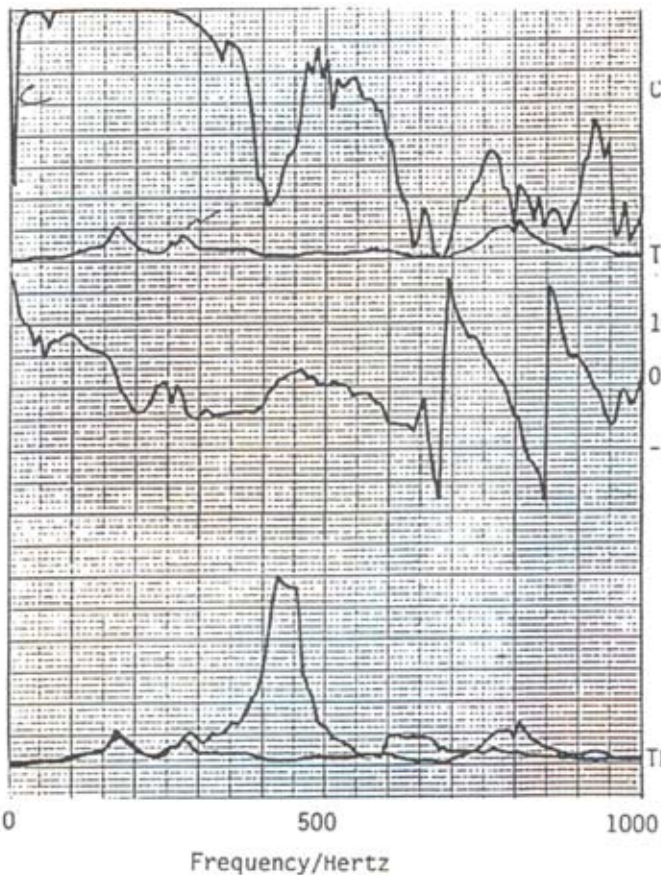
Figure 15

Transfer Function Measured for MOD 5 (Added Mass)

MOD 5 The weight was increased to 50 lb.

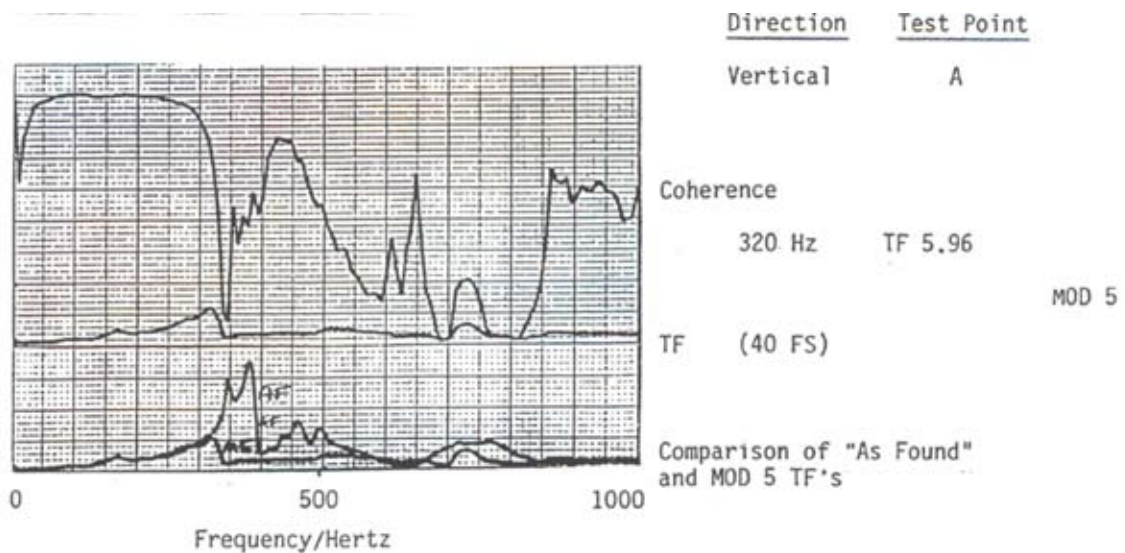
Figure 16

**Transfer Function Measured for
MOD 5, Vertical (Added Mass)**

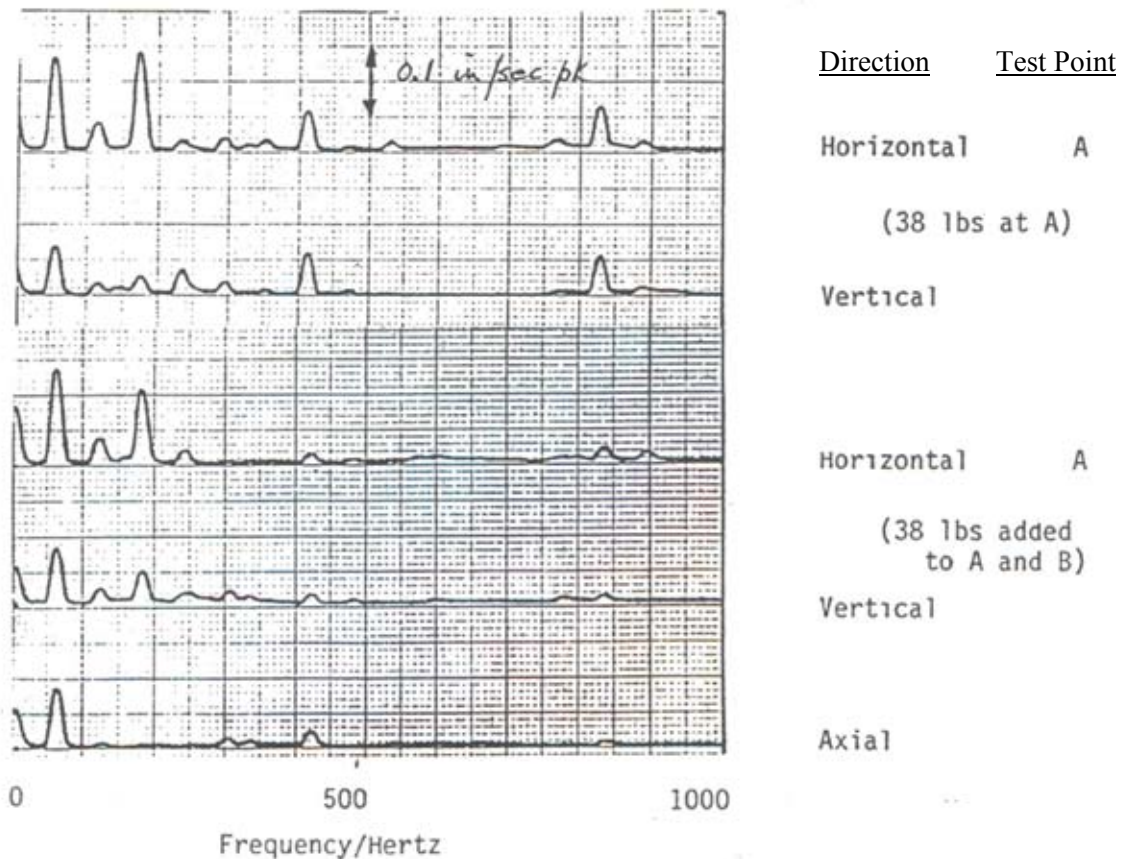
Figure 17 shows vibrations at A, first with 38 lbs. clamped on bearing A, and then with 38 lbs., also on bearing B. Note the further reduction at A due to lower vibrations at B.

**Running Vibrations on Boiler Feed Pump
Outboard Bearing with weights clamped
to Bearings A and with weights clamped
to Bearings A and B**

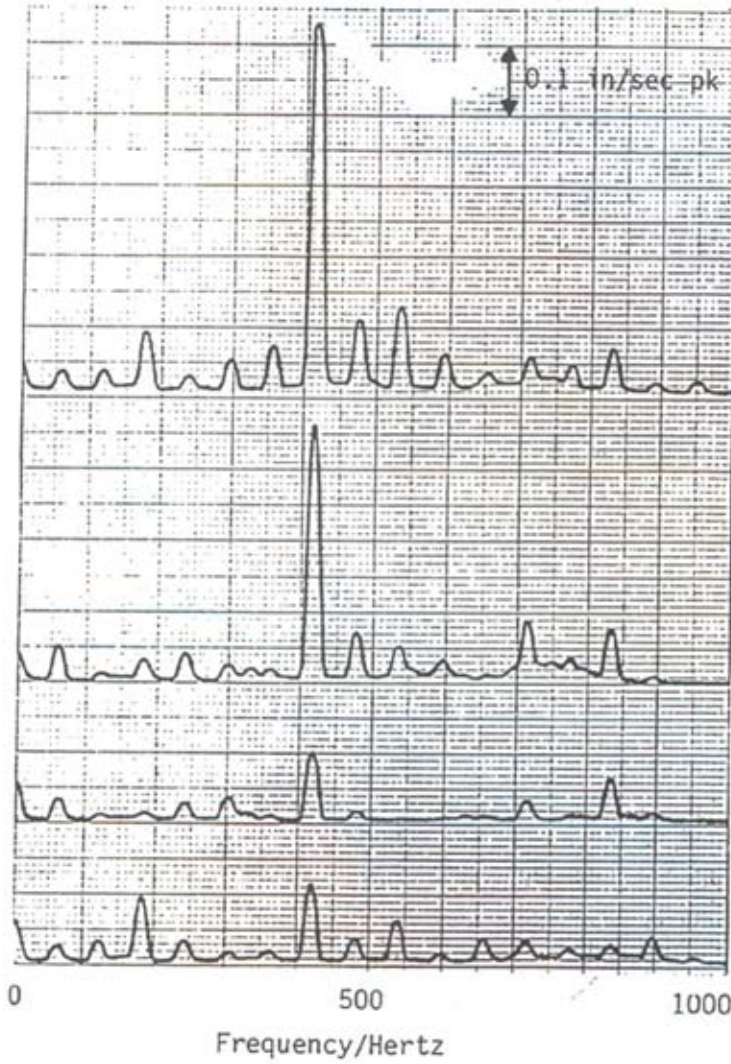
Figure 18 shows vibrations at B, first with 38 lbs. added only on bearing A, then with 38 lbs. also on bearing B.

**Running Vibrations on Boiler Feed Pump
Inboard Bearing with weights clamped
to Bearing A and with weights clamped
to Bearings A and B**

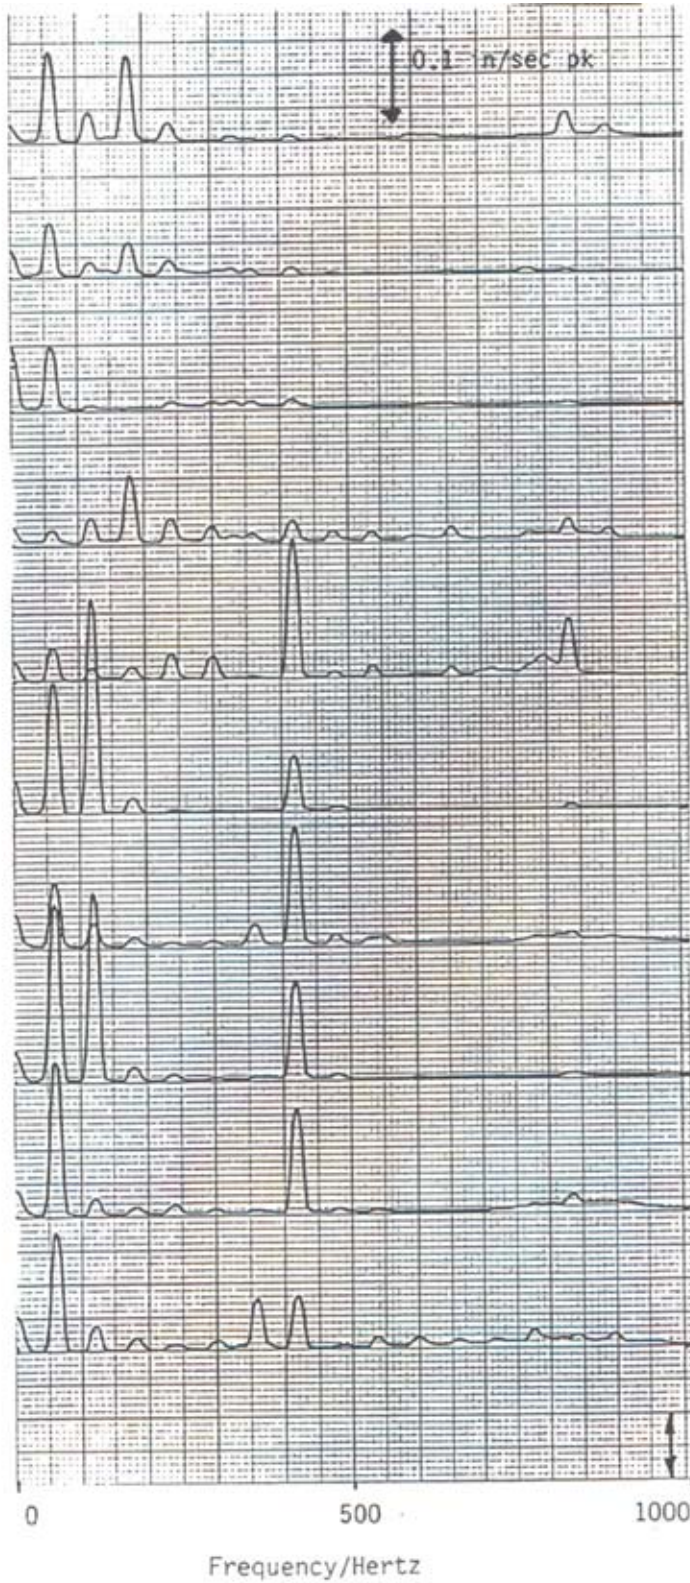
Figure 19 shows vibrations across the machine with 47.5 lbs. of weight clamped on both of the bearing housings. Note that the vertical vibrations have increased at bearing B at vane passing compared with the 38 lb. weight results in Figure 18, while the horizontal vibrations have decreased.

**Running Vibrations on Boiler Feed Pump
and Motor with 47.5 lb weights clamped
to Pump Bearings**

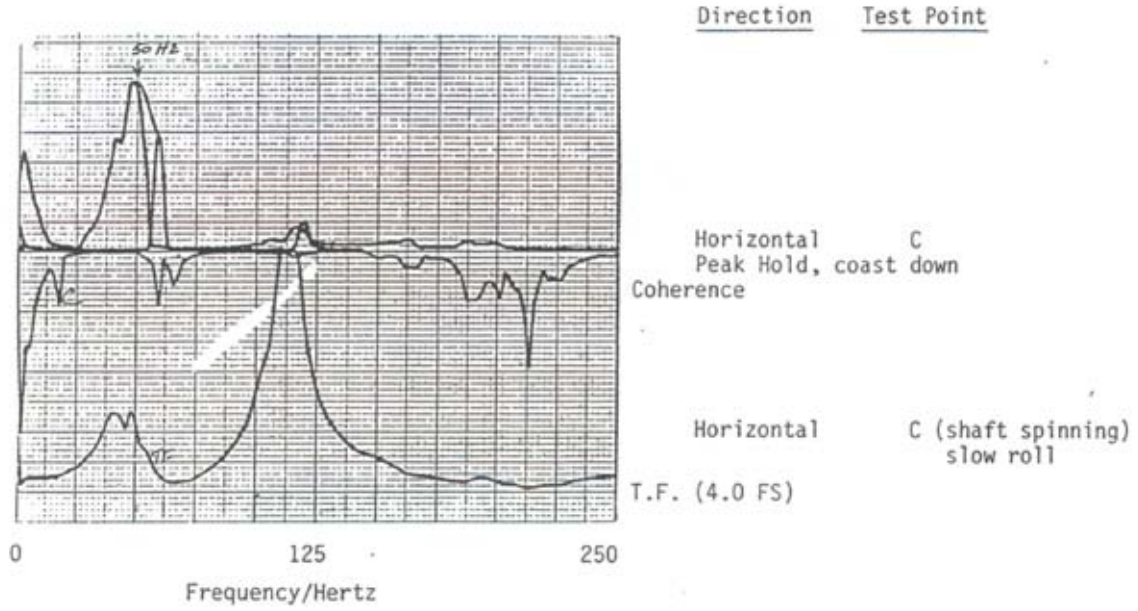
Figure 20

The motor vibration remained to be analyzed. Further structural response tests were made on the motor in the horizontal and axial directions. Refer to Figures 20 and 21. These Figures show structural resonances present at the same frequencies that show high response on the motor in Figures 2 and 3.

The skid showed signs of poor design which would explain the structural resonances. The skid was concrete filled, but the concrete was not connected to the steel due to shrinkage.

Horizontal Transfer Function and Rundown Response on Motor

Our recommendation for vibration reduction on the motor was to rebuild the skid.

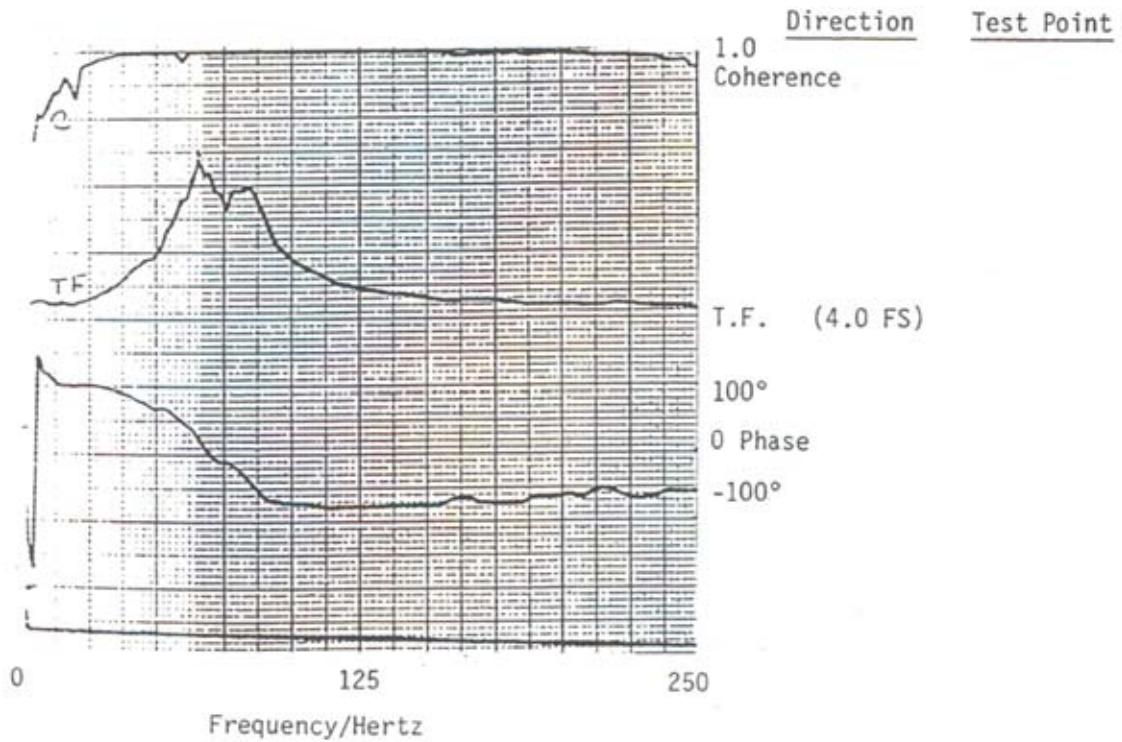
Figure 21

Axial Transfer Function Measured on Motor
