Piping Vibration Examples

These examples illustrate various piping vibration problems. Advanced vibration analysis is required to solve these dynamic issues: flow-induced vibration (FIV), acoustic induced vibration (AIV), and other common issues. BETA recommends that piping vibration be assessed during the design stage to avoid costly piping modifications during operations (see Piping Vibration and Integrity Assessment).

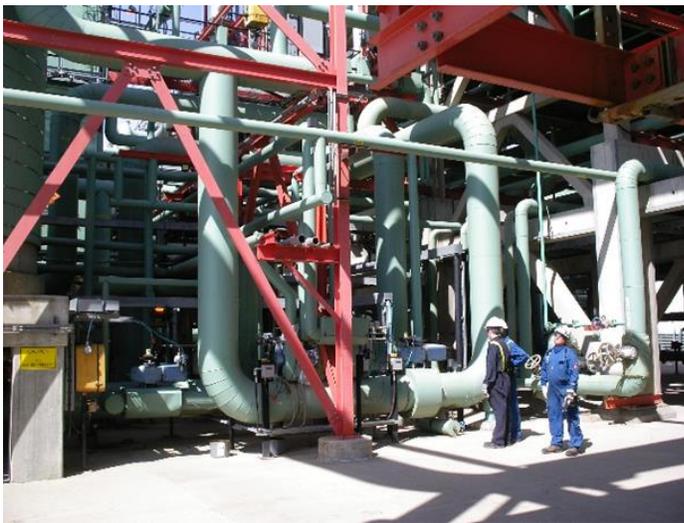
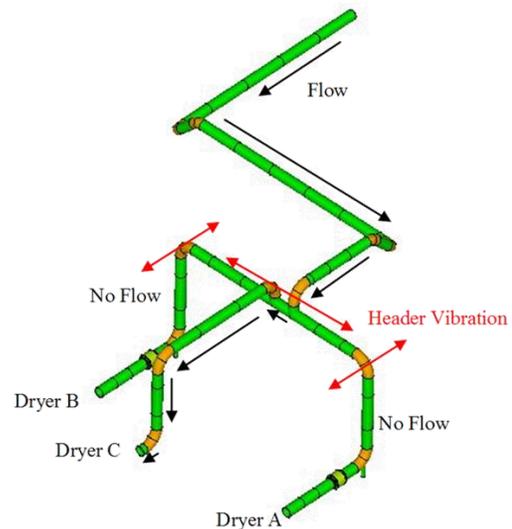
This refinery utilizes large centrifugal compressors. The piping system is shown below (left). Vibration problems occurred on the piping header feeding three dryers (right).

Normally the gas flow travels through two dryers and no vibration issues occur but under regeneration, the operators use only one dryer. When flowing to one dryer, the operator measured high vibrations in the header as shown by the red arrows (above, right).

BETA's field team was hired to analyze and address the problem. While onsite, BETA measured natural frequencies, vibration displacement, pressure pulsations, operating deflection shape, and other parameters. After reviewing the results it was confirmed that the vibration was due to a complex FIV problem. Note that FIV can also be called Eddy Shedding or Vortex Shedding.

One solution was to eliminate flow induced excitations by changing the length of the inlet header and the distance between Dryer A and B inlet valves. This was determined to be too expensive, so BETA designed supports to be installed at specific locations in order to shift the mechanical natural frequency away from resonance.

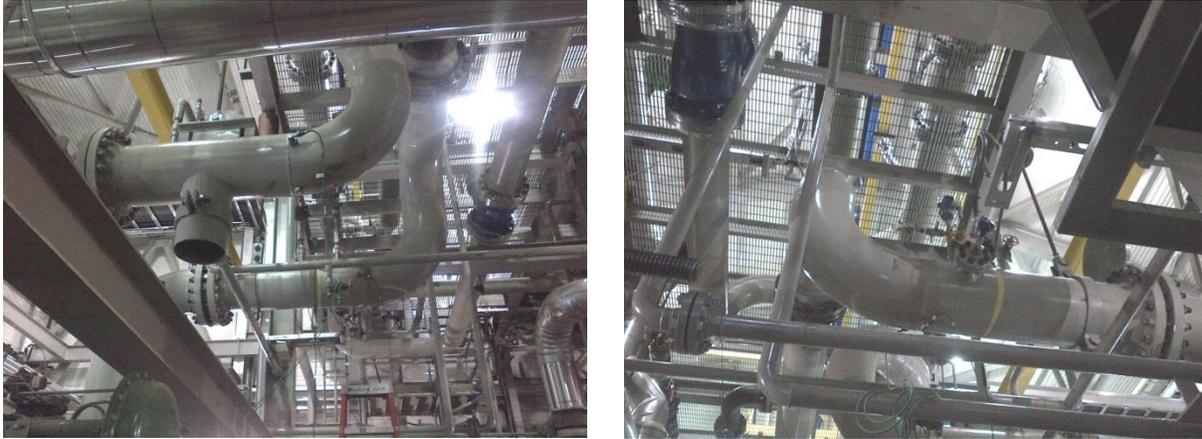
BETA was hired to address severe vibration in the overhead suction piping system. The vibrations were so severe that personnel did not want to be present in the building for fear of piping failure. As seen in the pictures below, the piping system is complex with many dead legs.

BETA measured high pulsations in the suction dead legs at 15 Hz, the same frequency as the calculated Strouhal frequency. This confirms the excitation force was due to the 15 Hz pulsations and is an FIV problem.

The standard FIV problem occurs when a quarter wave Acoustical Natural Frequency (ANF) coincides with the excitation frequency (15 Hz pulsations); but in this case, the problem was much more complicated than the standard FIV problem. All of the relevant dead legs were analyzed and it was discovered that none of them matched the 15 Hz frequency (quarter wave ANF).

After reviewing the piping geometry in more detail, BETA discovered that an entire piping section comprising of the header and dead legs had a 15 Hz ANF – something very rarely seen. Once the source of the FIV problem was found, BETA recommended modifications to alleviate the resonance.

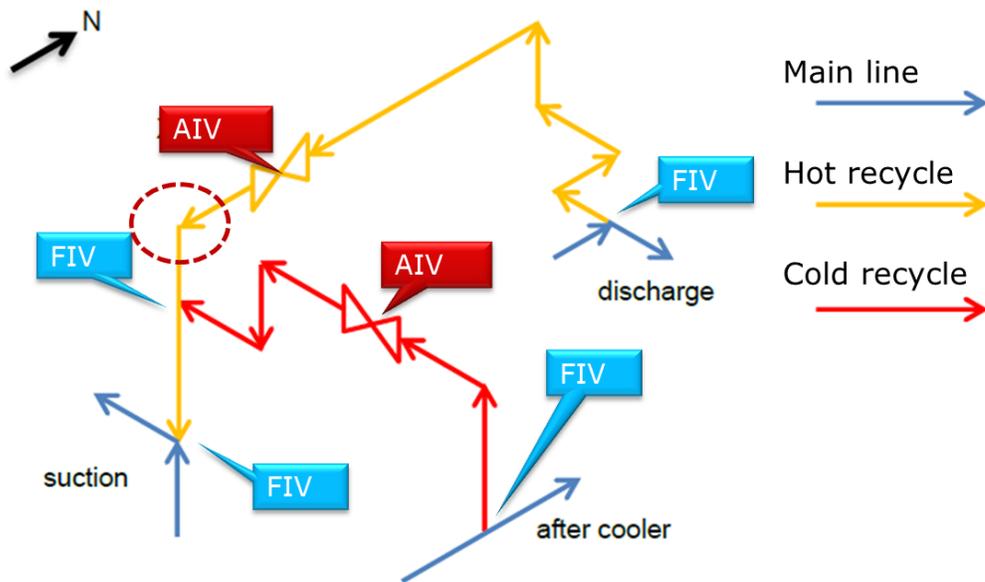
The following schematic shows the main piping system including hot and cold recycle. The area of high vibration is shown by the dotted circle. BETA's engineering design team identified many locations where FIV or AIV could be the source of the excitation forces.

Each of the potential FIV and AIV locations were evaluated in more detail including different operating scenarios (flows, temperatures, etc.). Through this advanced analysis, BETA was able to identify one FIV location and one AIV that likely contributed to the problem.

Recommendations to modify the valve trim will reduce the risk of AIV problems. To reduce FIV problems, certain flow rates should be avoided. This is not always practical, therefore, other solutions were provided. This case illustrates the combination of FIV and AIV risks that affect piping systems.

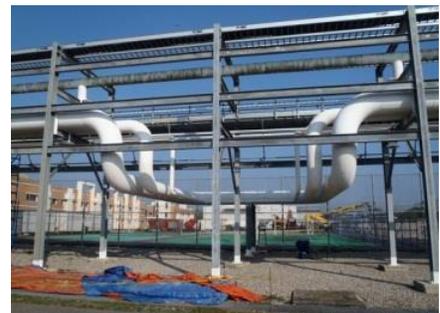
Based on the field analysis, the vibration upstream of the control valve is caused by Flow Induced Excitation (FIE, also called FIV) which is created when gas flows past a deadleg. The deadleg creates vortices, which are amplified by the standing wave in the deadleg. These pulsations travel through the pipe and cause it to shake.

Three solutions were identified to reduce the excitation forces. These options included: modifications to the operation of the bypass valve; a minor modification at the mouth of the deadleg; or modifying the piping geometry by moving the recycle valve.

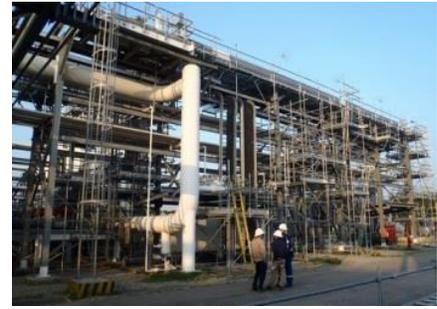
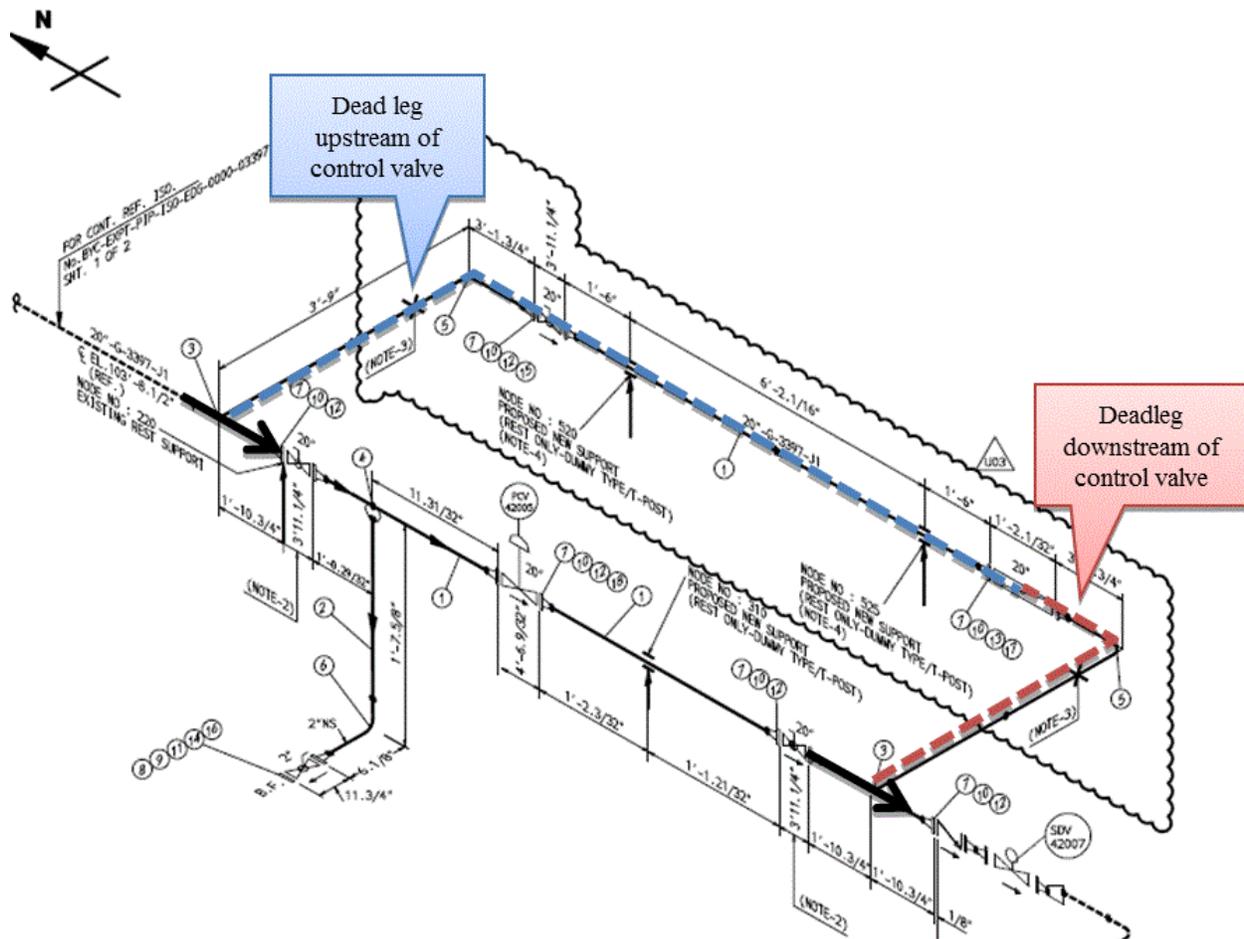
Under some flow condition the piping at the expansion loops was observed to exhibit very high vibration. The piping in this area is very loosely supported and any unbalanced force in the piping system will result in high vibration on these lines. If the FIV created by the deadleg near the control valve cannot be controlled, then increasing the stiffness of the expansion loops will help control vibrations. BETA provided recommendations on adding beams to support the elbows. In addition to these piping support recommendations, a pipe stress analysis is required to ensure the additional supports do not create thermal stress problems.
