# THE BETA BULLETIN

VOLUME 11 #1

## A Major Wreck Prevented

# “PROFILING” OF PULSATION AND VIBRATION IN COMPLEX RECIPROCATING COMPRESSOR FACILITIES

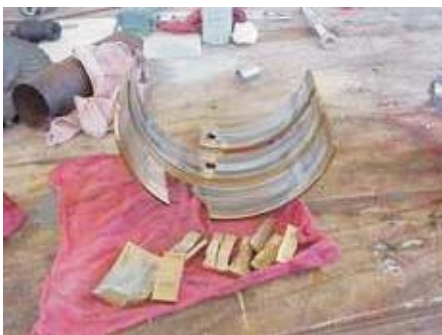
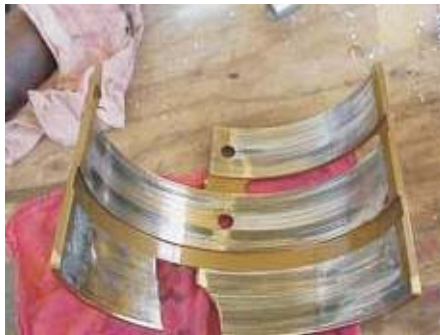
What they found is shown in the pictures below. Customer personnel were, in their own words, "amazed". They are sure that if this unit had run much longer in this condition there would have been a severe crash causing major crankshaft and frame damage. A Company specialist estimated that the repair cost could easily have run \$500,000 to \$1,000,000. Lost production revenue would likely have been even greater since this unit is critical to production.

Then came the "show stopper", as the customer representative described it. A rod bearing clearance on a large integral unit was measured at 0.017". This is two to three times a normal and

reasonable clearance for this particular situation. The Beta analyst immediately informed the facility manager. The manager deployed a maintenance crew to remove and inspect the bearing.

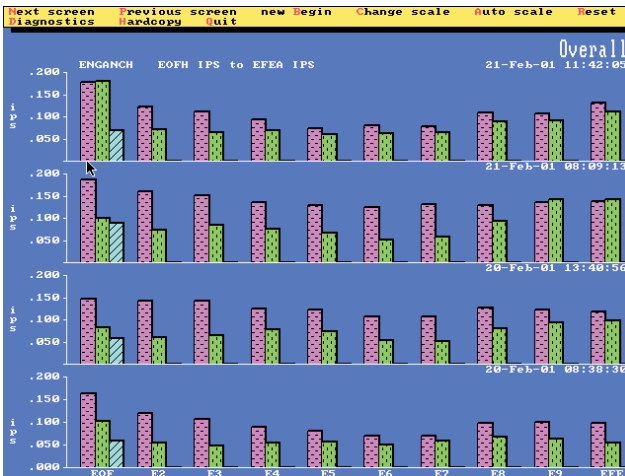
**Fig. 2.5: Engine Anchor Overall Vibration.**

**2.5** Unit K705 has slightly higher overall vibration across the machine as compared to K707. Both units show an increase in vibration levels with the increase in speed to 350 RPM. Unit K707 shows an increase in vertical vibration at the opposite the flywheel end anchor location. Rotational dominate, discrete, and remainder profiles weren't significant and aren't included.

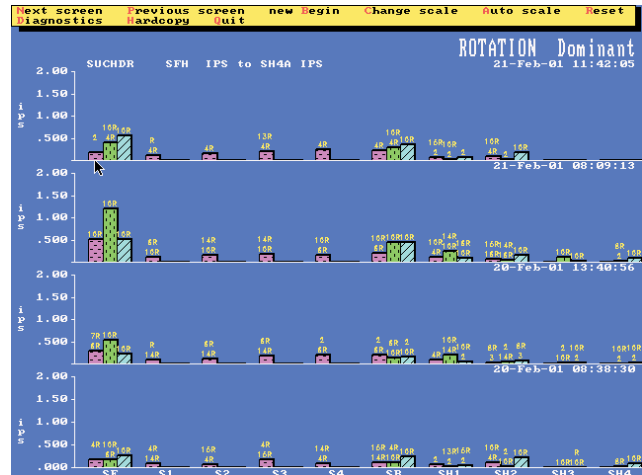
**Fig. 2.8: Suction system vibration rotational dominant profile.**

**2.8** The rotational dominant profile shows that the significant increase in vibration at the front end of the suction bottle is due to the 10R component.

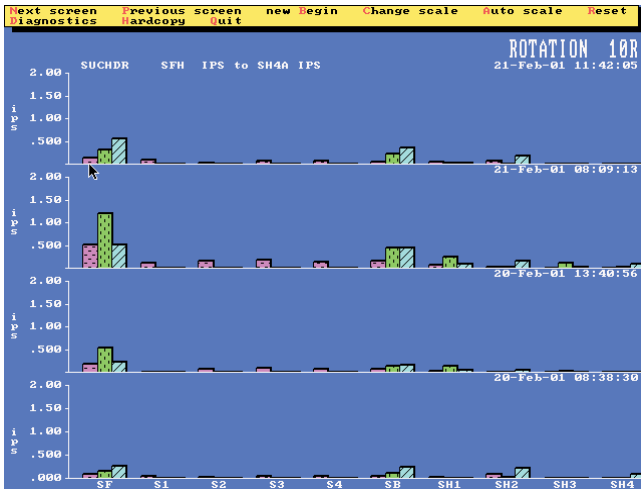
**Fig. 2.9: Suction system vibration 10R**

**2.9** The 10R or 58Hz component increases dramatically at the front end of the suction bottle but is not as significant elsewhere on the suction system. The increase is clear evidence of the mechanical resonance at this frequency.
