THE BETA BULLETIN

VOLUME 11 #4

A GEARBOX VIBRATION - FACT OR FICTION

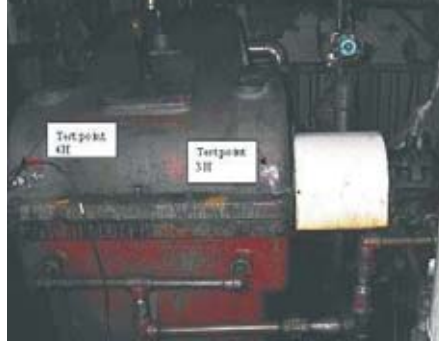
Picture 1: High speed side of the box, Test Points 3 and 4: (Turbine to the right)

Vibrations were collected in a similar manner at Test Points 3, 4 and 5 in the horizontal direction. Refer to Pictures 1 and 2 for details of the test point locations.

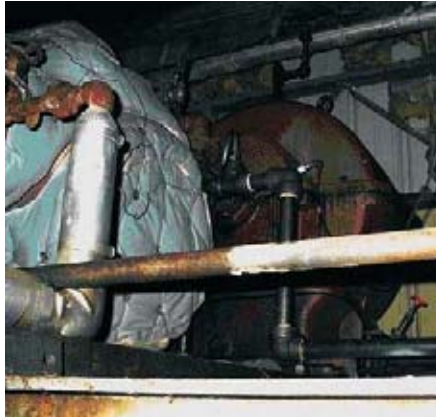
Picture 2: View of Test Point 5 with accelerometer mounted with stud on nut glued to box in Horizontal orientation. The oil pump is on the turbine side of the low speed shaft.

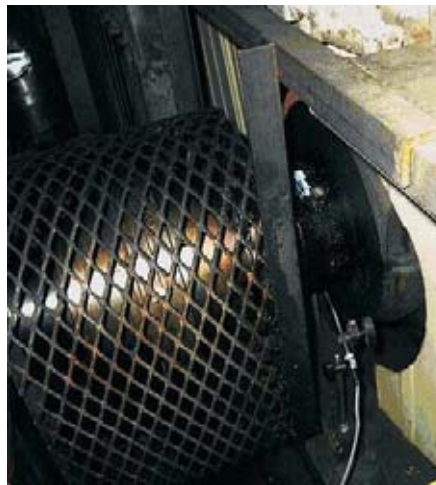
Picture 3: Optical pickup on the low speed shaft. Once per turn mark was put on the shaft while it was running.

Refer to Picture 3 for details of the once-per-turn setup. As noted, the mark was put on the shaft without shutting down the unit.

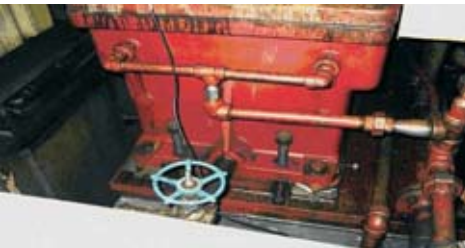
Picture 4: Gearbox base on the south side.

Picture 4 shows the feet of the gearbox on the south side. This is shown in connection with the soft foot check that was done. We checked for the effect of a soft foot on the vibrations by loosening and tightening one foot at a time. The change in vibrations was noted for each of the four feet. Foot 3 showed the largest change in vibrations. The overall vibrations (from the time domain data) decreased by 6%.

The amplitude of the vibration at 4828 Hz decreased by 22% when the anchor bolt was loosened.

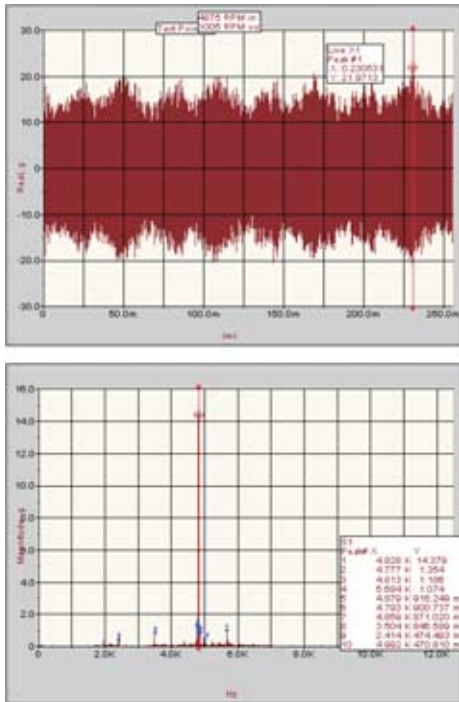
Figure 1 is representative of the data. It was collected in the horizontal direction, near the bearing on the output side of the low speed shaft. The accelerometer was mounted on a nut, which had been glued to the gearbox.

Based on the speed of the output shaft and the number of gear teeth given to us, the gearmesh frequency was 3494 Hz. Note in the spectrum plot in Figure 1, that there is a peak in the acceleration spectrum approximately at this frequency (3504 Hz). However, the major peak in the spectrum is at 4828 Hz, which is 1.38 times gearmesh frequency.

Close inspection did not disclose significant amplitudes at harmonics of gearmesh, or sidebands. The time domain data did not show any spikes. Generally, the gearbox looked to be in good condition based on normal dynamic indicators, except for the unusual peak at 4828 Hz.

Further analysis of the 4828 Hz peak could not be done because of restrictions on changing speed. However, it can be seen that there are many small peaks around the main 4828 Hz peak. This energy is consistent with the idea that there is a mechanical natural frequency (MNF) of the gearbox case that is at or near 4800 Hz. Changing the speed of the unit would have permitted us to test this theory. Experience has shown, however, that frequently there are MNFs which are excited in a gearbox. While it is not a particularly good sign, it is not necessarily an indication of a serious problem with the gearbox in the absence of harmonics and sidebands. It is more likely a sign that the gearbox manufacturing tolerances were looser than what can be achieved (but at what cost?).

Figure 1: Test point 6H Acceleration Data

We concluded that the gearbox was in good enough condition to run till the planned turnaround next spring. We did, however, recommend doing a few additional checks to ensure that this conclusion was correct. We recommended checking the oil in the gearbox for wear metals. We also recommended checking the oil filters for any sign of metal.

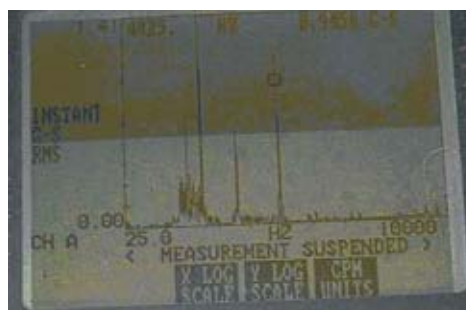
Picture 5: Vibrations at 6H with magnet mount

Observe the dramatic change in vibration energy below the gearmesh frequency peak at 3500 Hz. Stud mounting increased the amplitudes of the peaks at gearmesh and 4820 Hz.

The good news is that all of the peaks are present, albeit at different amplitudes, in both spectra. The biggest reason for not using a magnet to mount an accelerometer for high frequency measurements is the desire to collect data repeatably. The frequency response of the accelerometer is influenced by the connection of the magnet to the gearbox. Changes in the thickness of the paint will change the frequency response and produce an apparent change in the condition of a gearbox. Dirt under the magnet will do the same thing. Poorly mounting the magnet (not "wiggling" the magnet to ensure the magnet is solidly mounted) will do the same.

Methods of mounting of transducers, such as accelerometers used for measuring high frequency data, are important. Repeatability of data collection is the most important consideration in choosing a mounting method.
