THE BETA BULLETIN

VOLUME 12 #3

“Compressor Hasn’t Run this Quietly or Smoothly in 18 Years of Operation”

A Case Study about Field De-tuning of Mechanical Resonance on Fixed Speed Screw Compressor Packages - Bryan P. Fofonoff, BMA and Abnil Dejarne, Dow Chemical

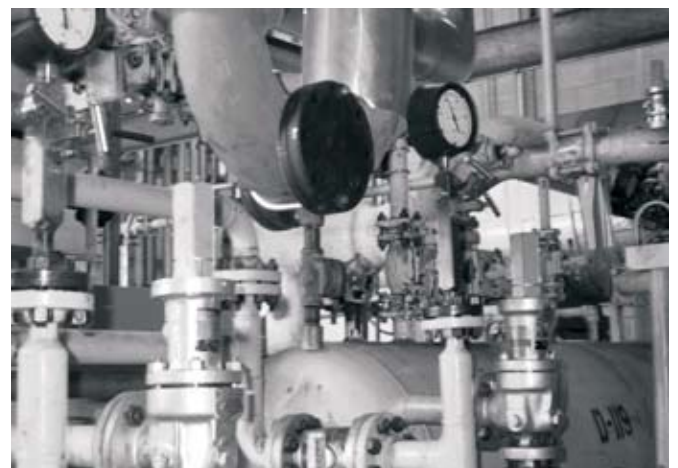
Figure 3 Discharge piping from vessel D118 with de-tuning weights secured

Separator Discharge Piping Very high vibration was also observed on the separator discharge piping. Vibration levels greater than 4.0 inches per second peak were observed at a frequency of 119 Hz on the lower elbows of the discharge line. The vibration on the discharge line drain valve was extreme, measuring greater than 9.0 inches per second peak. 4" 150# blind flanges were u-bolted one at a time to the discharge piping as shown in Figure 3.

Vibration levels were checked after each flange was secured in place. With four blind flanges secured, the vibration on the discharge line dropped to a peak of 0.8 inches per second. Vibration on the drain line was still marginally high at a peak of 2.0 inches per second. At this point there was a noticeable decrease in the noise level around the C118 compressor.

Adding de-tuning weight resulted in a considerable reduction in the vibration levels. At the conclusion of the project with all the de-tuning weights installed, an even more dramatic reduction in levels was observed. Final readings on the discharge line were measured to be 0.42 inches per second peak at 119 Hz and the level on the drain line dropped to 0.115 inches per second peak at this same frequency.

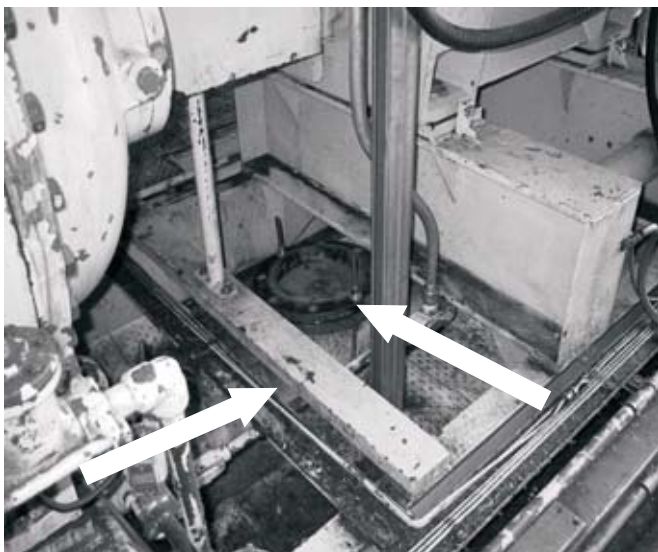
Discharge Line The discharge line between the compressor and the separator D118 exhibited high vibration. Initially vibration levels on the pipe in the vertical direction measured 3.4 inches per second peak at a frequency of 119 Hz. Several tests were conducted to determine the effect of the pipe clamp located under the coupling end of the motor.

Figure 5 Discharge line de-tuning weight located under compressor/motor coupling

The greatest reduction in vibration levels on the discharge piping was achieved with the pipe clamp

removed and two sets of de-tuning weights clamped to the discharge line. A set of weights was located on the discharge line directly under the compressor/motor coupling and another was installed at the lower elbow of the discharge line into the D118 vessel. Both sets of weights were secured with a bent length of ready rod and were made up of 8" 150# blind flanges and rings.

Final vibration levels on the discharge line under the coupling were measured to be 0.21 inches per second peak in the horizontal direction and 0.85 inches per second peak in the vertical direction. Both peaks were at 119 Hz. Vibration levels on the discharge pipe, just before the elbow rising up to the vessel, saw reductions at 119 Hz from 1.3 inches per second peak to 0.15 inches per second peak in the horizontal direction. At the same location and frequency, vertical vibration dropped from 2.8 inches per second peak to 0.58 inches per second peak. The de-tuning weights installed on the discharge line are shown in Figures 5 and 6.

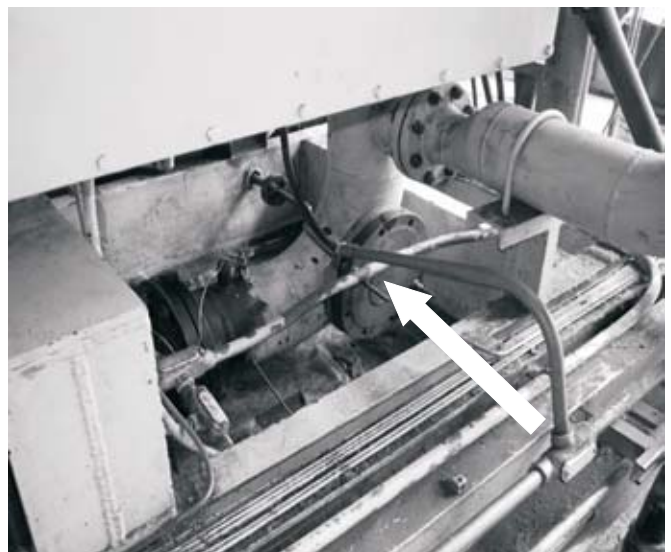
Figure 6 Discharge line de-tuning weight located at lower elbow before D118
