## THE INFLUENCE OF TILTING PAD BEARING CLEARANCE ON ROTOR RESPONSE OF A STEAM TURBINE

Brian C. Howes and Donald D. Leung

### Abstract:

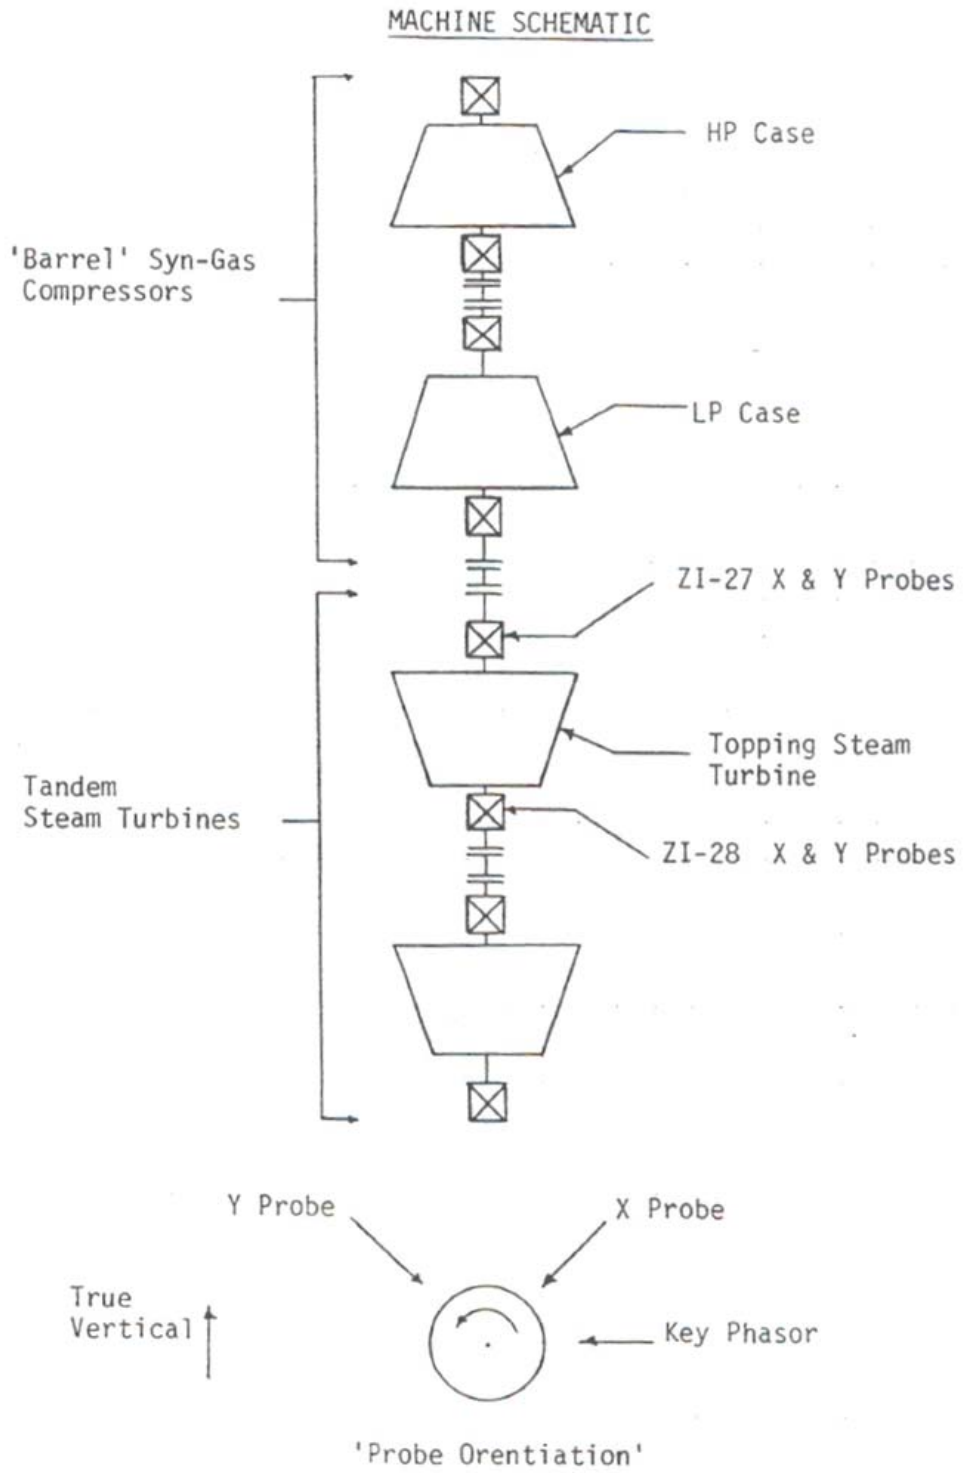
FIGURE: 1

The machine train consisted of tandem steam turbines directly coupled to the topping steam turbine which drives two syn gas compressors (high pressure and low pressure). See Figure 1 for a schematic sketch of the machine layout.

Pairs of eddy-current proximity probes mounted at 90° as shown in Figure 1 were used for shaft motion measurements with a modified axial thrust proximity probe being used for speed and phase reference purposes.

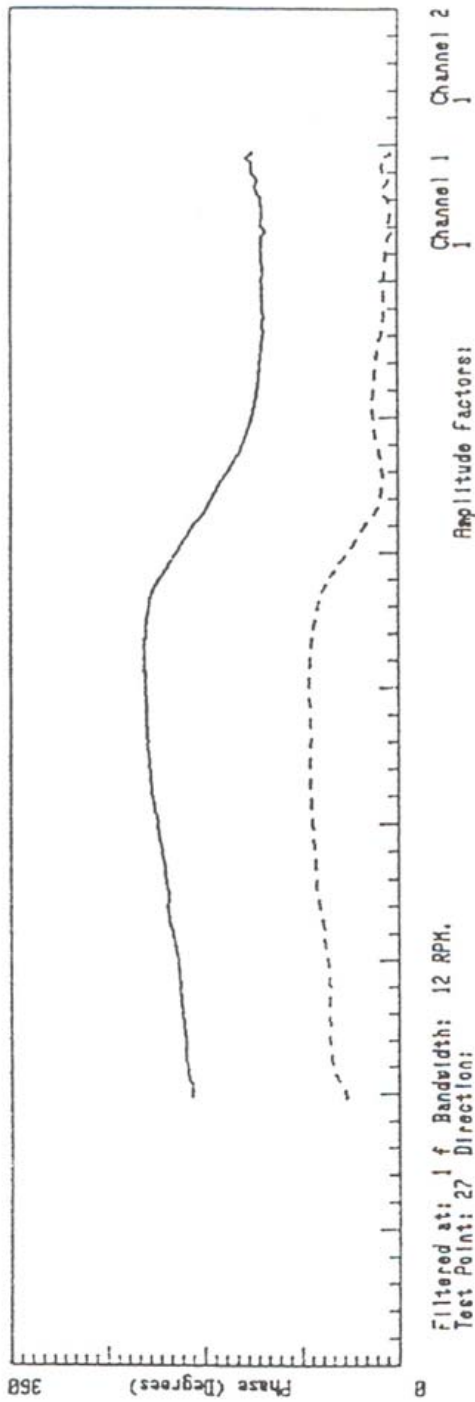
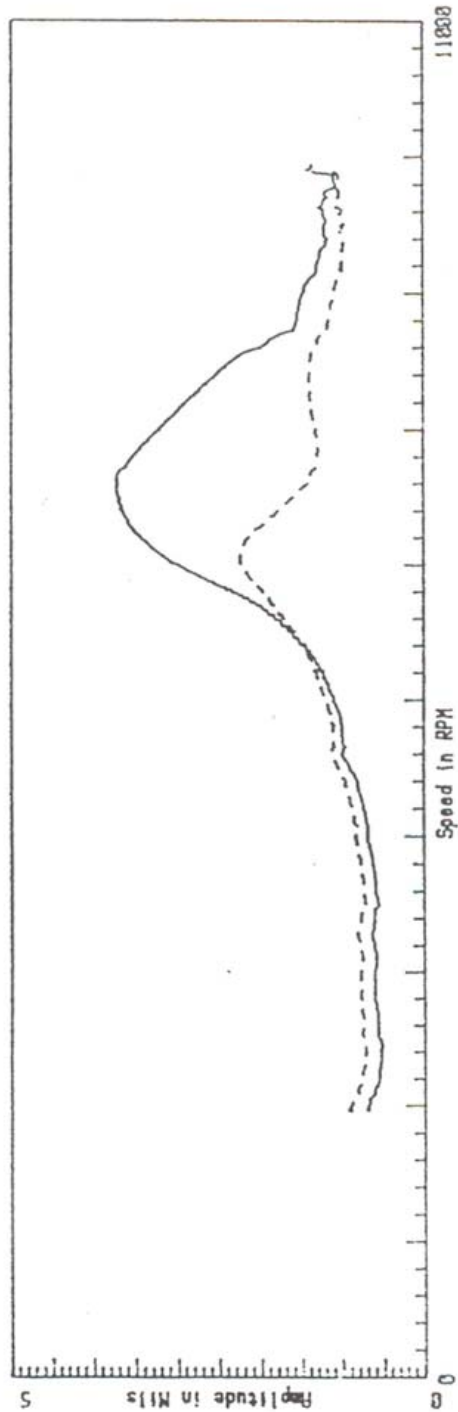
FIGURE: 14

The results of this start-up were the lowest vibration levels noted during the testing and good vibration stability under load throughout the normal operating speed range (see Figure 14). Monitoring after fourteen hours of continuous operation under load showed that the vibration levels (amplitude and phase) were almost identical to those recorded immediately after the load was initially applied. This was true over the normal operating speed range.

Beta Machinery Analysis Ltd., Bode Plot.

CFL - 'FIN BRIL COUPLED WITH :EX OUT BRG' START-UP 14:40h NOV 24, 1983  
CH 1 : ZI - 27X CH 2 : ZI - 27Y
