PERPLEXING VARIABLE FREQUENCY DRIVE VIBRATION PROBLEMS

Brian Howes¹

¹Beta Machinery Analysis Ltd., Calgary, AB, Canada, T3C 0J7

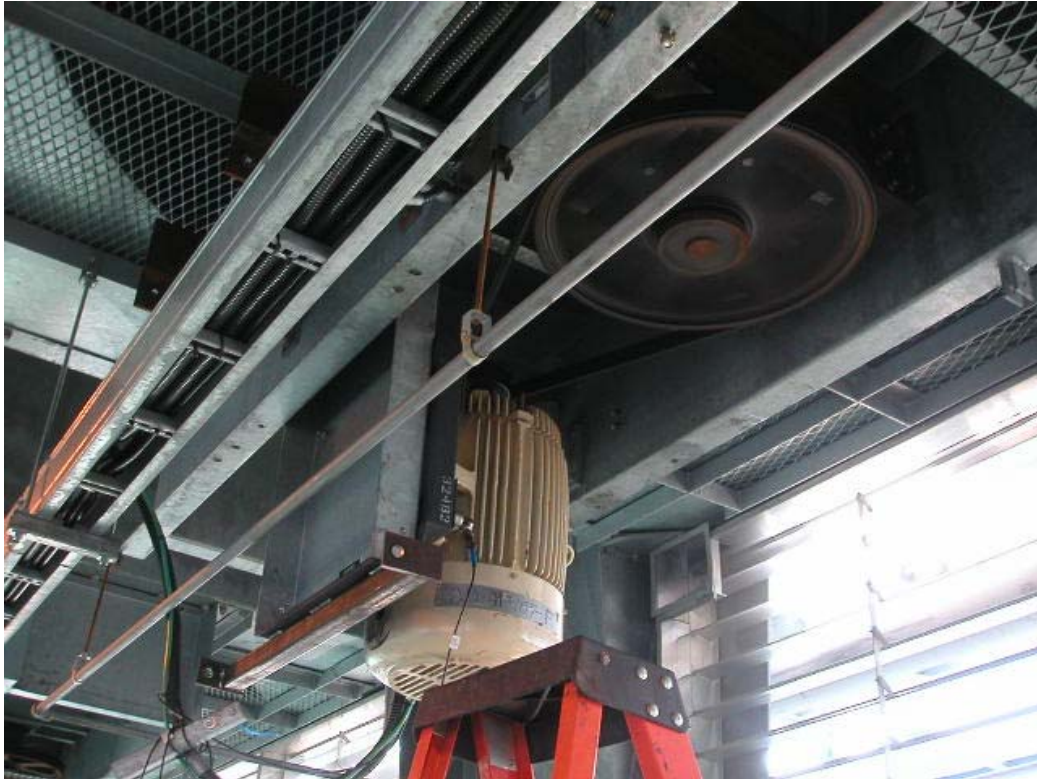
Photograph 1: Motor, belt and driven sprocket on unmodified system

Eight motors driving cooler fans (8 blades) through cog belts. The drive manufacturer did not supply the motors.

See Photographs 1 and 2 below.

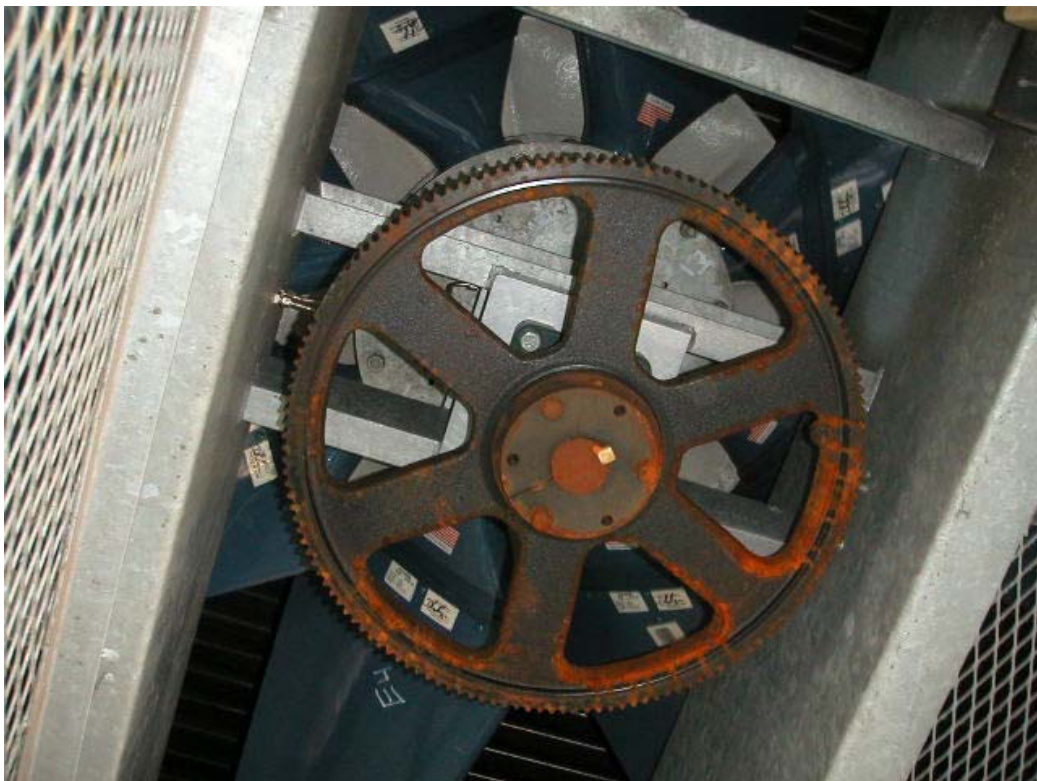
Photograph 2: Fan and driven sprocket viewed from below

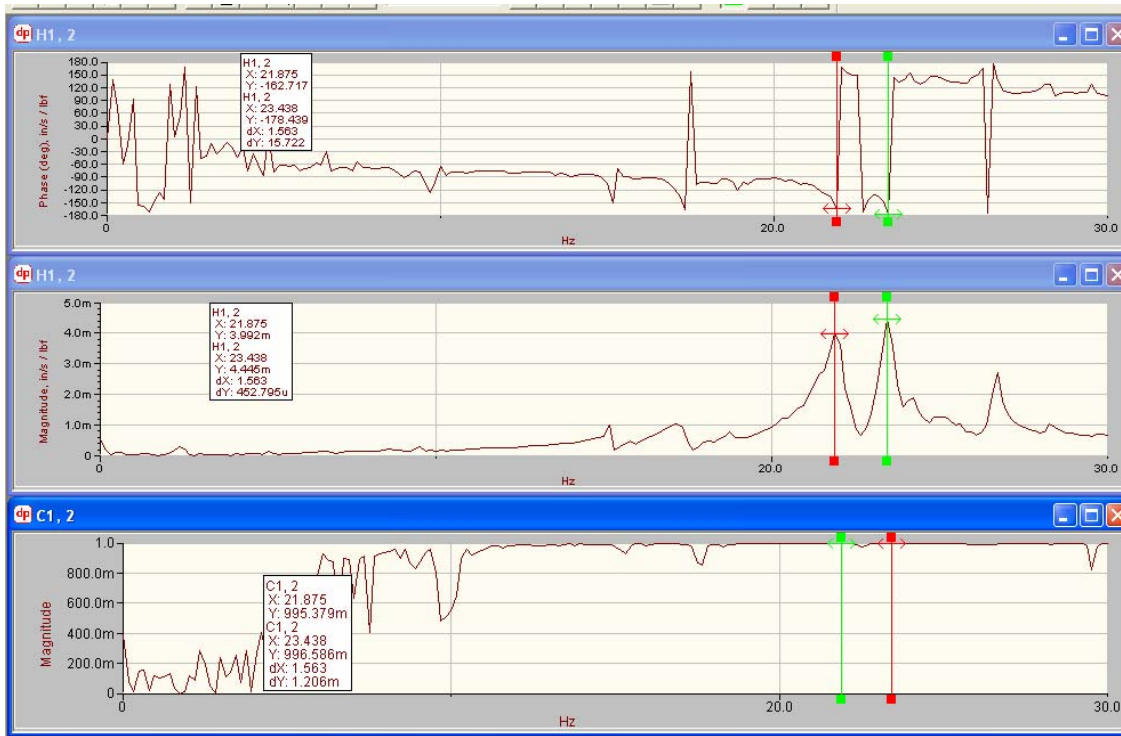
Figure 1: Typical MNF, measured in the east-west direction on a motor, as found

The relevant MNFs are shown in Table 2 below. Figure 1 below shows a typical mechanical natural frequency measurement.

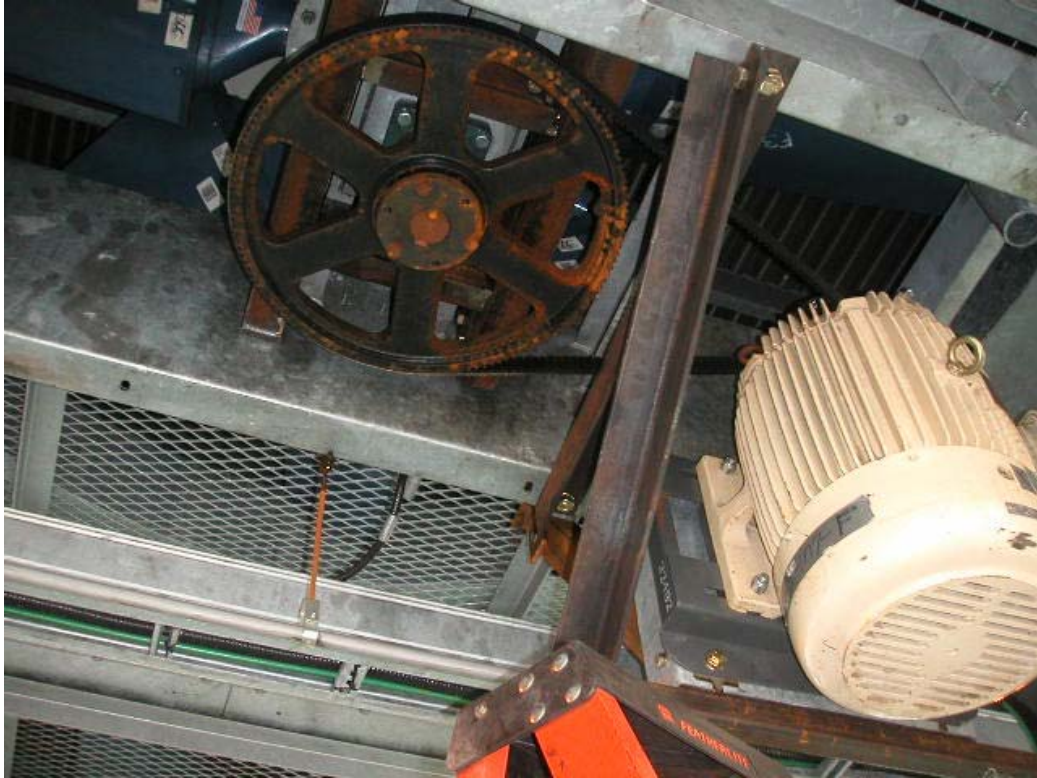
Photograph 3: The photograph above shows one side of the bracing. The stiffening was primarily in the north-south direction.

This brace was installed before we arrived. It did not make much difference to the vibrations. The dominant frequency increased about 7%, as discussed above.

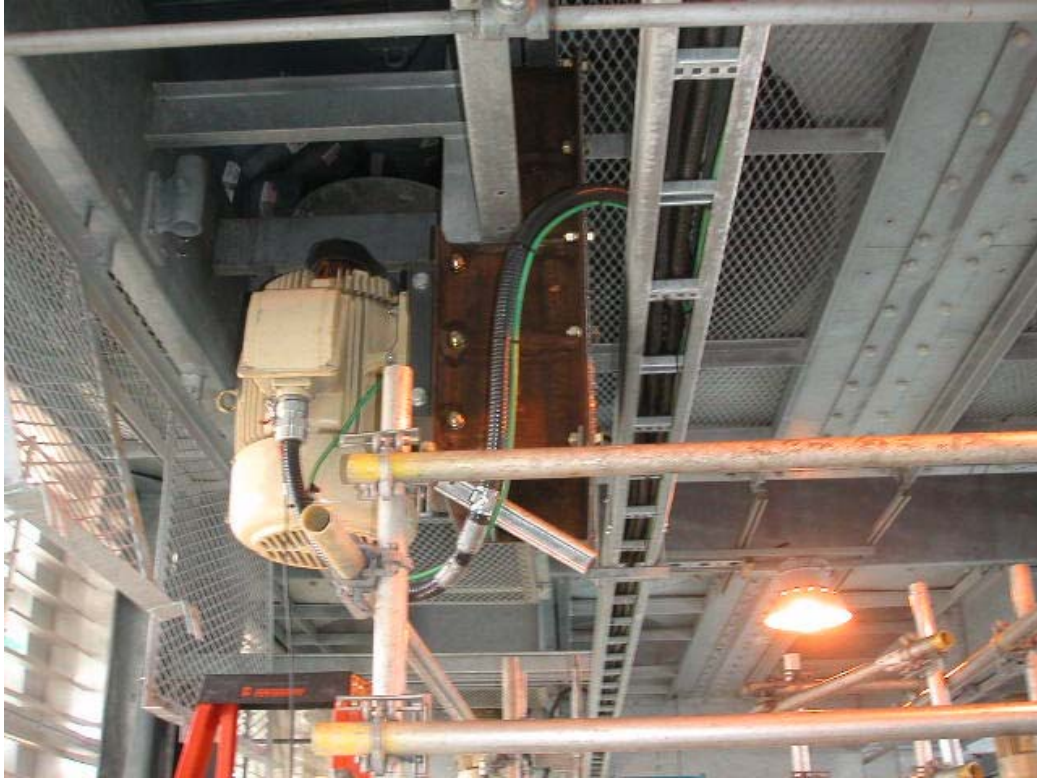
Photograph 4: Looking west at the rotationally stiff brace on motor D

This brace was designed to increase the stiffness in the rotational direction about a vertical axis. It was quite effective, and the vibrations were reduced dramatically, but not enough to be acceptable. The dominant or fixed frequency of vibration actually went down by about 7% with this brace installed.
