# Root Cause of Piping Failures: Reliability Issues for Compressor Systems

Gas Machinery Conference 2014

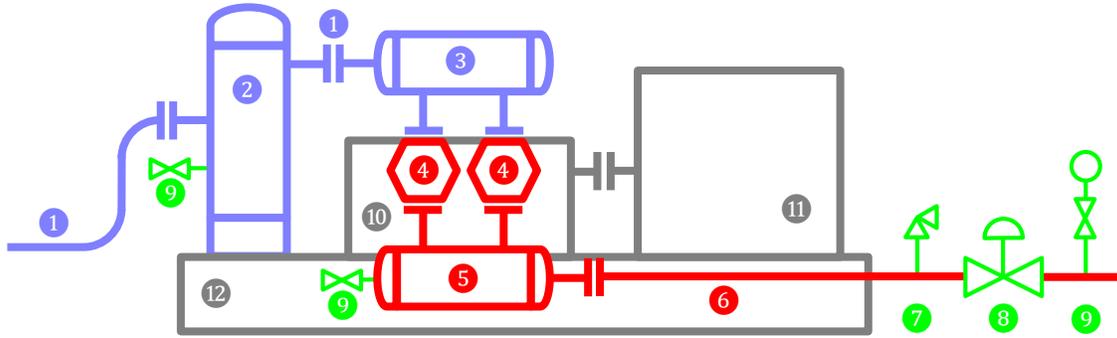
Figure 1. Problem Areas on Compressor System

For purposes of this Root Cause Analysis (RCA), Williams has shared the inspection results from 27 different compressors located at 10 different stations in the Northeast United States. Figure 1 on page 3 defines the general inspection areas focused on during the vibration inspections (labeled inspection areas 1 through 12). These inspection areas are grouped together because components in these areas tend to have similar type problems. A description of these inspection areas and the typical problems found in them is shown in Table 1 on page 3.

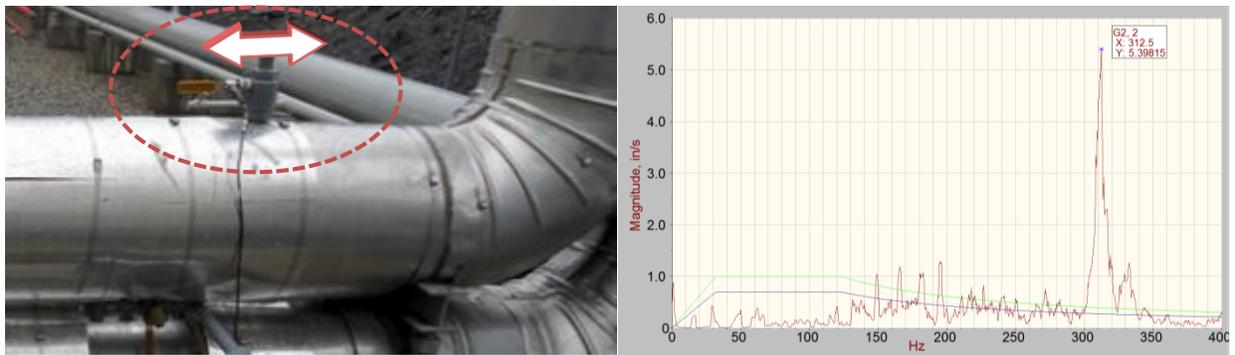
Figure 2. Small bore attachment with high vibration (left) and vibration spectrum (right)

A resonant small bore attachment had high vibration at its natural frequency (Figure 2). It was flagged as a potential failure risk during the vibration audit, and failed shortly after the vibration audit report was received.

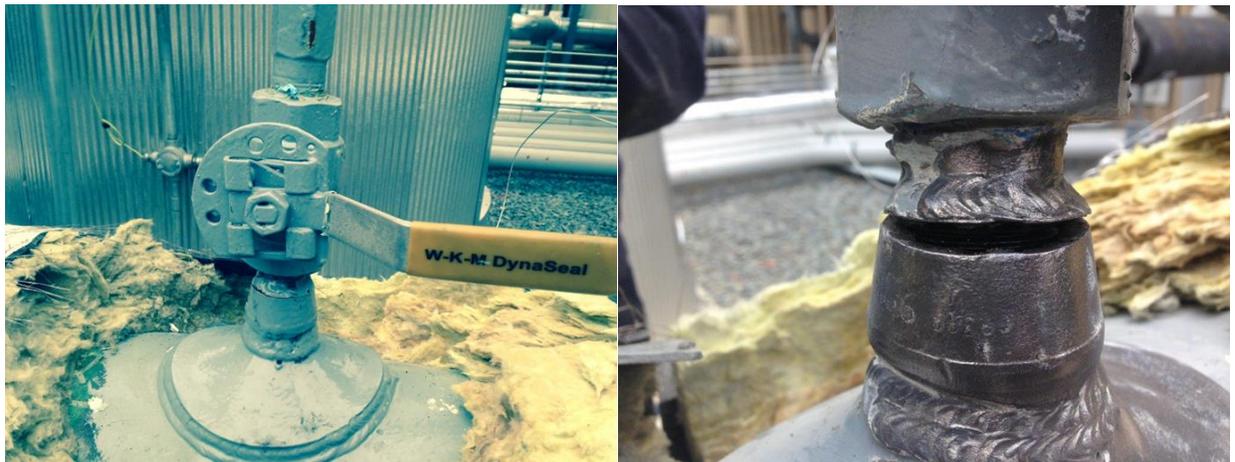
Figure 3. Original small bore attachment (left) and crack detail (right)

The original design had a FxF valve, which necessitated a small MxM coupling between the fitting and the valve. An MxF valve was recommended in the vibration audit report, which would have reduced the length, but the broken attachment was replaced with a similar design (Figure 3).

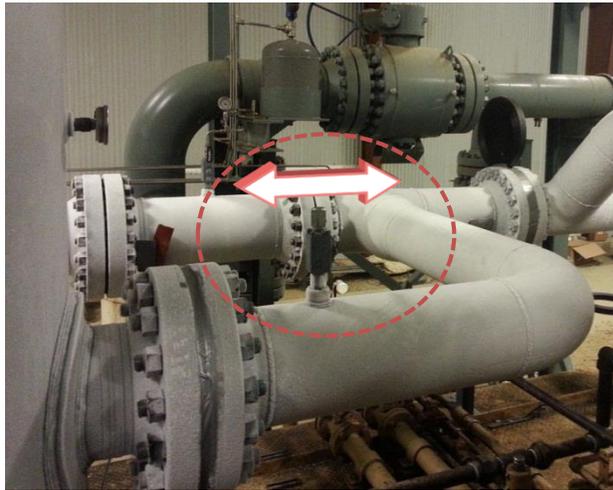
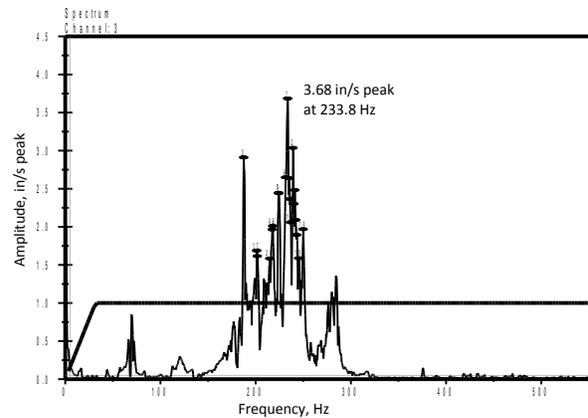
Figure 4. Small bore attachment upstream of scrubber with high vibration (left) and vibration spectrum (right)

A small bore attachment, directly upstream of a suction scrubber, was found to have high vibrations (Figure 4). During the vibration audit, it was discovered that the fitting was leaking. The fitting was replaced after BETA left the site with a similar designed fitting and failed again.

Finally, the fitting was replaced with a design with a longer nipple, which also broke and contributed to a fire that destroyed the machine.

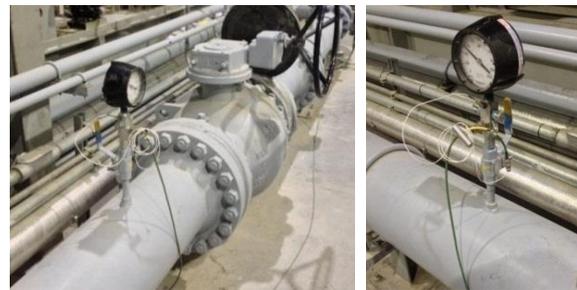
Figure 5. Small bore attachment

Several small bore attachments were resonant and vibrating excessively. The problem was due to the tall design of the small bore attachment, its location near a control valve (which creates acoustic energy when partially closed), and the flexible main piping support design (Figure 5).

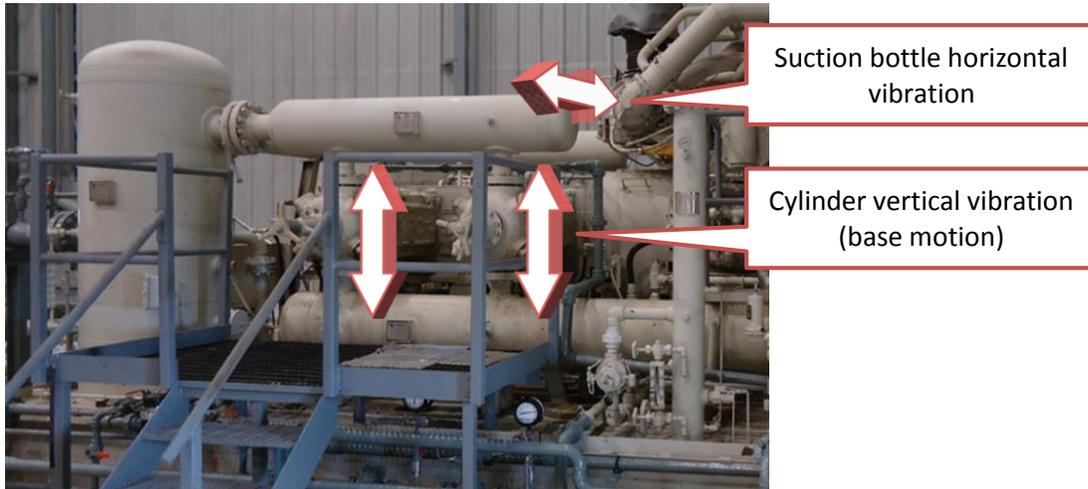
Figure 7. Suction bottle vibration caused by cylinder vibration

On compressor “C1” (Table 2 on page 5), a suction bottle was found to be vibrating a 2.9 in/s peak in the horizontal direction at its closed end. Further investigation found that the nearby cylinder vertical vibration was 1.1 in/s peak. The flexibility was traced to either the inboard support connection or loose wedge supports. Fixing those, or installing outboard cylinder supports, will fix the suction bottle vibration, which was due to base motion of the cylinders (Figure 7).

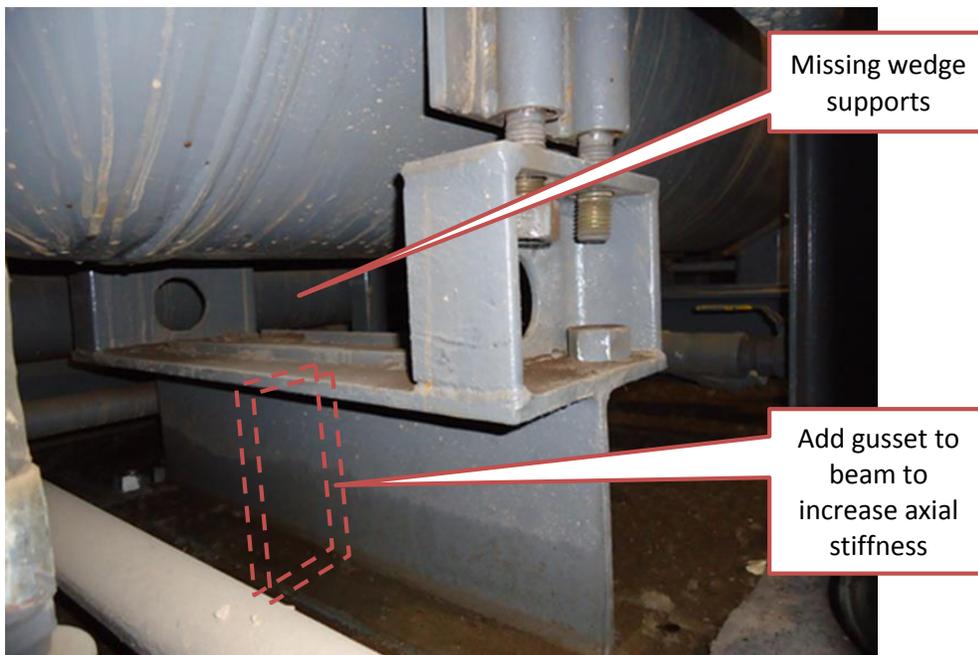
Figure 8. Discharge bottle wedge supports

On compressor “D2” (Table 2 on page 5), wedge supports were found loose and in some cases missing (Figure 8). These wedge supports were reinstalled and tightened, and vibration levels were found to actually increase. When all wedge supports were removed completely, the vibrations did not change significantly, therefore it was decided to leave them off.

Also note that the beam under the wedge supports has no gussets, and is therefore very flexible in the axial direction (although the stiffness is reasonable in the horizontal and vertical directions). Gussets are always recommended for supports similar to this; see Figure 9 for a good example.

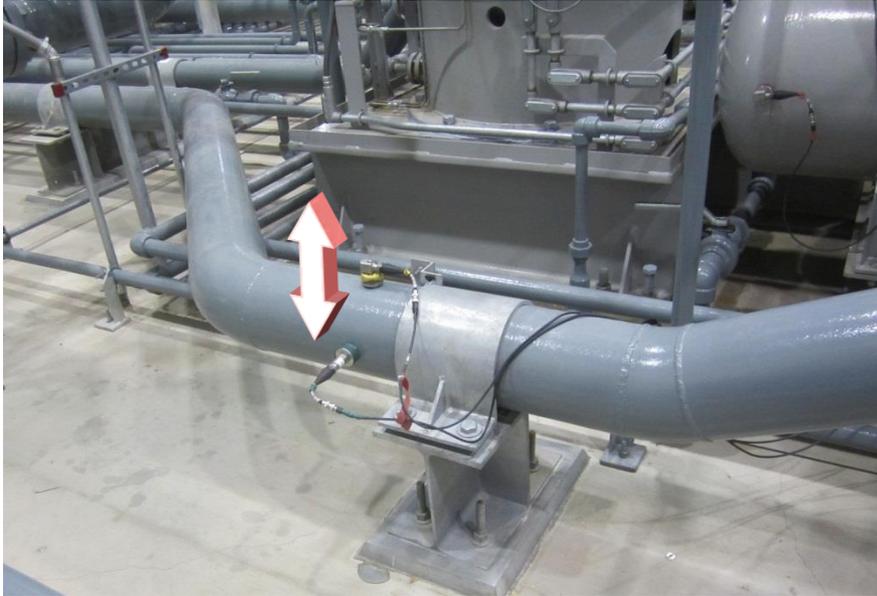
Figure 9. Discharge piping near discharge pulsation bottle

On compressor "14" (Table 2 on page 5), high vibration (1.5 in/s peak) was found (Figure 10) on piping that was well supported on well-design sleepers with gussets and good grouting (Figure 9). When the clamp was loosened, a gap opened up between the pipe and the support structure below it. Shimming this gap reduced the vibration of the piping, especially the high frequency vibration.

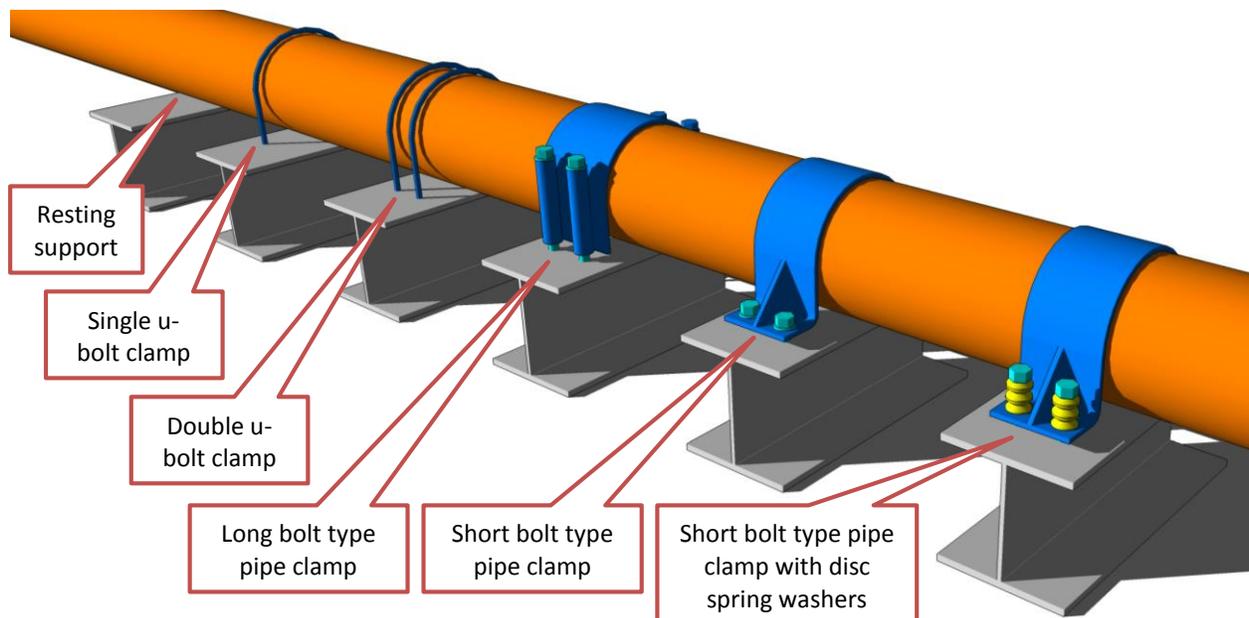
Figure 11. Pipe support designs

Several common pipe support designs are shown in Figure 11. Comments on each of the designs are shown in Table 4.

Pipe Support Design	Comments
Resting support	<ul style="list-style-type: none"> <li>Not typically acceptable on reciprocating compressor installations.</li> <li>May be permitted away from the compressors, but not within 10 mainline diameters of elbows, tees, reducers and vessels.</li> </ul>
Single u-bolt clamp	<ul style="list-style-type: none"> <li>Not typically acceptable on reciprocating compressor installations due to tendency vibrate loose and/or wear into pipe wall.</li> <li>May be permitted away from compressor if lined to prevent pipe wear.</li> </ul>
Double u-bolt clamp	<ul style="list-style-type: none"> <li>Not desirable on reciprocating compressor installations.</li> <li>If used, have u-bolts lined to prevent pipe wear.</li> </ul>
Long bolt type pipe clamp	<ul style="list-style-type: none"> <li>Acceptable design for use on reciprocating compressor installations.</li> <li>Long bolt helps prevent vibratory loosening of clamp.</li> <li>Some axial thermal growth can be accommodated due to lower clamping force.</li> <li>If lateral thermal growth is required, slots can be cut in support structure underneath pipe clamp.</li> </ul>

Short bolt type pipe clamp	<ul style="list-style-type: none"> <li>Acceptable design for use on reciprocating compressor installations.</li> <li>Can be susceptible to vibratory loosening due to short bolt.</li> <li>If axial thermal growth is required, PTFE slide plates can be used.</li> <li>If lateral thermal growth is required, slots can be cut in clamp or support structure underneath pipe clamp.</li> </ul>
Short bolt type pipe clamp with disc spring washers	<ul style="list-style-type: none"> <li>Acceptable design for use on reciprocating compressor installations.</li> <li>Disc spring washers help prevent vibratory loosening.</li> <li>Axial thermal growth can be accommodated due to lower clamping force (disc spring washers).</li> <li>If lateral thermal growth is required, slots can be cut in clamp or support structure underneath pipe clamp.</li> </ul>
