LATERAL AND TORSIONAL VIBRATION PROBLEMS IN SYSTEMS EQUIPPED WITH VARIABLE FREQUENCY DRIVES

Beta Machinery Analysis Ltd., Calgary, AB, Canada T3C 0J7

2. CASE HISTORY 1

3. CASE HISTORY 2

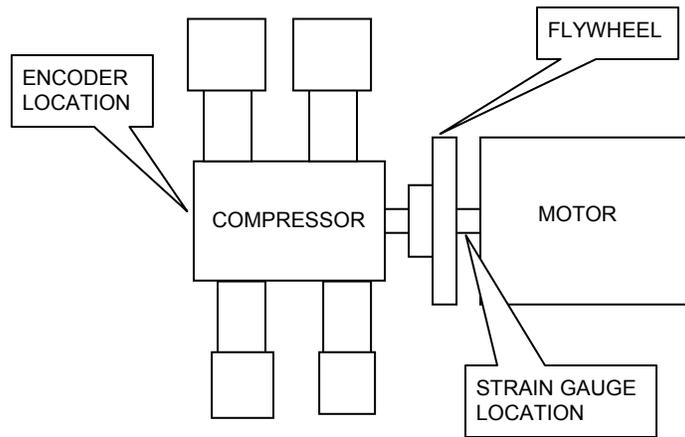
Figure 2.1. Compressor Package Layout

The system discussed consists of two four-throw pipeline reciprocating compressors driven by induction motors. Figure 2.1 shows a schematic configuration of one package. There is a large flywheel between the motor and the compressor. One of the compressors is normally started up using the VFD and then switched across the line, delivering the maximum capacity. The second compressor's speed is varied to match the production requirements. Any of the compressors can lead or lag. The VFD manufacturer did not supply the motors.

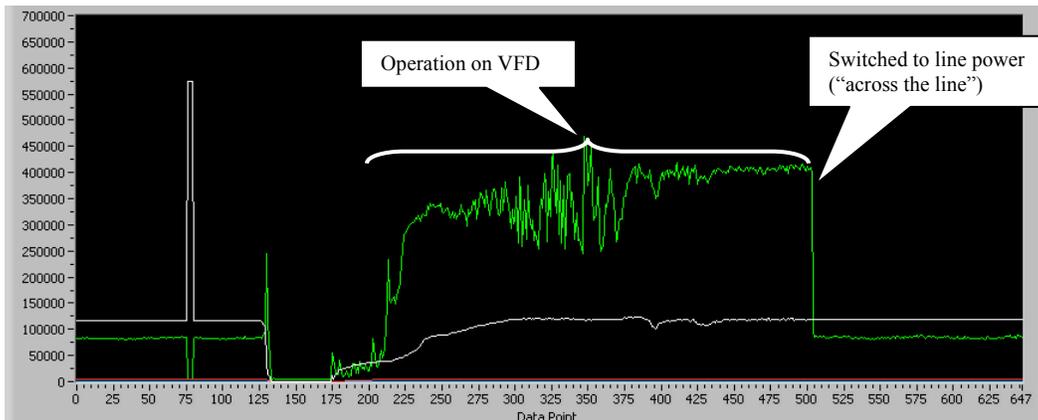
The original symptoms were exhibited in one of the systems. As the speed was increased and the first torsional critical speed was excited, the TVs peaked and then the amplitude of the torsional vibration stayed high at the TNF even though the motor speed was still increasing. This speed sweep process is shown in Figure 2.2. The trend shows two traces: mean torque and dynamic torque. The higher values while operating under VFD control correspond to the dynamic torque caused by torsional vibration.

Figure 2.2. Trend showing the peak to peak or dynamic torque fluctuation (green trace) and the Average torque (white trace). The dynamic torque drops significantly after switching from VFD operation to Line Power

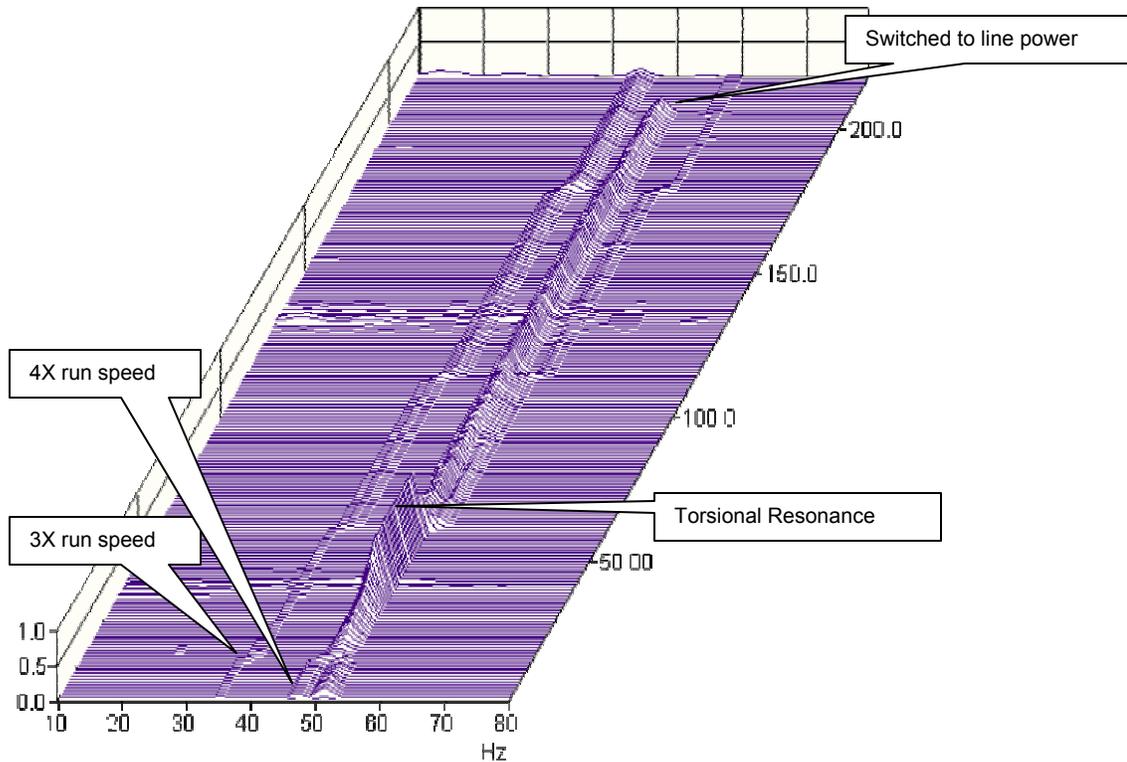
Figure 2.3 shows the waterfall of the dynamic torque spectra during the speed sweep and switching process. Two orders of run speed can be seen clearly; 3X and 4X run speed. These orders increase frequency as the motor is sped up from 700 rpm to 900 rpm. The amplitude at 50 Hz increases significantly when the motor speed reaches 750 rpm and torsional resonance occurs. At higher speeds the 50 Hz peak reduces its amplitude; however, it is still higher than any other order, despite operating out of resonance.

Figure 2.3. Torsional Vibration - motor shaft - Speed Sweep - Loaded
3X and 4X components vary with speed
Peak at 50 Hz is shows the highest amplitude
Switched to line power after trace 200 and 50 Hz peak disappeared

Figure 2.3 also shows that the peak at 50 Hz virtually disappears after switching to line power.

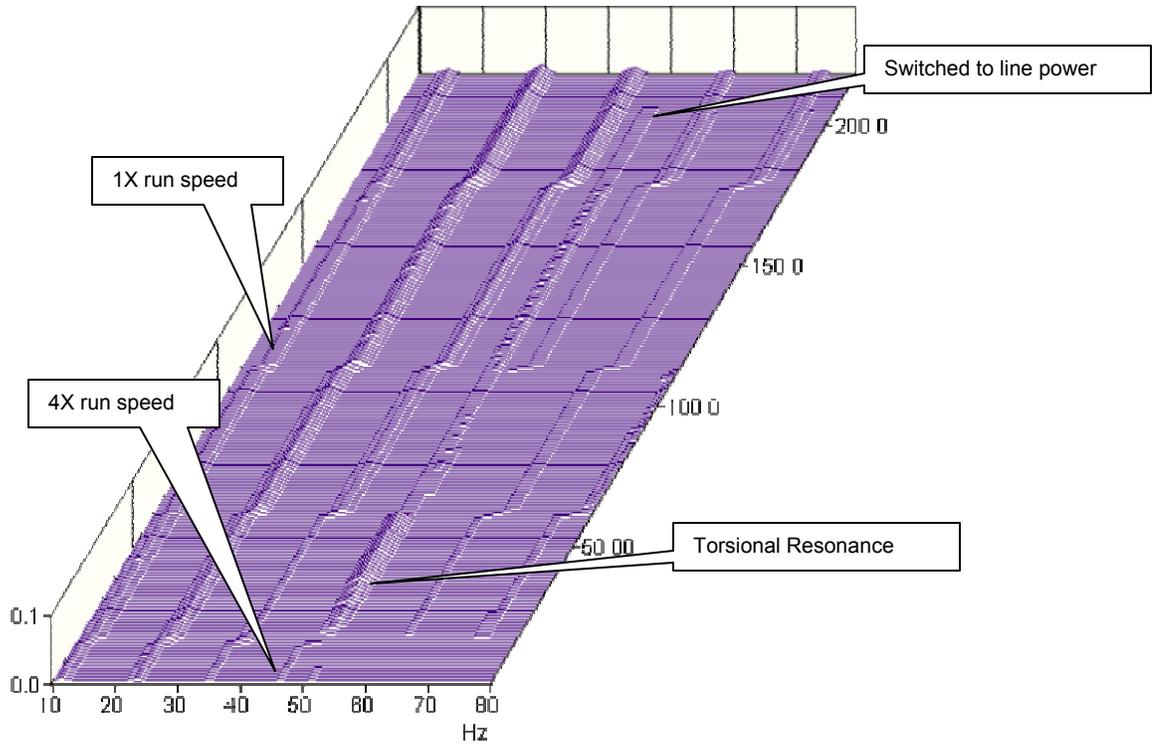
Figure 2.4 shows the waterfall of the crankshaft auxiliary end spectra during the speed sweep and switching process. Six orders of run speed can be seen clearly: 1X through 6X run speed. These orders increase frequency as the motor is sped up from 700 rpm to 900 rpm. The amplitude at 50 Hz increases significantly when the motor speed reaches 750 rpm and torsional resonance occurs, but the rise is not as much as that in the torque signal. At higher speeds the 50 Hz peak reduces its amplitude and it is still present despite operating out of resonance. After switching to line power, the 50Hz peak disappears.

Figure 2.4. Torsional Vibration - compressor auxiliary end - Speed Sweep - Loaded
1X through 6X components vary with speed
Peak at 50 Hz is not the highest amplitude, but is present while VFD
Switched to line power after trace 200 and 50 Hz peak disappeared

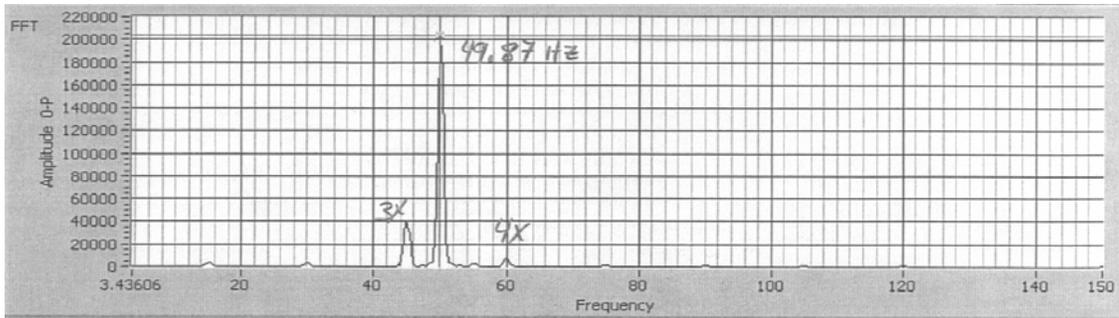
Figure 2.5 shows a spectrum of the torque oscillation when the motor is run under VFD control at 900 rpm. This plot corresponds to a slice of the waterfall shown in Figure 2.3, just before switching to line power. Notice that the 49.87 Hz peak (referred as 50 Hz peak in other paragraphs) is much higher than any other orders of run speed. 49.87 Hz is not synchronous. A slice of the same waterfall, after switching to line power, is shown in Figure 2.6. The spectrum of the dynamic torque under line power shows no evidence of 50 Hz excitation. The change in the dynamic torque pattern is not caused by mechanical loading, as the mechanical loads do not vary when switching from VFD to line power.

Figure 2.5. Torque Oscillations – High amplitudes at 49.87 Hz – VFD Control 900 rpm
The peak at 49.87 Hz is not a multiple of run speed
See coincidence of sidebands on the current spectrum (Figure 2.7)

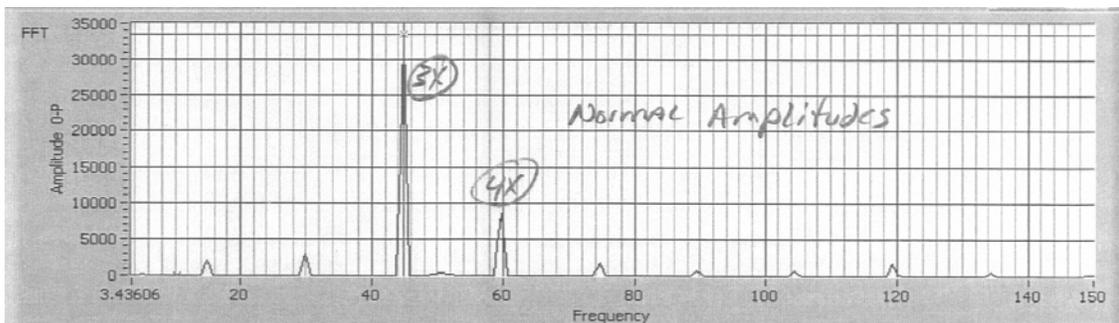
Figure 2.6. Torque Oscillations – Normal Amplitudes at 895 rpm – across the line
Amplitudes at multiples of run speed.
Levels are much lower than those seen under VFD Control.

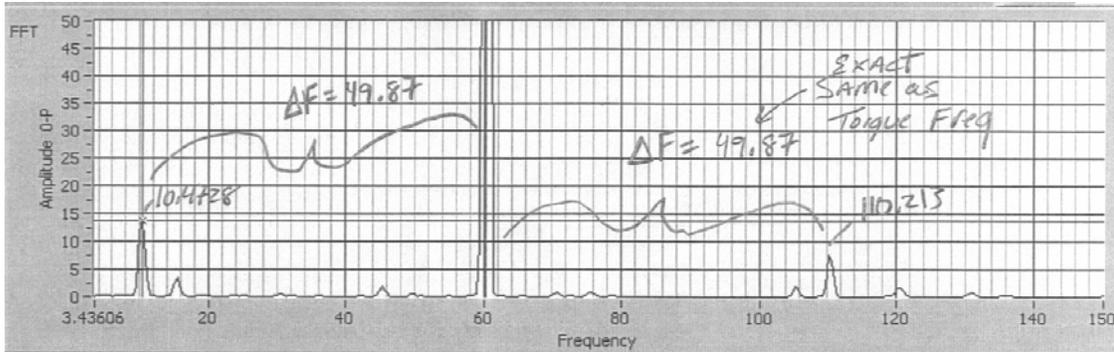
Figures 2.7 and 2.8 show the spectra of the current signals under two different operating modes for the as-found system: VFD control (900 rpm) and across the line (895 rpm), respectively.

The operation under VFD control shows high amplitude at 60 Hz (center frequency) and sidebands at 49.87 Hz from the center frequency. The 49.87 Hz is the same frequency at which the torque shows the highest oscillating amplitudes (see Figure 2.5). The contrast between VFD operation and across-the-line operation is the lack of sidebands in the latter.

Figure 2.7. Current Oscillations – High Amplitudes at 900 rpm – VFD Control Sidebands at 49.87 Hz from the center frequency and small peaks at multiples of run speed (15, 45, 105 and 120 Hz)

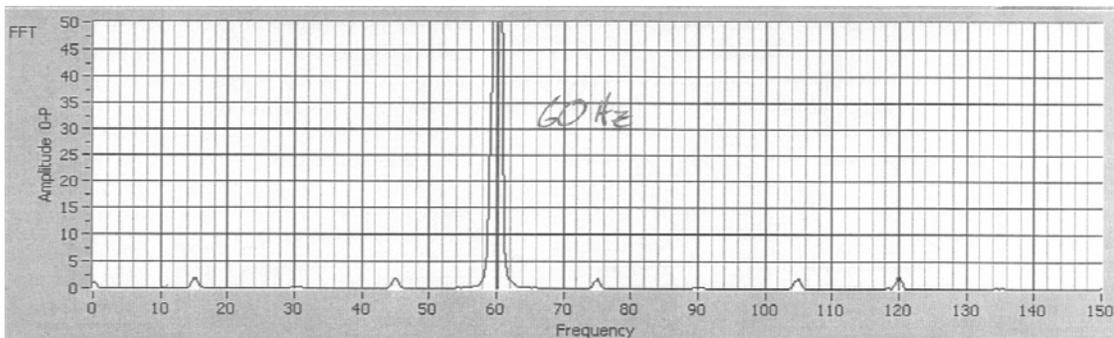
Figure 2.8. Current Oscillations – Normal Amplitudes at 895 rpm – across the line No sidebands of significant amplitude Small peaks at multiples of compressor run speed (15, 45, 75, 105 and 120Hz)

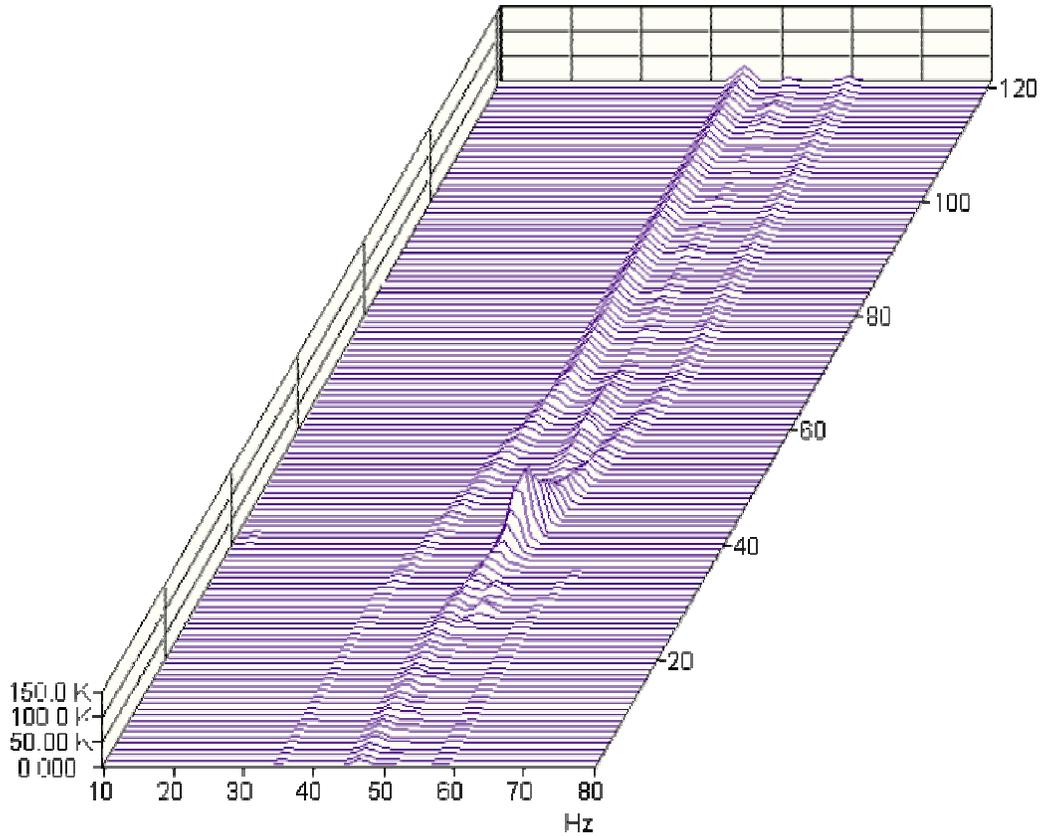
The torsional vibration after the changes were made to the VFD parameters showed a pattern similar to that of a traditional motor/compressor train, in which the torsional vibration increases as the speed approaches resonance and then reduces as the speed moves away from resonance. Figure 2.9 shows the waterfall of the final condition.

Figure 2.9. TV at motor shaft - Speed Sweep – Loaded – Modified System
3X and 4X components vary with speed
Peak at 50 Hz still shows the highest amplitude when the 4X component passes through resonance, and then decreases significantly

The result of the last set of changes was that the 50 Hz excitation was significantly reduced off-resonance. The two motors then behaved similarly under VFD control. One system showed higher TVs than the other, but the amplitudes were improved from the as found configuration. The lock-in pattern was eliminated and the torsional vibration reduced as the speed moved away from resonance. There was still some remaining torsional vibration at 50 Hz while the motor was under VFD control; however, the amplitude was much lower than the 3X or 4X torsional components.

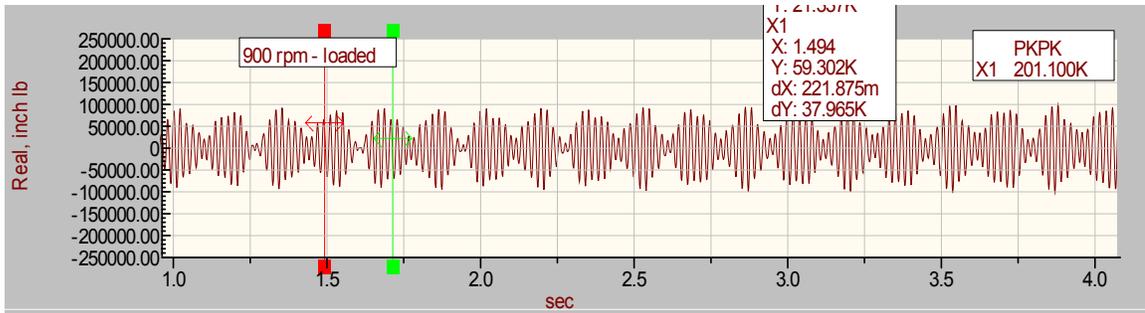
Figures 2.10 and 2.11 show the overall torsional vibration traces for the first unit under maximum speed loaded conditions and VFD control. These traces are included to illustrate the changes. The peak to peak amplitude is displayed on the plot. The amplitude of the overall torsional vibration was reduced 54%.

Figure 2.10. As-Found System - Loaded – Highest Speed under VFD control

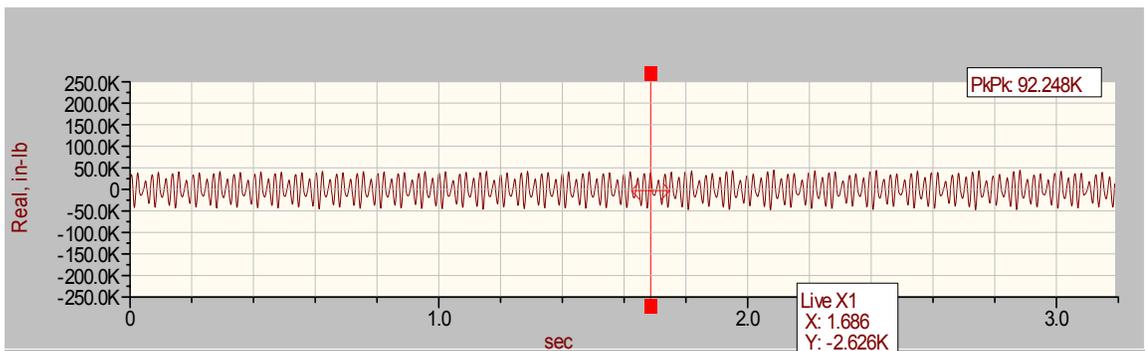
Figure 2.11. As-Left System - Loaded - Highest Speed under VFD control

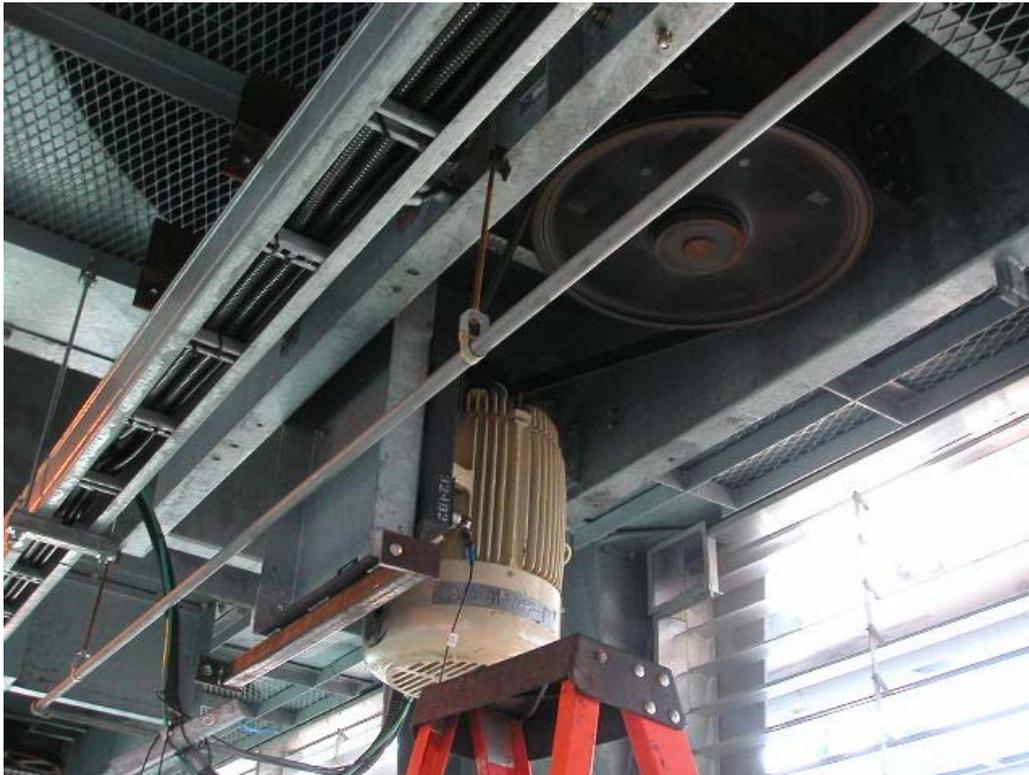
Eight motors driving cooler fans (eight blades) through cog belts. The drive manufacturer did not supply the motors. See Figures 3.1 and 3.2.

The worst vibrations were in the east-west direction, which is the direction from the motor to the fan. The operating deflected shape (ODS) of the vibration exhibited a rotational motion about a vertical axis through the base of the motor.

The vibrations were so large they were visible. They were so extreme that the system could not have been run. In fact, a Unit F motor bearing may have been damaged in the relatively limited testing that was done in the attempts to troubleshoot the vibration problem.

Figure 3.1. Motor, belt and driven sprocket on unmodified system

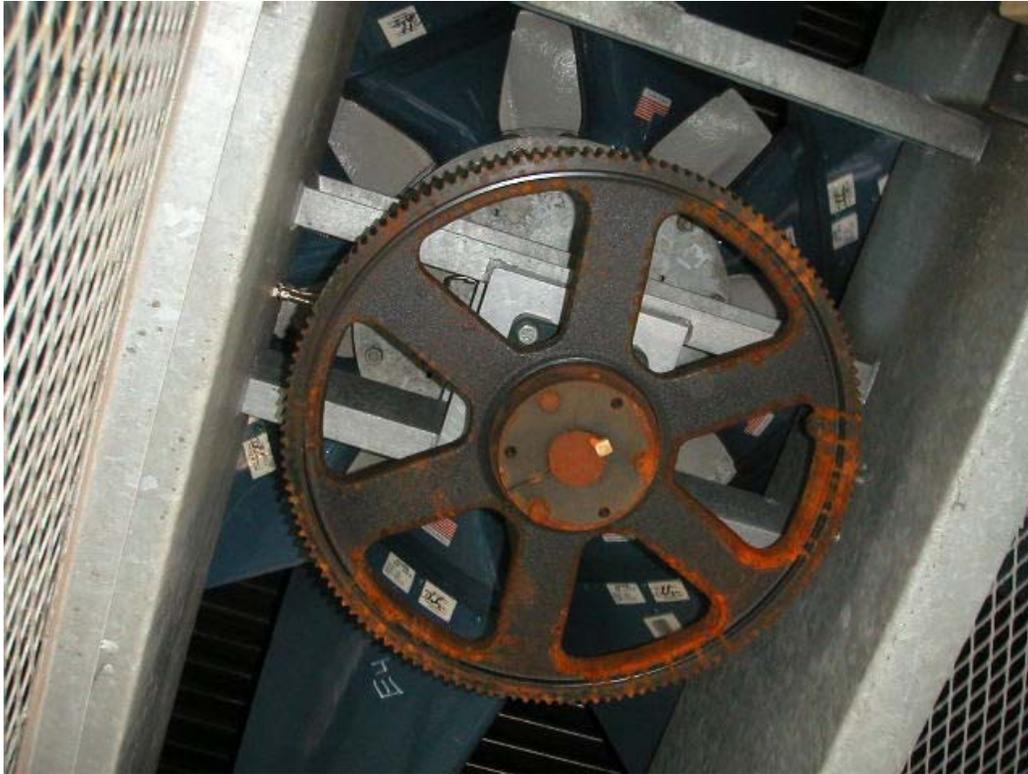
Figure 3.2. Fan and driven sprocket viewed from below

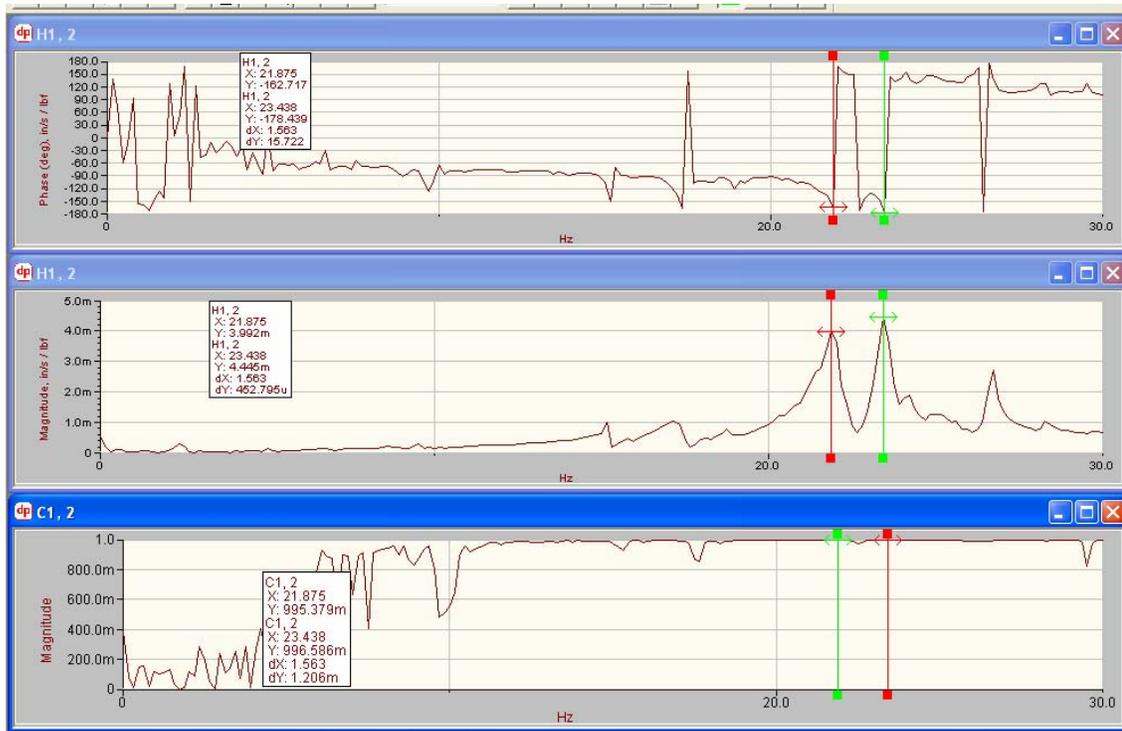
The relevant MNFs are shown in Table 3.2 below. Figure 3.3 below shows a typical mechanical natural frequency measurement.

Figure 3.3. Typical MNF, measured in the east-west direction on a motor, as found

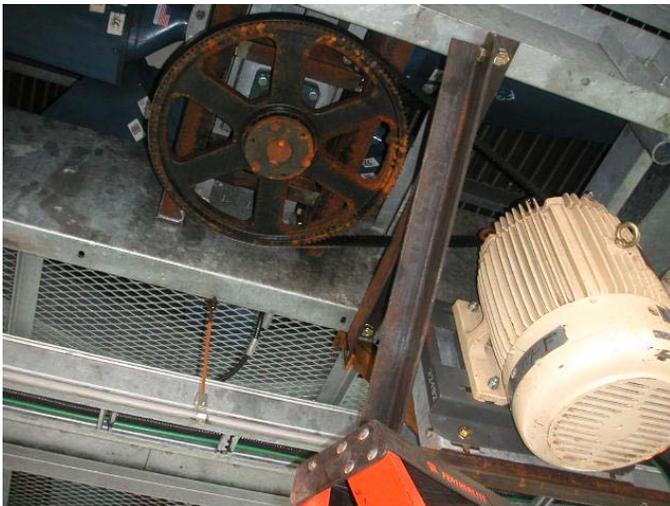
Figure 3.4. Braces in the north-south direction.

This brace was installed before BMA arrived to the site. It did not make much difference to the vibrations. The dominant frequency increased about 7%, as shown in Table 3.1.

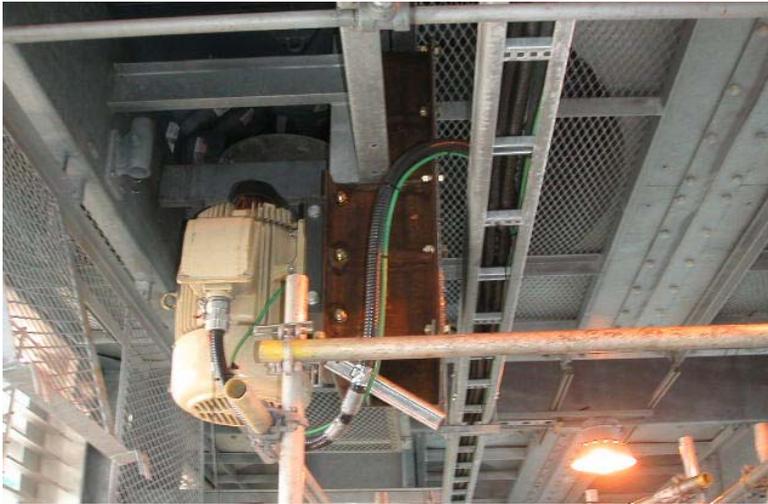
Figure 3.5. Looking west at the rotationally stiff brace on motor D

This brace was designed to increase the stiffness in the rotational direction about a vertical axis. It was quite effective and the vibrations were reduced dramatically, but not enough to be acceptable. The dominant, or fixed, frequency of vibration actually went down by about 7% with this brace installed.
