Performance Monitoring Examples

Monitor, Analyze, Optimize

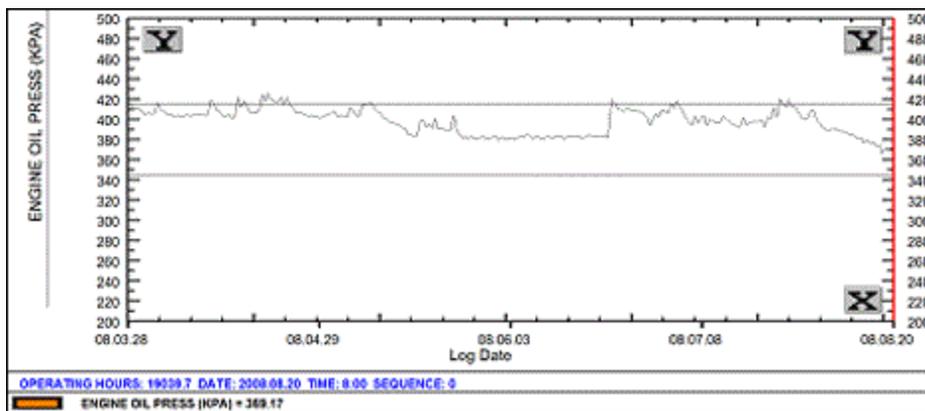
An engine oil pressure pattern anomaly was observed by a BETA analyst. The pressure was seen to be on a downward trend, though still at acceptable levels.

First alert was sent to customer on Aug 20

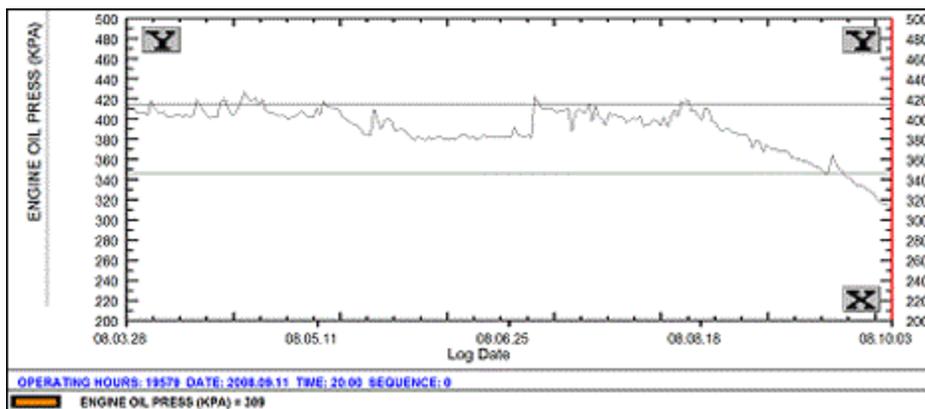
Second alert was sent to customer 11 days later, on Sep 1, with a high risk level calling for immediate action.

Customer reported finding the oil relief spring worn into the housing.
The problem was corrected and oil pressure returned to the normal range.

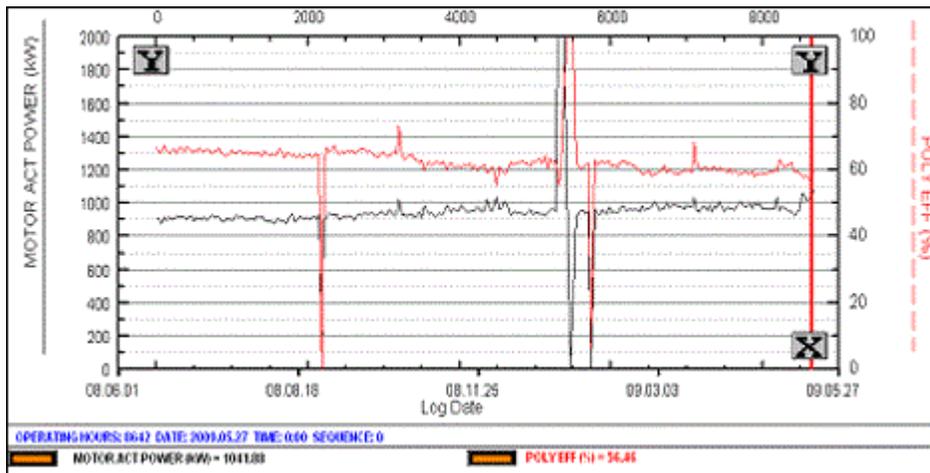
The graph shows that polytropic efficiency (red curve) decreased steadily from 66% to 58%. Motor power (black curve) to deliver the same flow increased by about 100 kW. If the driver is operating below its rated power, as was the case here, the main consequence is an increase in operating cost. When the driver reaches its limit, any further efficiency decrease causes a loss of throughput, which is usually very costly.

Decreasing efficiency is likely due to some combination of impeller fouling, impeller wear, and/or increased clearances. Monitoring enables planning and scheduling maintenance on an informed basis.

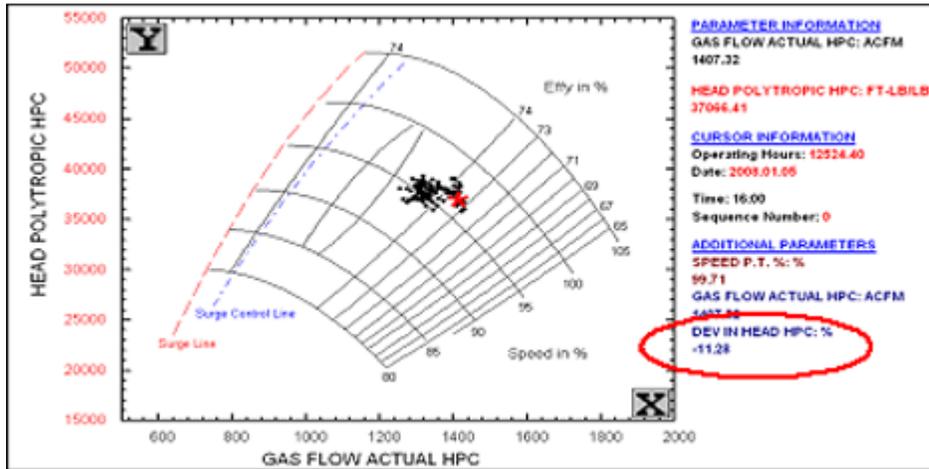
In the figure below, this unit had an 11% deviation in head at the point shown, likely due to impeller fouling, impeller wear, and/or increased clearances.

The decrease in stage performance (measured as head deviation) required extra power to compress this gas; about 325 BHP in this case. It was estimated that the extra fuel cost was over \$250,000 per year, based on prices at the time.

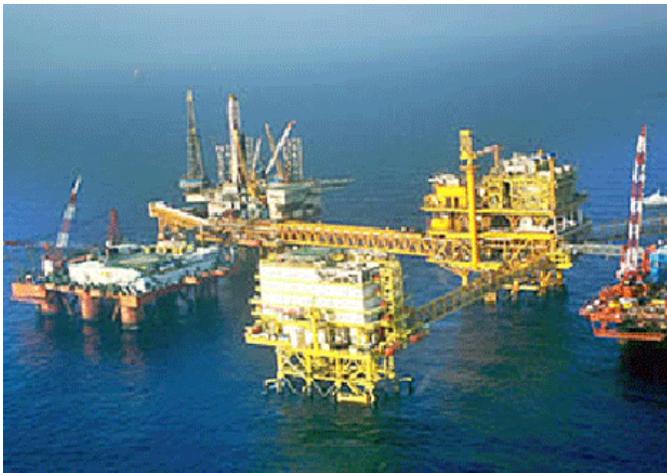
2.3 OFFSHORE PLATFORM UNITS - VARYING GAS TURBINE INLET DIFFERENTIAL PRESSURE INDICATES AIR FILTERS BEING BYPASSED

Several large gas turbine/centrifugal compressor units located on offshore platforms were being monitored under BETA's Performance Assessment service. One important parameter is the measured differential pressure across the inlet air filters on the gas generator section of the gas turbine.

Air inlet differential pressure had been quite steady at 1.5 – 2.0 in. H₂O. Then, near the end of September, 2011, the reading started to vary, from about 2 in. H₂O down to zero.

It was concluded that a filter had been replaced and the fit of the replacement filter was not quite correct; thermal distortion of the inlet ducting allowed air to bypass the filter during the hottest part of the day. The problem with this situation is that dust and other contaminants can accumulate on the initial stages of the gas generator compressor causing performance to decrease rapidly.

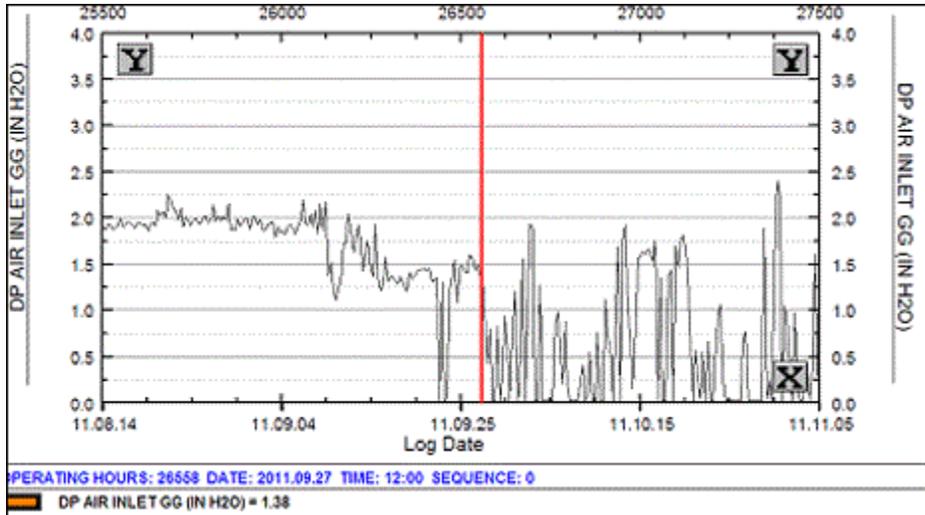
The concern in this case is the low, near zero readings as these indicate that air was bypassing the filters at that time.

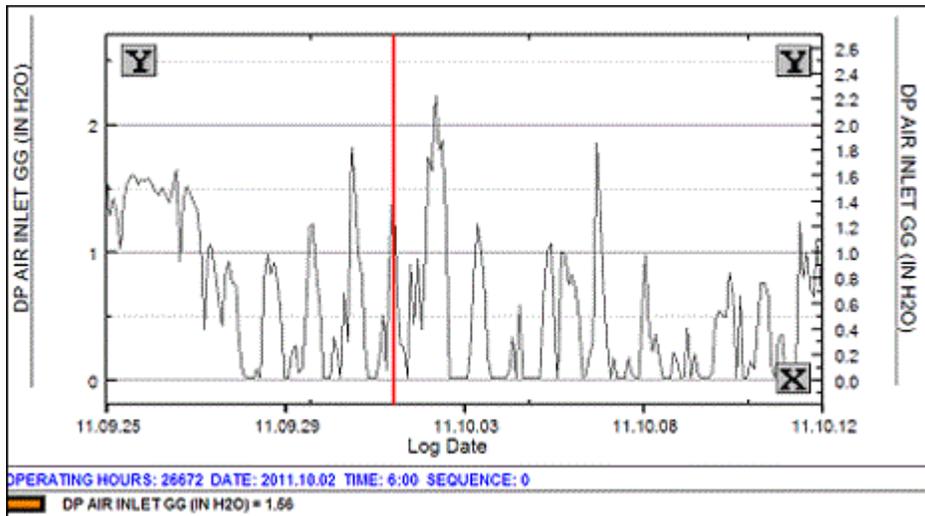
A closer inspection shows that there were peaks about every 24 hours. The zero readings were mostly occurring during the hottest part of the day. (This site is around 20 degrees north latitude.)

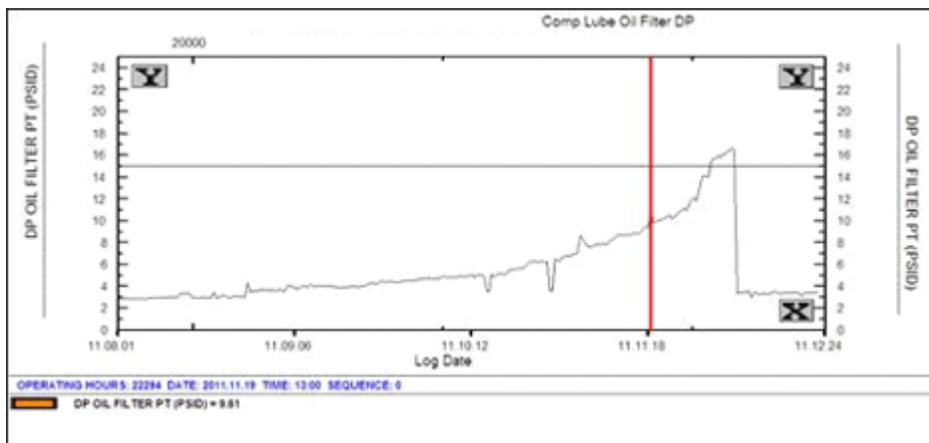
| <u>Observation/Action</u> | Unit 1 power turbine oil filter differential pressure (tag DPT-301) has been trending up and reached 11 psi on November 19. |

The graph below illustrates what happened to that point and subsequently. The cursor (vertical red line) is parked at November 19th. The horizontal solid black line is an alarm level of 15 psi. By December 2, eight days later, the differential pressure reached the alarm level. The customer changed the filter on December 7th. Early warning from BETA enables planned maintenance, avoiding, or minimizing lost production that could occur due to a machine trip.

| <u>Recommendations</u> | Plan for filter change; probably within 1 month |

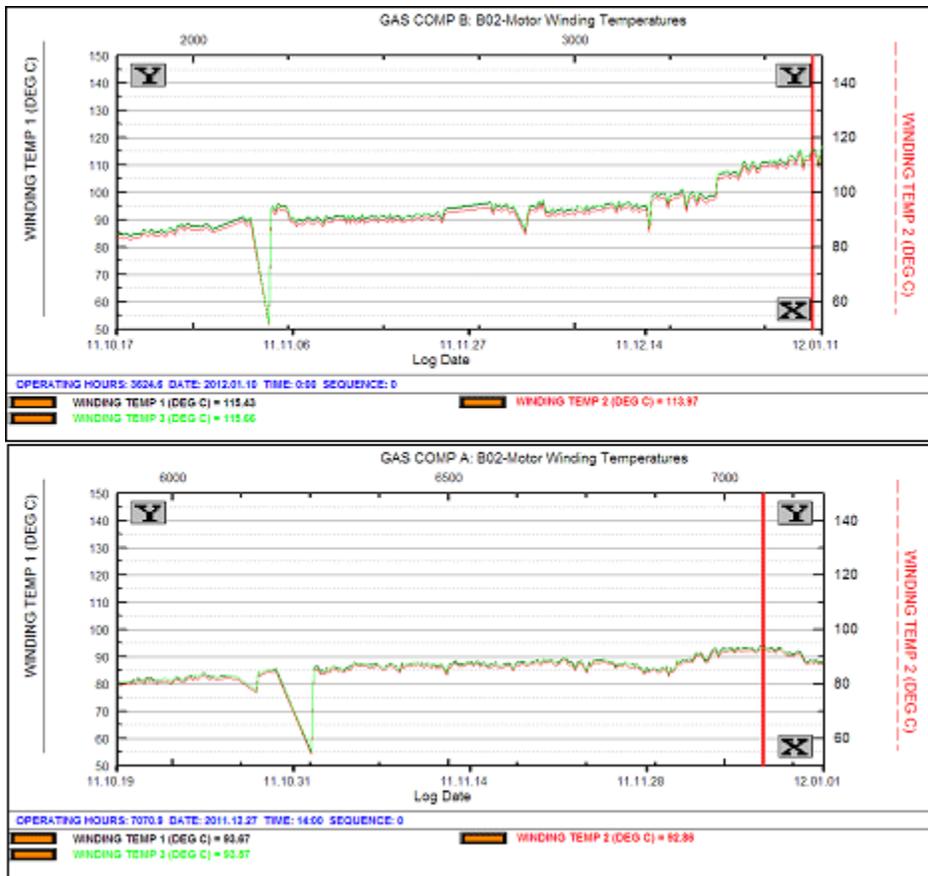
| <u>Observation/Action</u> | B1105, created Jan 16, 2012. Unit B motor winding temps are near 115 °C and have been rising steadily since Dec 30. Comparable unit A temperatures are about 95 °C and unit C about 85 °C. |

| <u>Recommendation</u> | Verify measurements; ensure proper cooling flow. |

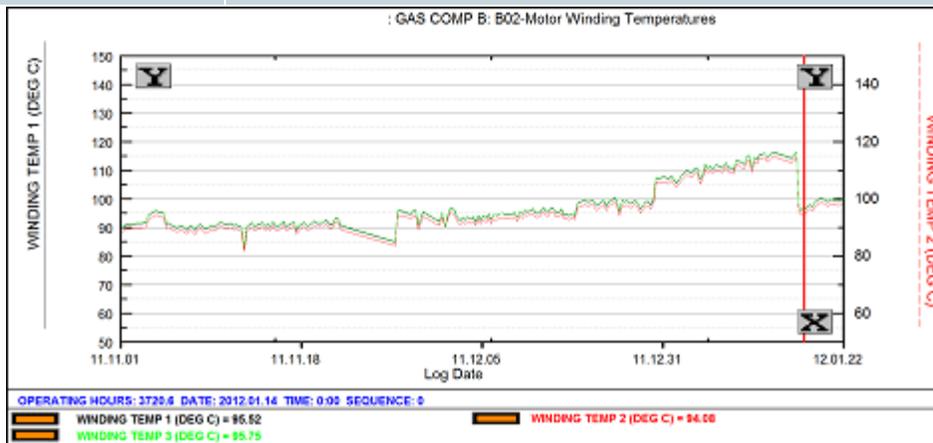
| <u>Observation/Action</u> | B1105, created Jan 16, 2012. Unit B motor winding temps reached 116 °C and were rising steadily. Unit A motor winding temperatures were about 95 °C, and unit C motor about 85 °C. |
| <u>Resolution</u> | Inadequate cooling flow and fouled seawater exchanger were found and corrected. |

| <u>Recommendation</u> | Verify measurements; ensure proper cooling. |

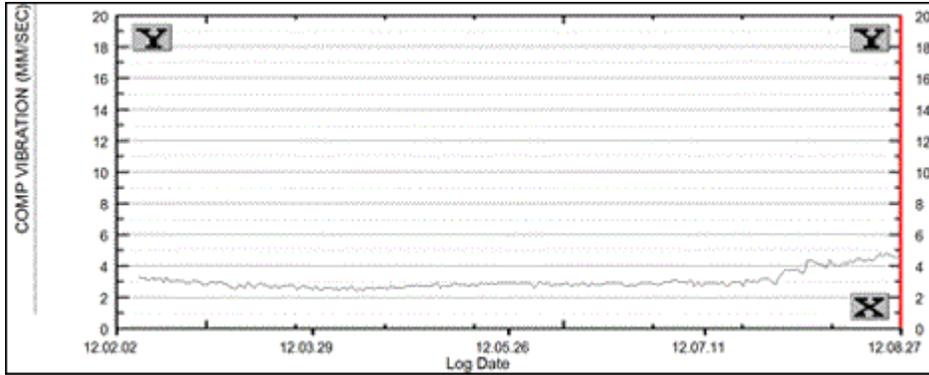
"I am seeing a clear compressor vibration increasing trend. Current level of vibration is not very high but a trend is obvious. I do not see any speed/load change on this unit."

The vibration was still well below the alert level, but was recognized as abnormal by the remote monitoring specialist.

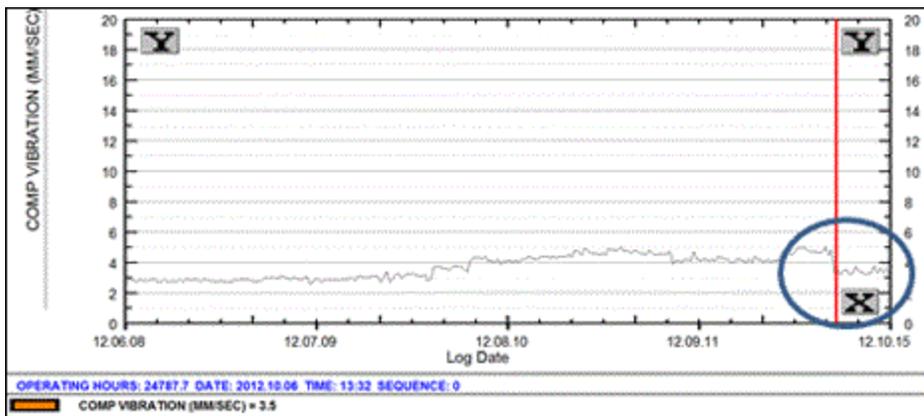
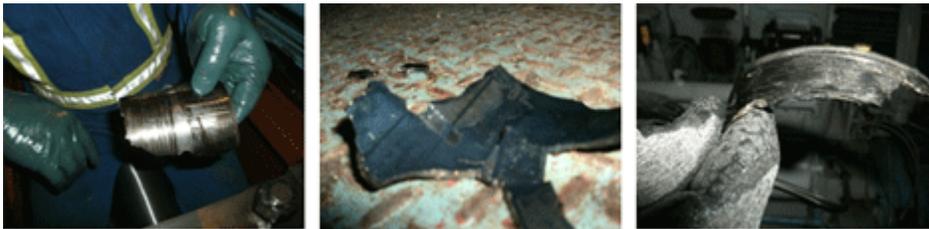
Connecting rod bushing failure

“Because of your alert we investigated and found that the small end bushing in the #2 throw of the compressor had failed. We have corrected the issue and the unit has been online since Oct 5th, 2012 with the new bushing installed. The vibration levels appear to have returned to their nominal values. Thank you.”

Significant and costly damage was avoided thanks to BETA monitoring the unit. This failure would likely have eventually resulted in seizure of the assembly and a major wreck.

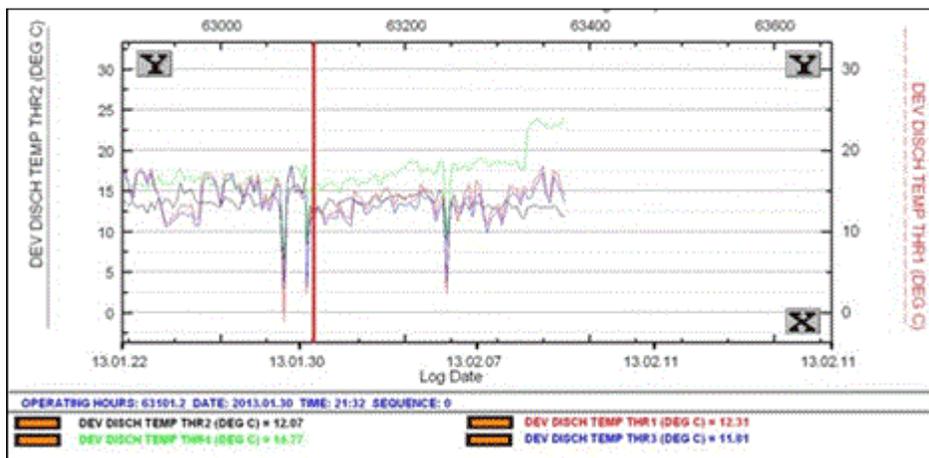
Unit 3, Throw #4

| <u>Observation/Action</u> | Issue raised Feb. 11, 2013. Discharge temperature deviation on throw 4 has been increasing since Jan. 30 2013 and reached from 14 to 24 °C on February 11, 2013. |

The unit was discovered to have one **failed head end discharge valve**.

| <u>Recommendations</u> | Check throw 4 for a valve problem. Also check lubrication rates on this throw. |

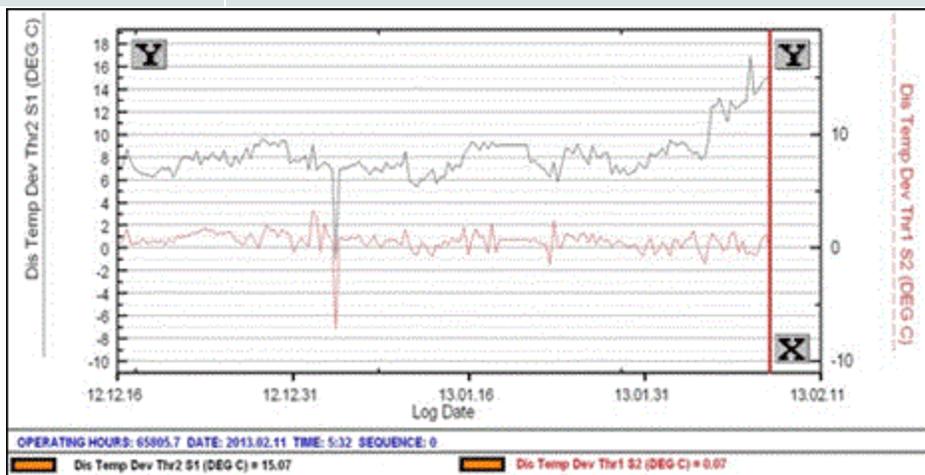
A similar problem occurred on unit 21, throw # 2 and the unit was discovered to have two **failed crank end discharge valves**.

| <u>Observation/Action</u> | Issue raised Feb 11, 2013: Discharge temperature deviation throw 2 stage 1 has increased from 8 to about 16 °C since Feb 05, 2013. |

| <u>Recommendations</u> | Check throw 2 for a valve problem and/or lube rates on this throw. |

The early detection of failing compressor valves preserved compressor capacity and efficiency, and prevented secondary damage that can occur if a valve disintegrates. The second case is particularly significant; failed crank end discharge valves can lead to catastrophic failure, as the rod load tends toward continuous tension with little, or no reversal. Fortunately, the customer took immediate action and both units were repaired within four days of receiving the alert, averting significant equipment failure.

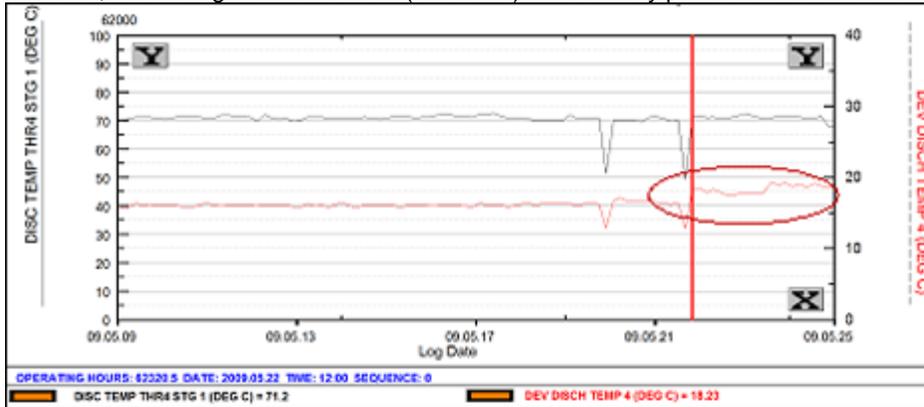
This graph shows a history of cylinder 4 discharge temperature (the black curve). Close examination shows a small increase, but not enough to cause any concern.

However, we see significant increase (red curve). This usually points to a valve leak or possibly a ring leak.

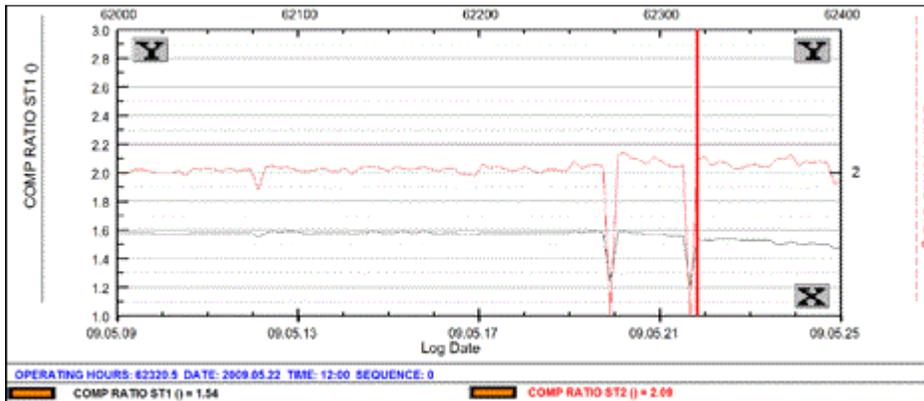
For confirmation we can check the stage compression ratios. The stage 1 compression ratio decreases and the stage 2 compression ratio increases. This is consistent with performance degradation on stage 1.

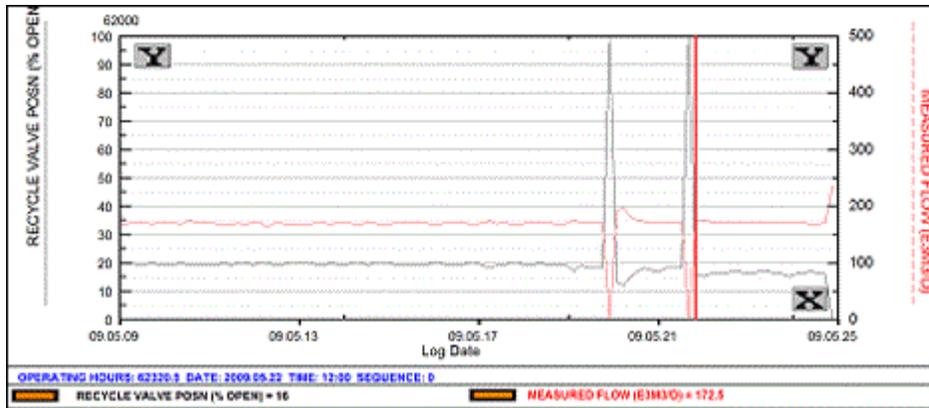
Further confirmation is found from measured flow (after the recycle valve) and recycle valve position. Over the same time period as the previous graphs, the flow is essentially constant. But the recycle valve position decreases from about 20% to about 15%.

The data indicates a loss of compressor throughput.

Conclusion: There is a valve or ring leak on throw 4.
