PVP2016-63816

TESTING SYSTEM SET-UP TO EVALUATE ACOUSTIC INDUCED VIBRATION

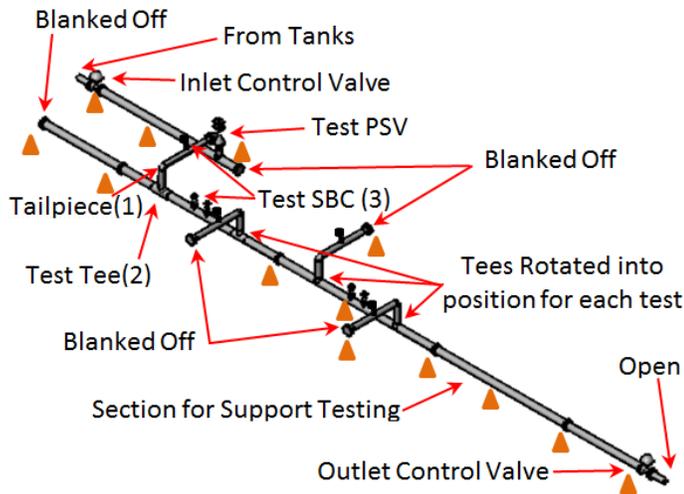
Figure 1: Complete test system.

Figure 1 shows an overview of the test system. To provide some scale, the length from the inlet valve to the outlet valve is over 150 ft.

The triangles in Figure 1 show the support/tie-down points for the piping. The supports consist of a stand placed under the flange or on the piping. Each tie-down consists of a chain that is wrapped around the flange or pipe and anchored to the

concrete floor. No support/tie-down is used on the test section except at the flanges and the blanked off tailpiece not under test.

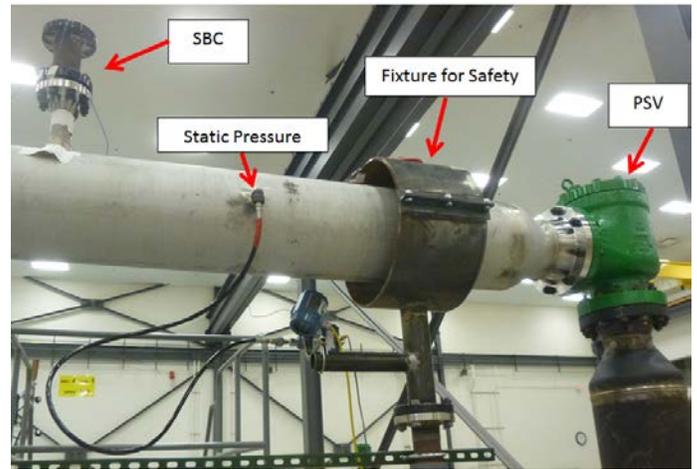
Figure 2: PSV, tailpiece and SBC on tailpiece.

Figure 2 shows the PSV, NPS12 tailpiece, and SBC. The metal ring was in place for safety and did not have any contact with the piping.

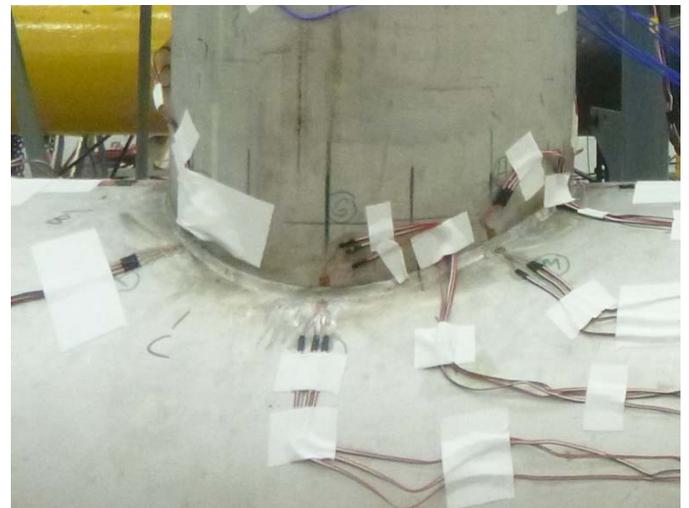
Figure 3: Stub-on tee (NPS 12x20)

1. Stub-on (Figure 3)
2. Stub-on with full encirclement wrap (Figure 4)
3. Sweepolet® (Figure 5)
4. Butt weld Pipet® (Figure 6)

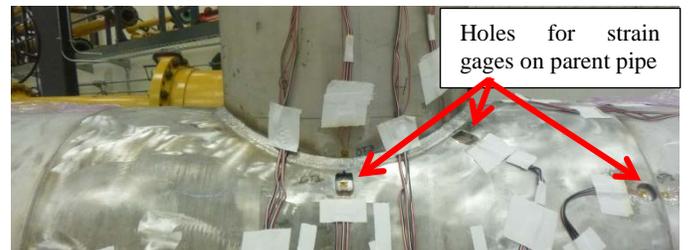
Figure 4: Stub-on tee with full encirclement pad. (NPS12x20)

In the case of the stub-on tee with full encirclement pad, holes were made in the pad to allow for strain measurements on the parent pipe; this can be seen in Figure 3. Strain was also measured on the pad.

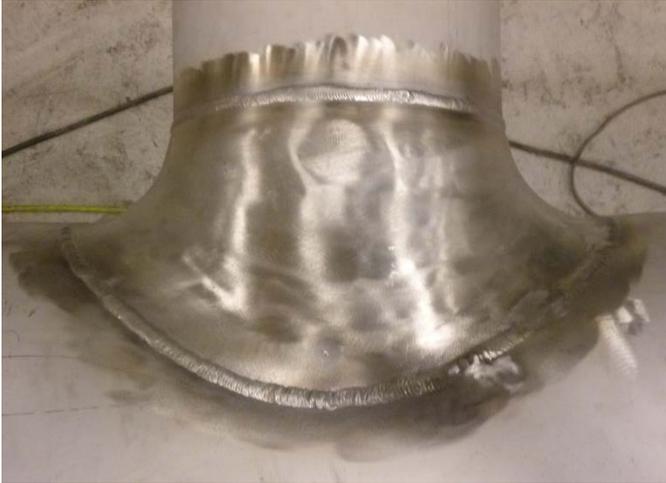
Figure 5: Sweepolet tee (NPS 12x20)

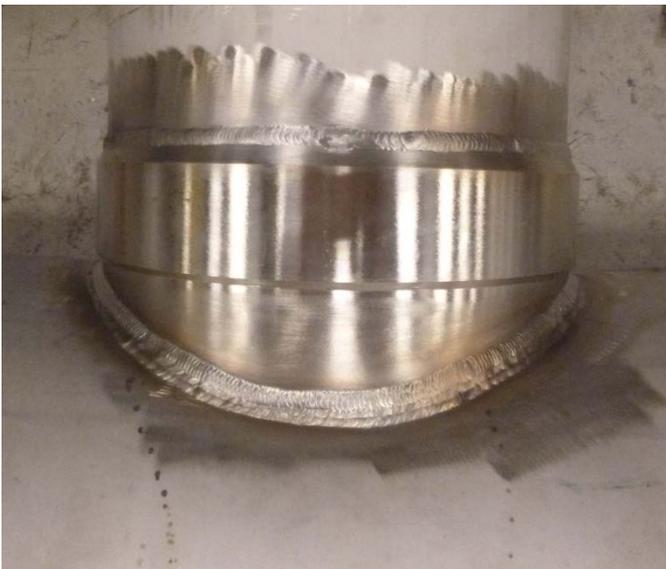
Figure 6: Butt weld Pipet tee (NPS 12x20)

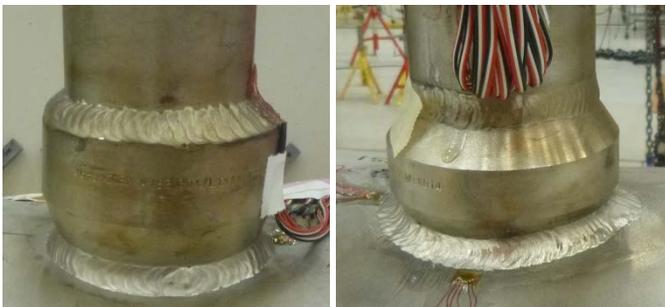
Figure 7: Sockolet (LEFT) and Butt weld Pipet (RIGHT) NPS2x20 SBC.

1. Butt weld Pipet® with a partial wrap (or repad)(Figure 8)
2. Sockolet® (Figure 7)
3. Sweepolet® (Figure 8)
4. Butt weld Pipet® (Figure 7)

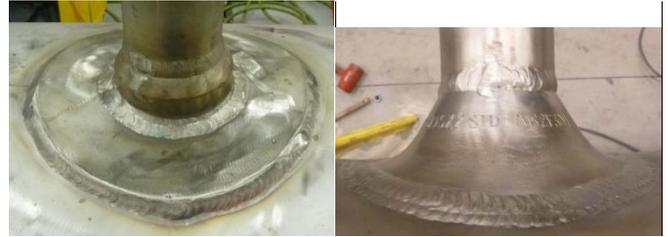
Figure 8: Butt weld Pipet with a partial wrap (LEFT) Sweepolet (RIGHT).

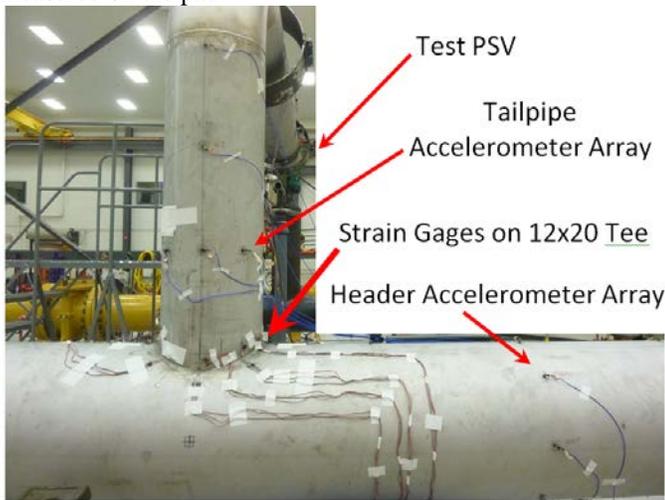
Figure 9: Overview of transducer for Tailpiece to Header joint.

The 20x12 test tee was instrumented with 5 pairs of strain gauges. The strain gauges were Vishay C2A-06-062WW-350 stacked rosettes. For each pair one was on the tailpiece and one on the header side of the test tee. Figure 9 shows a picture of the Stub-on tee showing all the gauges, and Figure 10 shows a close up on one of the gauge pairs.

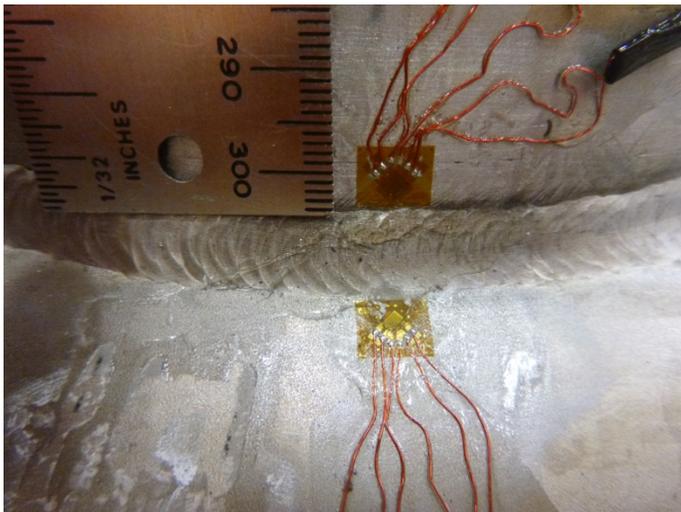
Figure 10: Close-up of one strain gauge pair.

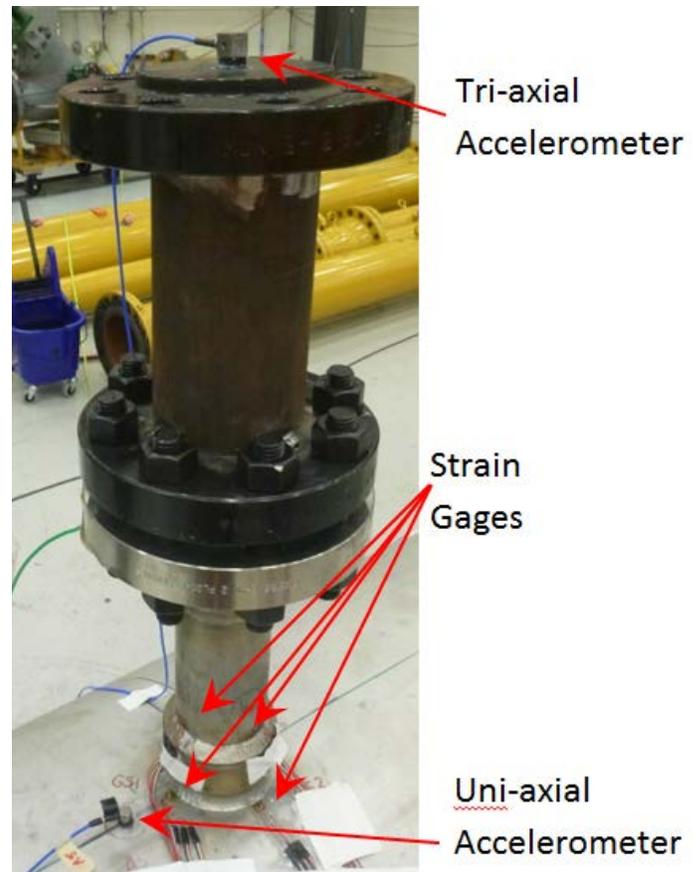
Figure 11: Close-up of a SBC with transducers notes.

The SBC's were instrumented with uniaxial strain gauges, measuring the strain normal to the weld. One gauge pair was mounted along the pipe axis and one perpendicular to the pipe axis as shown in Figure 11.

For the two SBCs, a tri-axial accelerometer was placed on the top of each SBC as well as a uni-axial accelerometer on the pipe adjacent to the SBC.

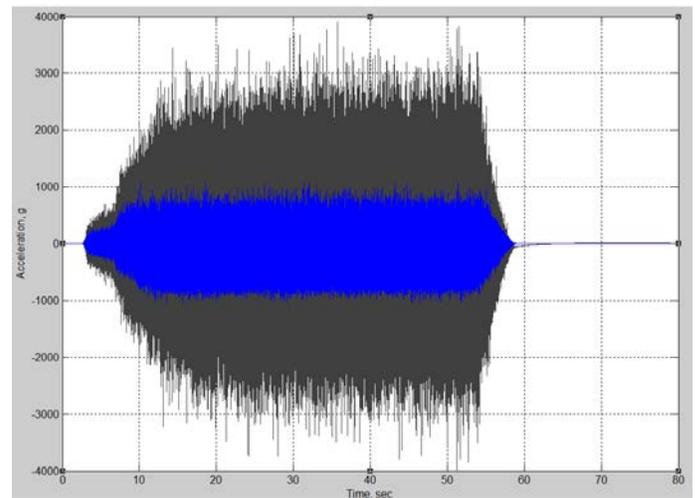
Figure 12: Example acceleration signals: BLACK – on NPS12 tailpipe BLUE – on NPS20 header.

The primary challenge in the testing was keeping the instrumentation intact and working. The vibration levels are very high, some as high as ± 3000 g, Figure 12. The pressure and temperature transducers downstream of the PVS experienced several failures. On the static pressure, the National Pipe Thread (NPT) fitting failed at the threads. A low weight fitting was eventually used that has survived multiple tests. The temperature transducer is an insertion type transducer, and typically fails after several tests.

Figures 12 and 13 show the time signals for two accelerometers and two strain gauges respectively. The accelerometer signals show the high acceleration levels on the NPS12 tailpipe and significant differences between the levels in the NPS12 and NPS20 pipes.

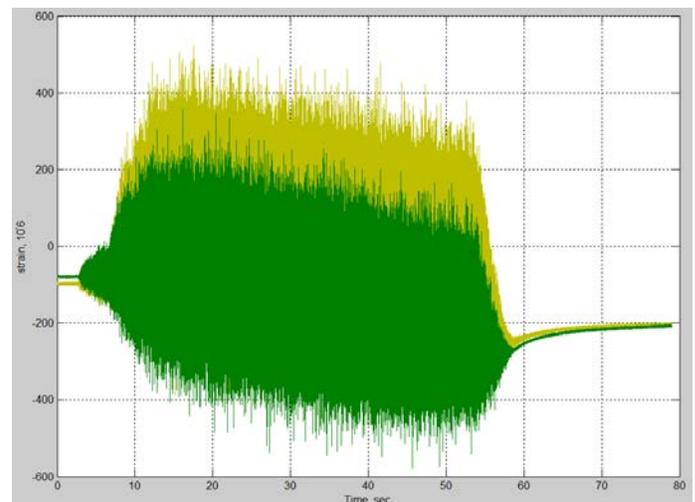
Figure 13: Example strain signals on two sides of a Stub-on weld.

The strain signals are on either side of the stub-on weld. The rise in the average of the signal is seen early, indicating the static strain induced by the increase in quasi-static pressure. Then the mean of the signal decreases, indicating the strain from thermal effects as the pipe temperature lowers. The dynamic strain fluctuations about the mean are clearly seen. Once the flow stops around 60 seconds, the offset in the strain level compared to time zero is caused by the temperature reduction of the pipe.
