FAULT DETECTION AND DIAGNOSIS IN RECIPROCATING MACHINERY

Bryan R. Long, Ph.D., P. Eng. And David N. Schuh, P. Eng.

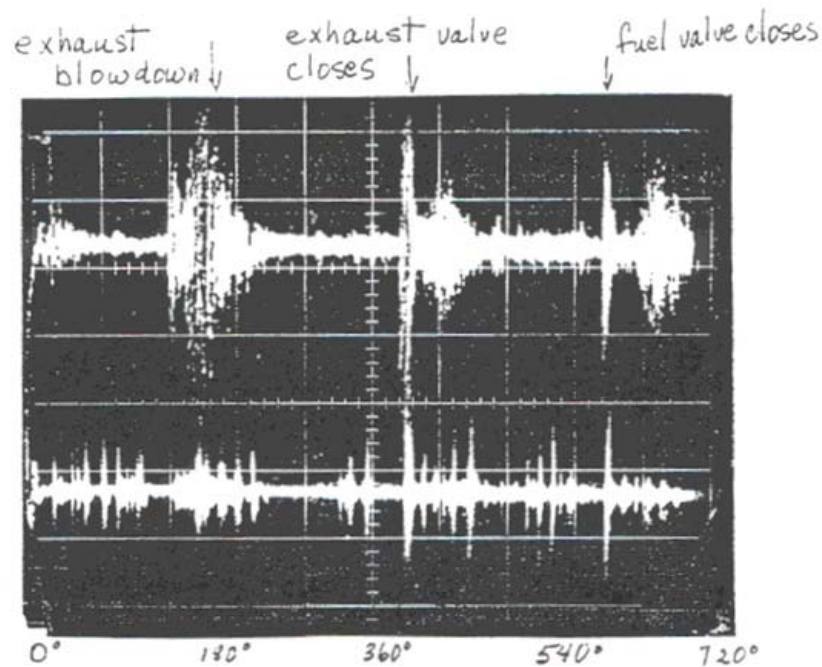
Figure 3 – Mechanical impacts tend to dominate vibration traces, while gas leakage shows up more clearly in ultrasonic traces

These patterns will be more sensitive to gas leakage and less sensitive to mechanical impact events. If we take both ultrasonic and vibration signals on a cylinder, problem detection becomes more sensitive and reliable, and diagnosis is also more reliable.

Figure 3 shows an ultrasonic pattern along with the corresponding vibration signal.

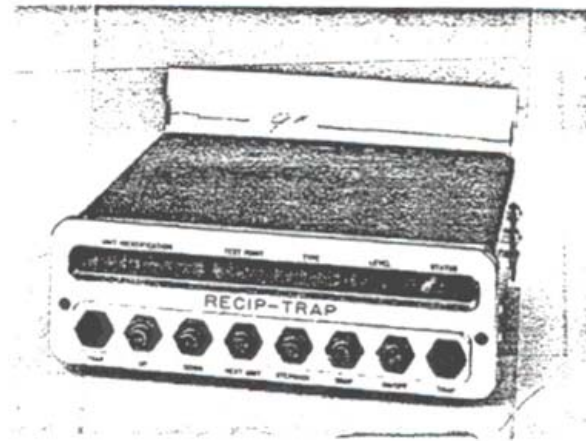
Figure 6 – The RECIP-TRAP Instrument is small and simple to use

A new analyzer system called RECIP-TRAP has been developed. This system uses a micro-processor based portable data collector (Figure 6) and a permanent data-base on a personal computer. The major advances are:

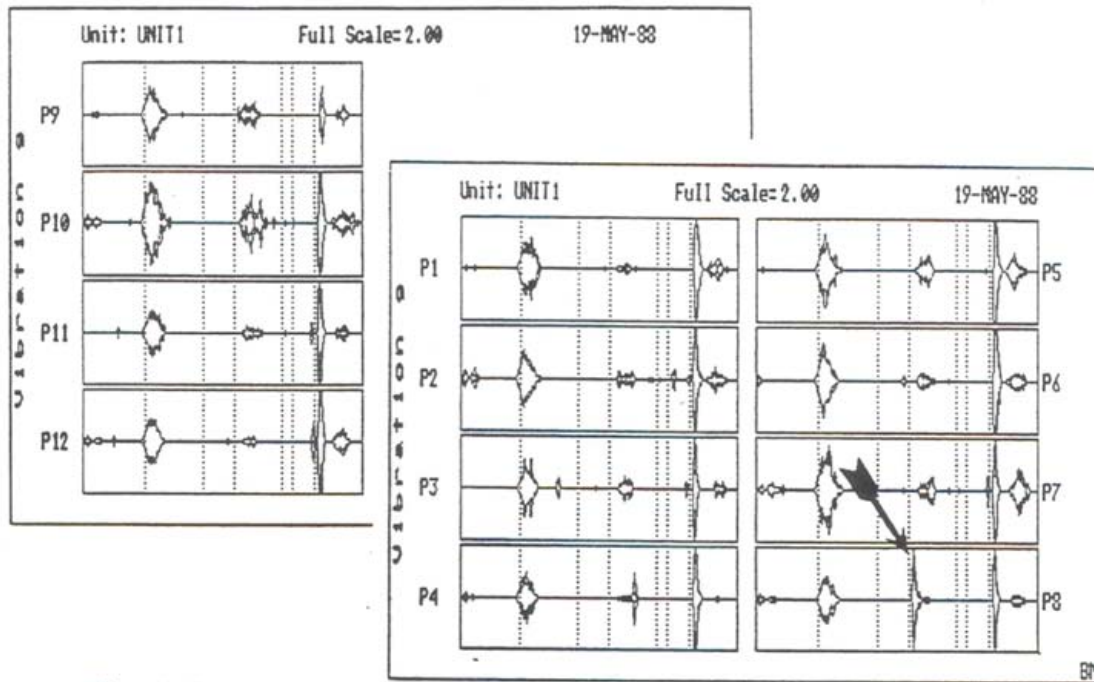
Figure 11 – Power Cylinder Vibration Patterns are displayed in groups of 8 for easy comparison

The power cylinder vibration display (Figure 11) shows up to eight vibration-time patterns. The patterns should be generally the same, this display makes it easy to identify differences.

The vertical dotted lines mark the bounds of the exhaust, intake and fuel injection events, as detailed in Figure 13.

Recalling that the POWERHEALTH Report determined that P8 was anomalous in the window 360 – 450 degrees, we note that the pattern for P8 has an anomalous event just after exhaust valve closure.

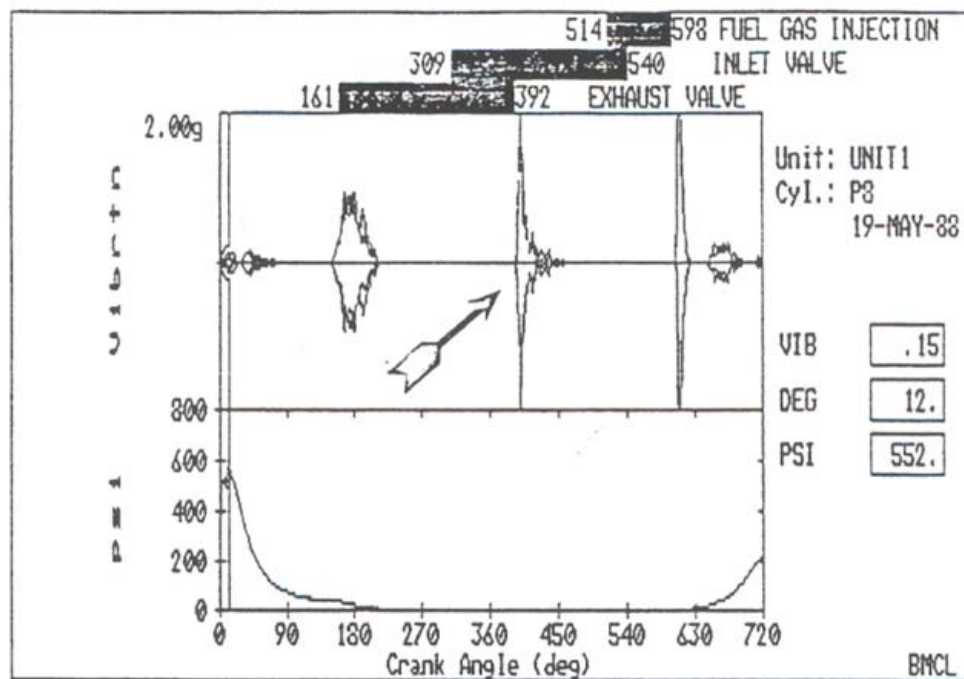
Figure 13 – The power cylinder signature relates the timing of exhaust, inlet, and fuel injection events to the vibration-time and pressure-time traces

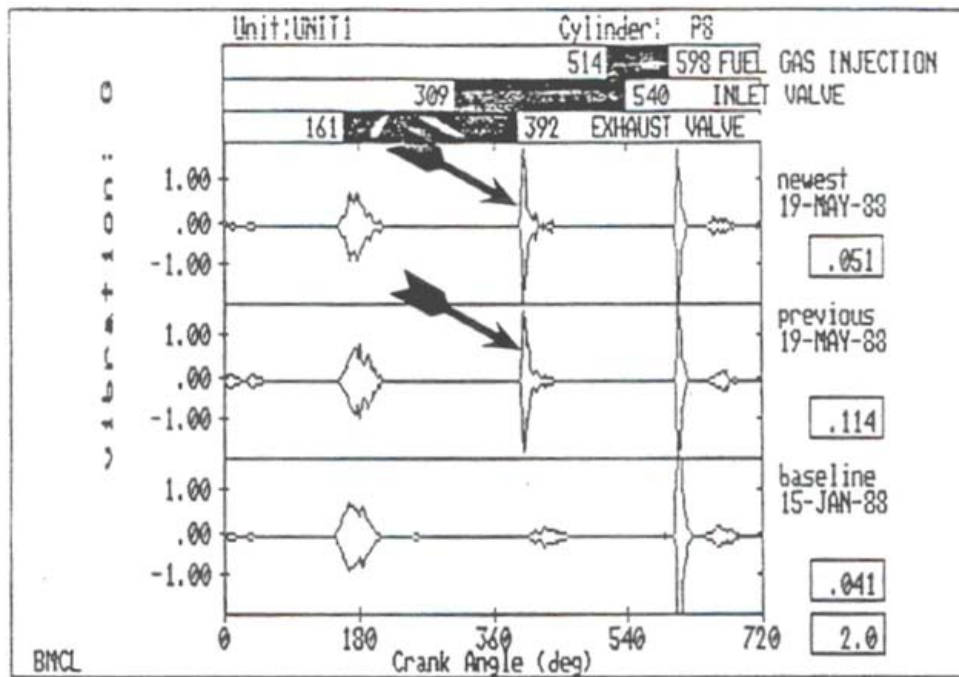
Figure 14 – The CODA Display lets you compare today's vibration data with historical data

Figure 14 contains the CODA display, where new, previous and baseline data are plotted on the same graph. The analyst can place a cursor anywhere on the display, and can then see actual levels at each degree along the plot.

Two sets of readings were collected on 19 May, 1988 and both of them show that the exhaust valve is behaving differently from 15 January, 1988. If we assume that the baseline data represents the healthy state of the unit, we must conclude that the health of P8 has deteriorated.

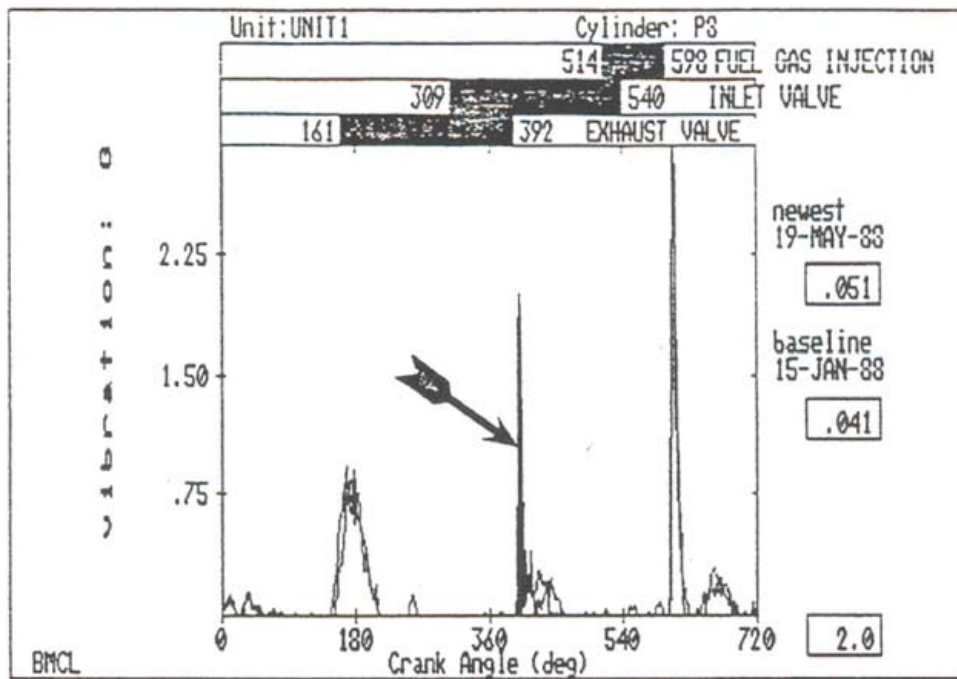
Figure 15 – The new over baseline display emphasizes differences

The new and baseline data can be overlaid to detect more subtle changes, as shown in Figure 15. In this display, the regions where the new data exceeds the baseline data are emphasized.

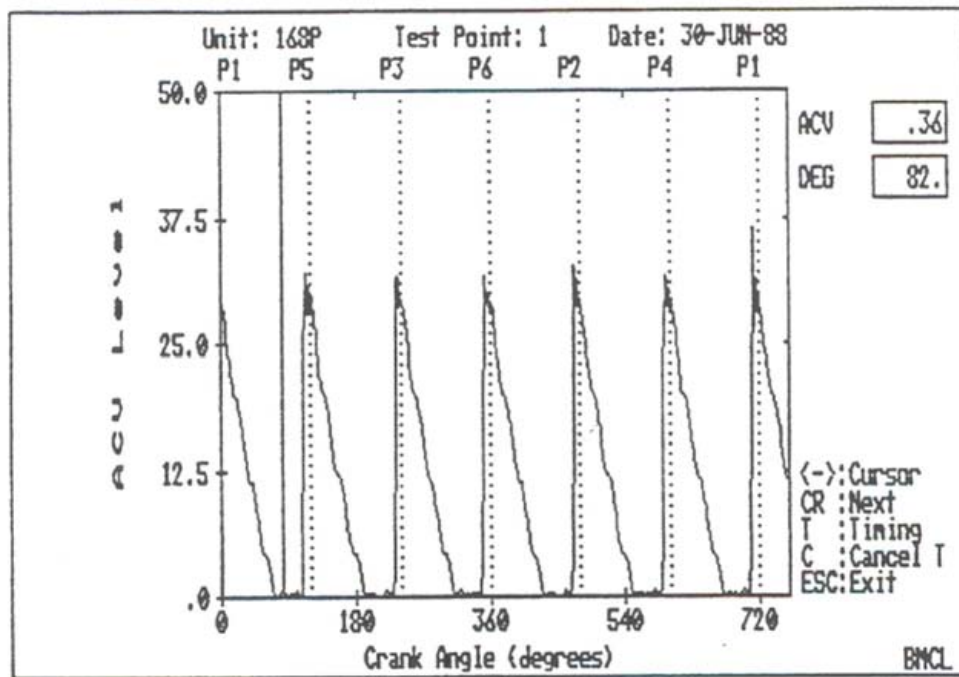
Figure 19 – Ignition primary patterns can be used to evaluate the ignition system

Figure 19 shows ignition primary traces generated by the RECIP-TRAP system.
