VERTICAL FORCES CAUSE VIBRATION IN A RECIPROCATING COMPRESSOR

Brian C. Howes, M.Sc., P.Eng.

Beta Machinery Analysis Ltd. Suite 300, 1615 Tenth Avenue Southwest Calgary, Alberta, T3C 0J7, Canada
Phone (403) 245-5666 Fax (403) 245-3257 E-Mail info@betamachinery.com

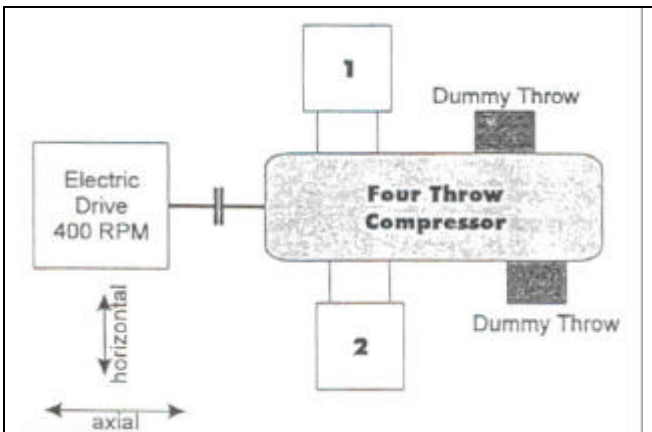
Two four throw compressors had been experiencing failures of pistons and rods over some years. On a visit to the site in February, 1994, the following problems were found:

- cylinder supports were loose or broken
- discharge bottle wedge supports were broken
- joints had fretted, shown by red dust (iron oxide) present at most of the joints in the cylinder supports
- anchor bolts and grout under the crosshead guide had broken

Figure 1 Rod and piston failures over many years made this unit uneconomic to run.

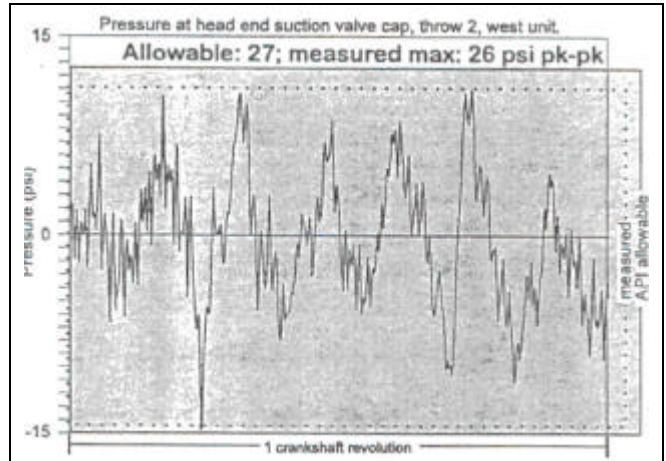
Pulsations were measured in the time domain at the suction and discharge valve caps (Fig. 2 & 3).

Suction side pulsations were within the compressor side guideline (CPL), while discharge side pulsations were about 120% of the guideline.

Figure 2 Suction side overall pulsation was within guideline.

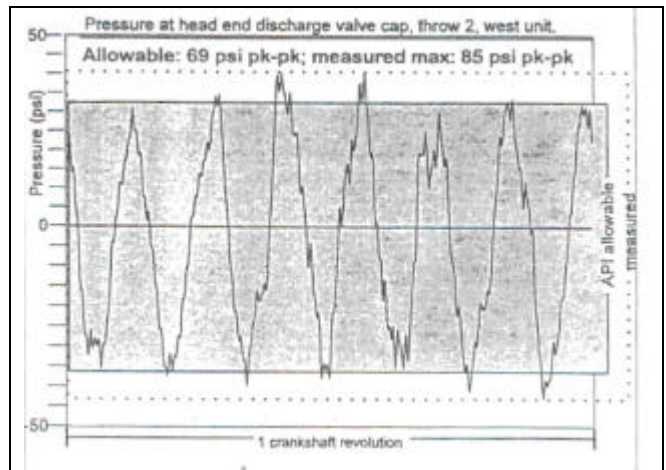
Figure 3 Discharge side overall pulsation was about 120% of guideline.

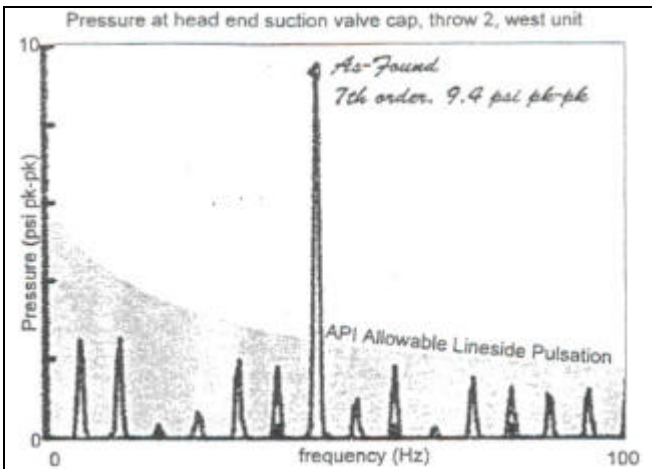
Figure 4 As-found spectrum on the suction side shows high pulsation at 7X shaft speed.

A spectrum of the as-found suction valve cap pulsation is shown in Fig. 4, and of the discharge valve cap pulsation in Fig.5.

The DPL is included as a reference in each plot, since there is currently no recognized pulsation limit based on discrete frequencies for the compressor side piping. In both cases, the DPL has been greatly exceeded at seven times crankshaft speed (7X).

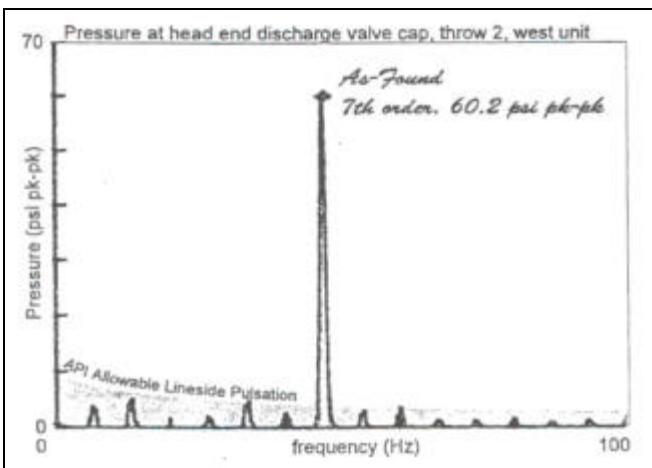
Figure 5 As-found spectrum on the discharge side shows pulsation at 7X shaft speed is about 15 X DPL.

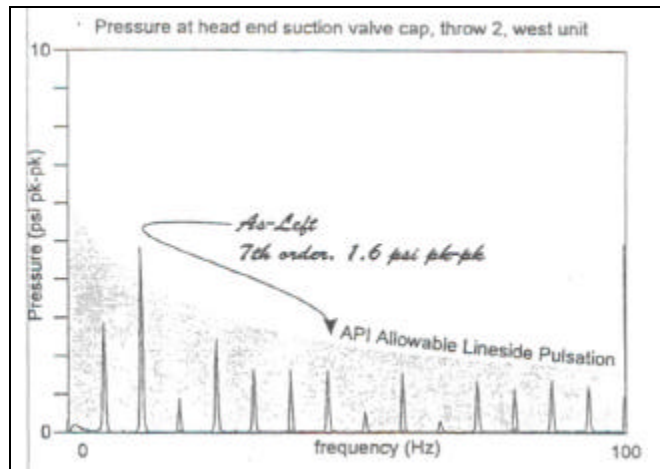
Figure 6 The orifice plate significantly reduced pulsation levels.

As-left readings (Fig. 6 & 7) were taken after orifice plates were installed in both the suction and discharge nozzles. As shown in Fig. 7, the as-left pulsation at the seventh order on the discharge side still exceeded the line side guideline by about 3X, even though it was only about 20% of the as-found reading.

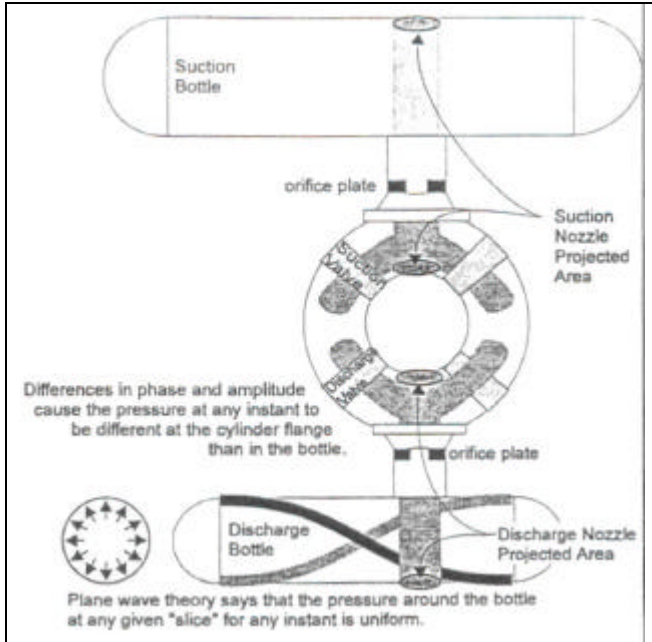
Figure 8 Vertical forces due to pulsation can develop between the cylinder and the bottle.

Figure 8 shows a cross-section of the suction and discharge bottles and cylinder on one side of the machine. The standing wave pattern of the pressure pulsation carries from the valves through the cylinder gas passages and the cylinder nozzle into the bottle, on each side of the cylinder. There is no direct connection between the two standing waves, because the suction and discharge valves are never open at the same time.

Varying pressure acting on an area produces a varying force. In the vertical direction, the areas of concern are the projected areas of the inside diameters of the suction and discharge nozzles (Fig. 8) on the bottle and the cylinder passages.

A computer model was used to predict pulsations, and the model was verified with field measurements (Figs. 5 – 7). The worst vertical forces in the discharge nozzles were calculated to be about 7000 pounds peak to peak (pk – pk) and in the suction nozzles about 1100 pounds pk – pk) and in the suction nozzles about 1100 pounds pk – pk, both at the seventh order. It is clear that these forces are sufficient to cause the problems found.

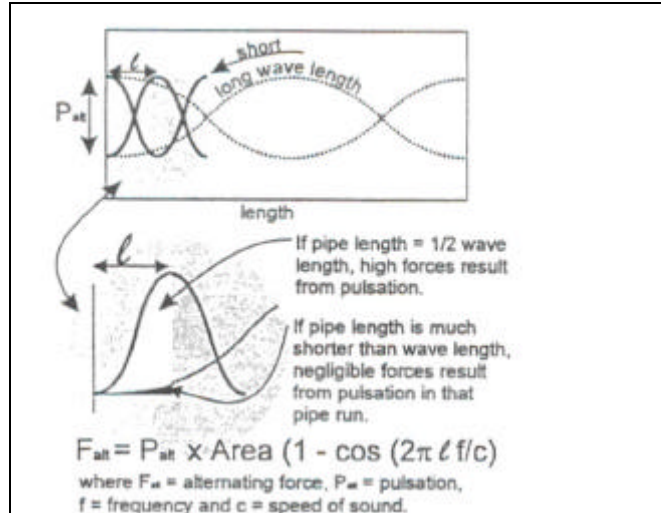
Figure 9 The maximum unbalanced force occurs when pipe length equals half wave length.

Note that over the short length between the cylinder and the bottle, there is very little change in pressure amplitude at low frequencies (Fig. 9). The unbalanced force generated in short pipe runs by pressure pulsations at low orders of run speed (long wave lengths) will be much lower than at higher orders, all other things being equal.

To illustrate, one can calculate from the equation in Fig. 9 the allowable pulsations for a particular system, as shown in Fig. 10. The CPL is too high to control vibration; the DPL is too stringent.

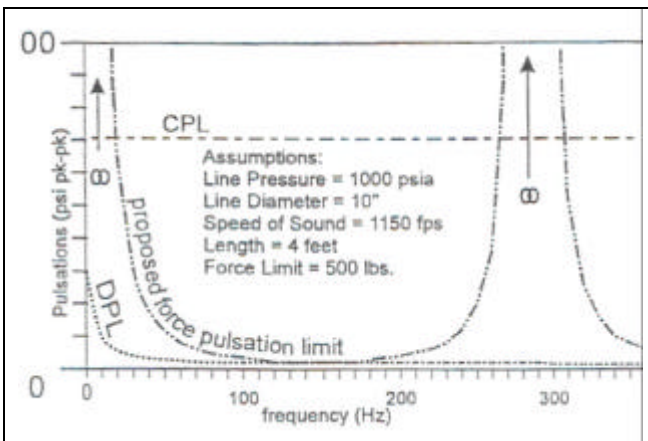
Figure 10 The proposed frequency-based compressor side pulsation limit is a compromise.

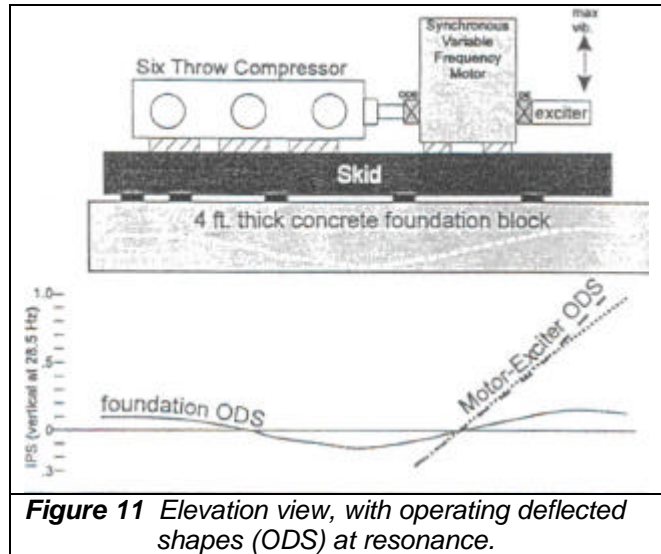
The three units (Fig. 11) are large variable speed horizontal compressors, mounted on skids bolted to 3 ft. thick concrete foundation blocks. The foundation blocks are embedded into the sandy soil. No piles were used.

Figure 11 Elevation view, with operating deflected shapes (ODS) at resonance.

Operating deflections (Fig. 11) showed that the exciter was amplifying the motion of the motor-compressor-foundation system due to geometry effects.

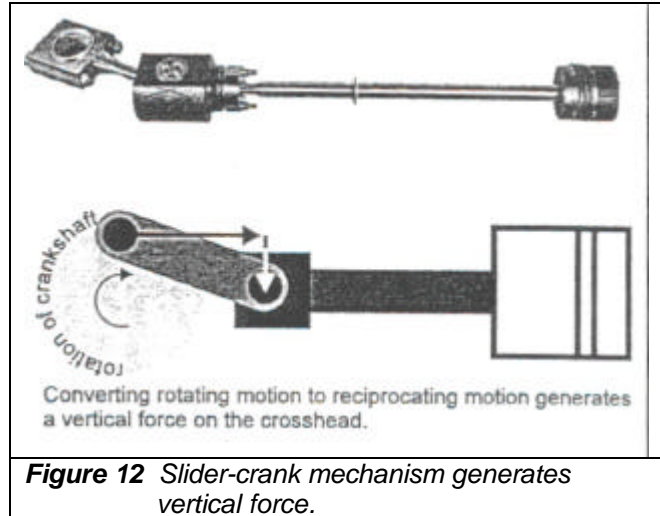
Figure 12 illustrates the source of vertical force at the crosshead. Figure 13 shows the vertical force versus crank angle for this compressor at the cylinder 1 crosshead. These vertical forces were considered and initially rejected as a source of the problem, since they are all equal in magnitude and vectorially cancel due to the phasing of the 6-throw crankshaft (120 degrees between throws).

Figure 12 Slider-crank mechanism generates vertical force.

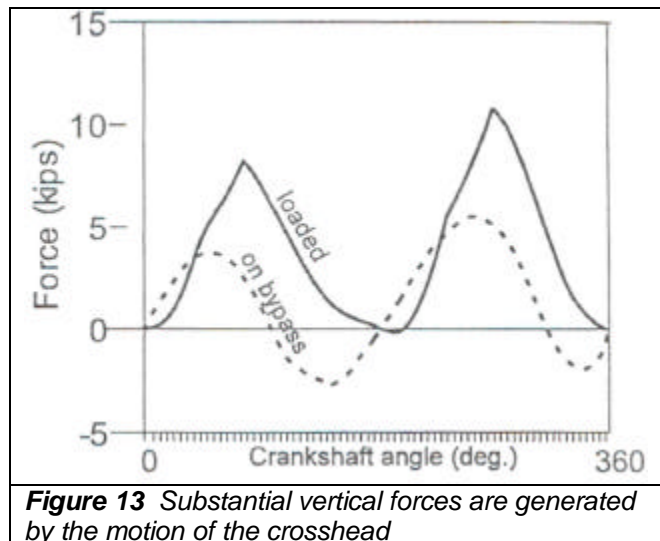
Figure 13 Substantial vertical forces are generated by the motion of the crosshead

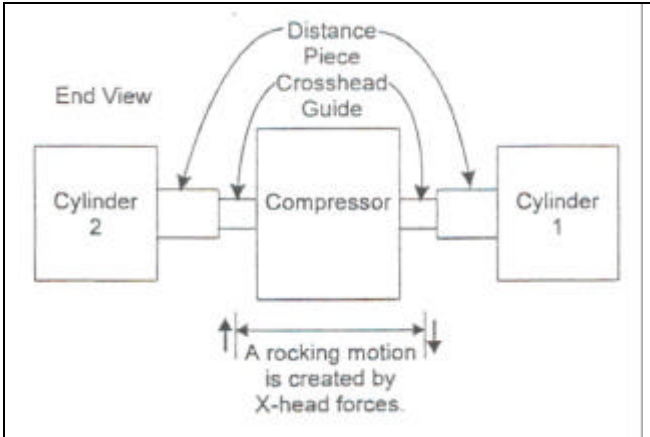
Figure 14 shows how the crosshead forces can cause the compressor to rock. Had there been a

torsional mode about the centreline of the crankshaft with a node in the middle of the compressor, the couple shown in Fig. 14 would have caused high vibration.

Figure 14 Crosshead forces produce a couple about the centreline of the crankshaft.

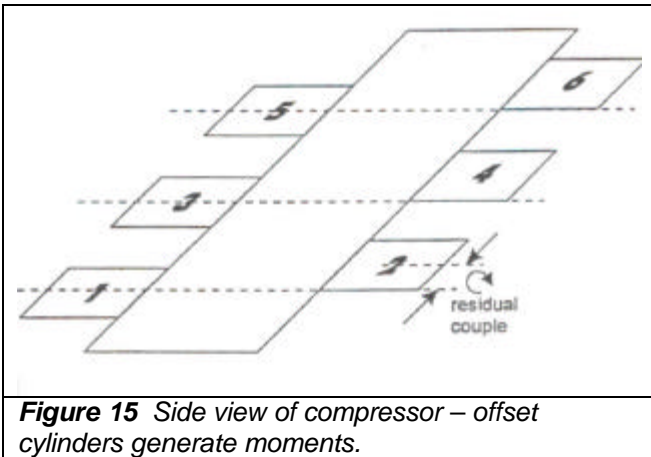
Upon reflection, it was realized that the offset between cylinders (Fig. 15) causes the forces in the opposed pairs (e.g. throws 1 & 2 or 5 & 6) to produce another couple, this one about an axis parallel to piston motion. If the foundation behaved as a rigid body, the three couples from the three pairs of throws would cancel.

In this case, the out-of-phase motion of the foundation at twice crankshaft speed allows the couples to excite the mode.

Figure 15 Side view of compressor – offset cylinders generate moments.

The amplitude of the vibrations was reduced by 30% by stiffening the connection of the motor end bells to the skid, using jacking bolts. This modification did not change the frequency of the peak response. It appears that no complete solution is possible except by changing the foundation natural frequency.
